Asbestos Assessment Report

February 2010

Prepared For

Auburn City Council

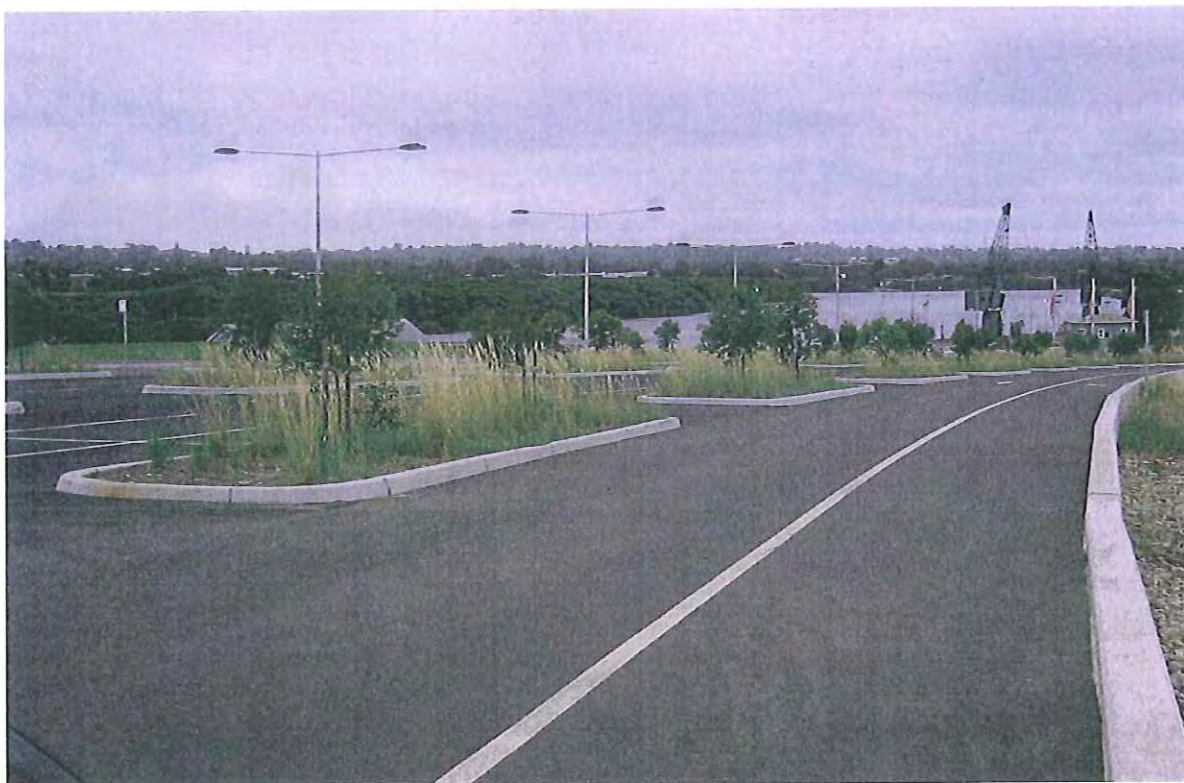
An assessment of the site conducted by DECCW on 14 February 2008 found that there was no visible evidence of asbestos at the site.

Figure 2 - Current condition of former James Hardie asbestos disposal site - Sydney Olympic Park.

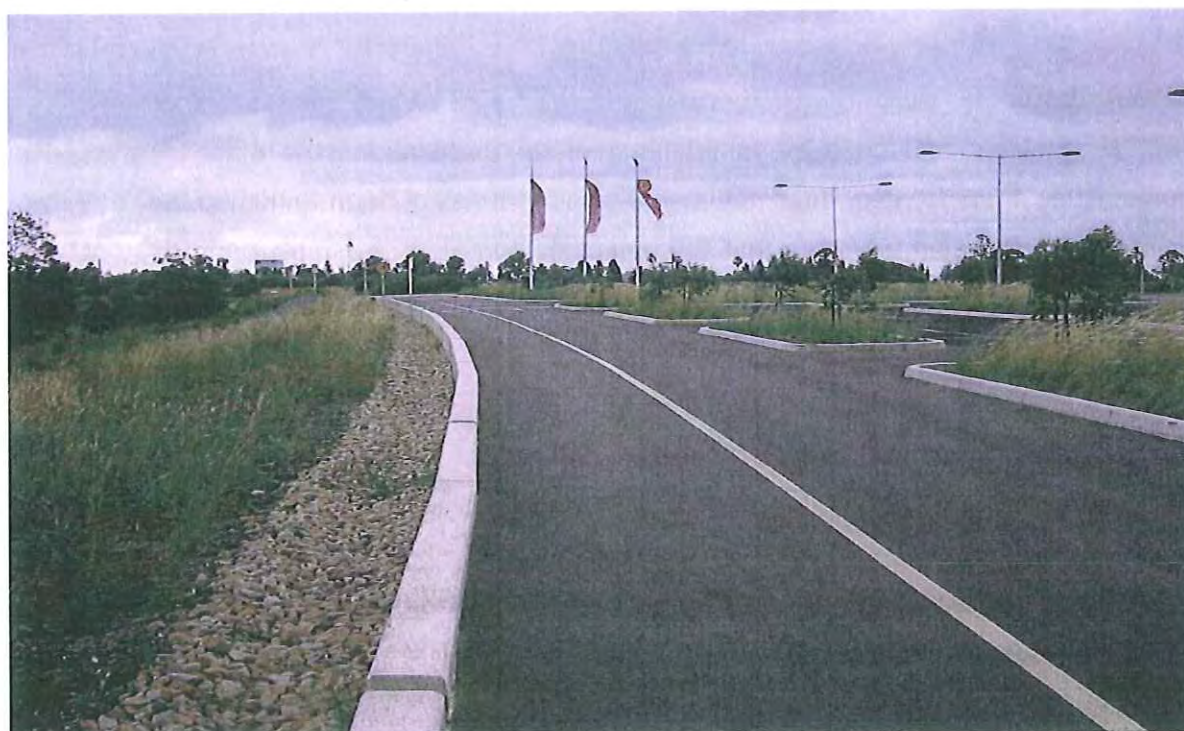
Figure 3 - Current condition of former James Hardie asbestos disposal site - Sydney Olympic Park.

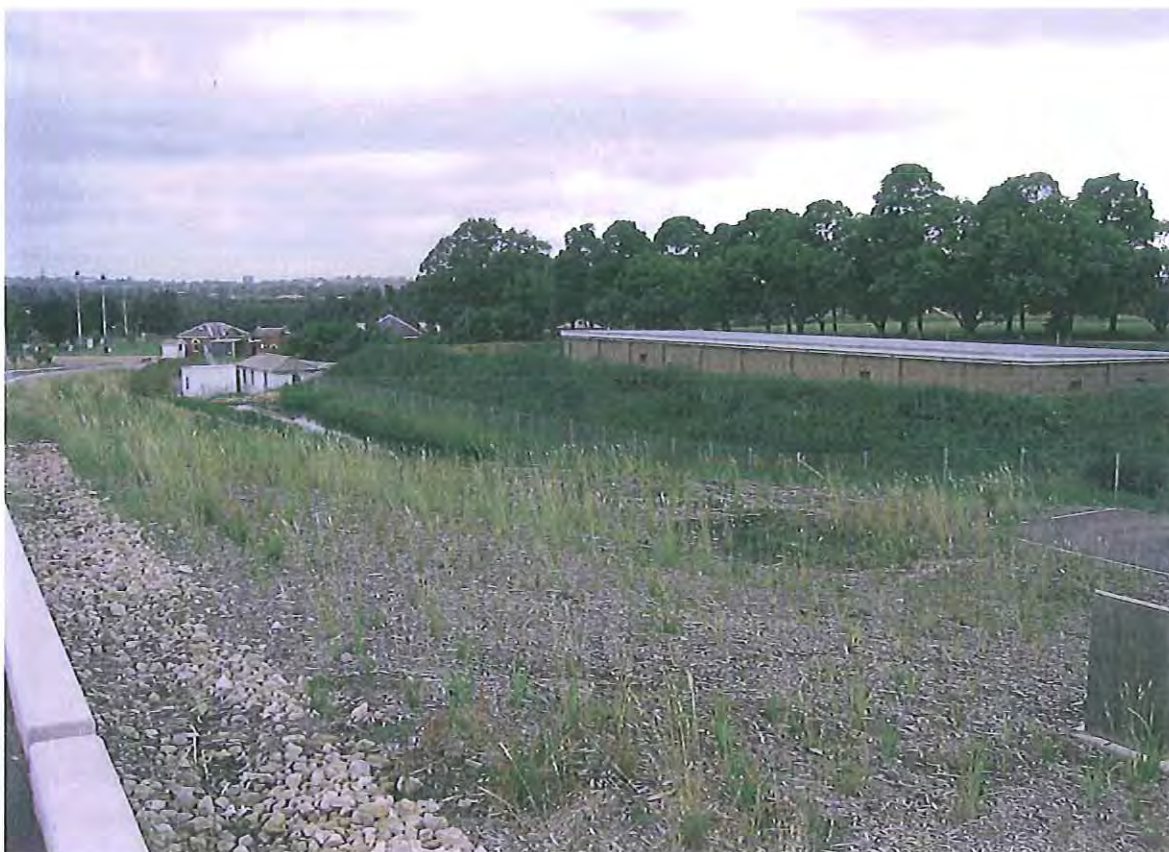
Figure 4 - Current condition of former James Hardie asbestos disposal site - Sydney Olympic Park.

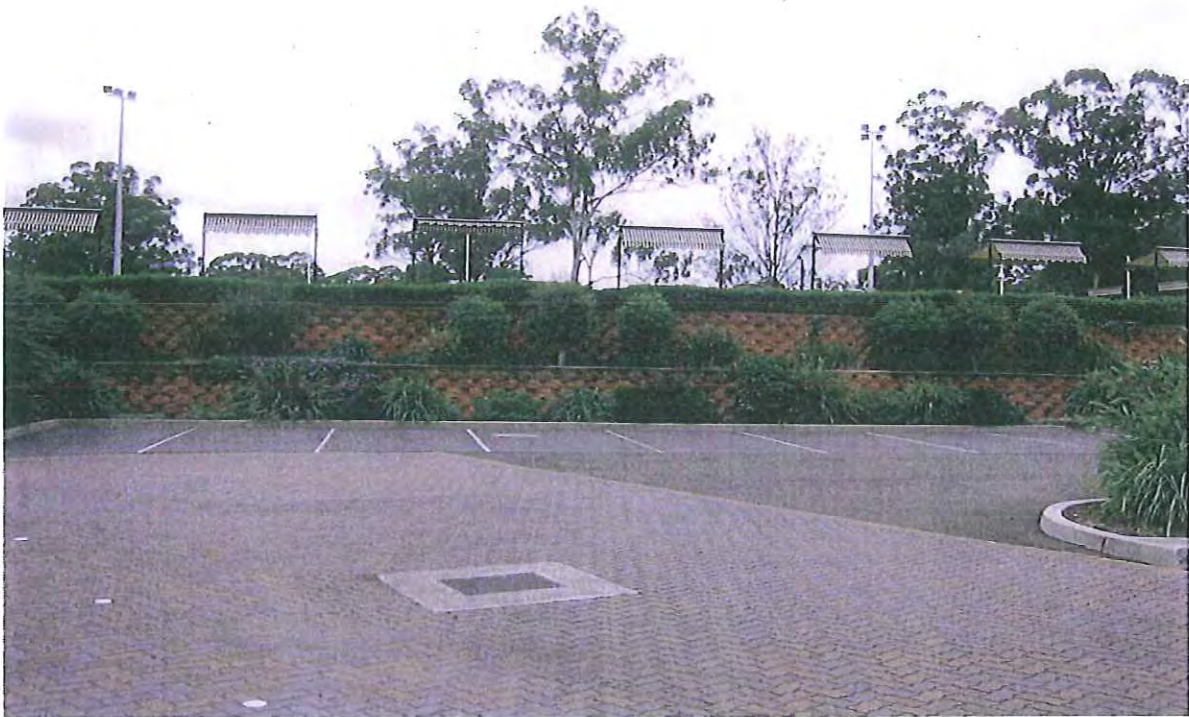
An assessment of the site conducted by DECCW on 14 February 2008 found no visible evidence of asbestos on the open area of the site. The site is mostly paved or covered with bowling greens.

Figure 3 - Current condition of St Johns Park Bowling Club

1. A management plan should be developed by an occupational hygienist with recognized experience in asbestos identification and management to ensure that the asbestos is not disturbed unless appropriate plans for investigation / remediation are developed as suitable for implementation by a site auditor accredited under the CLM Act.
2. Council should consider making appropriate notation on the relevant planning certificates (i.e. Section 149 planning certificate).

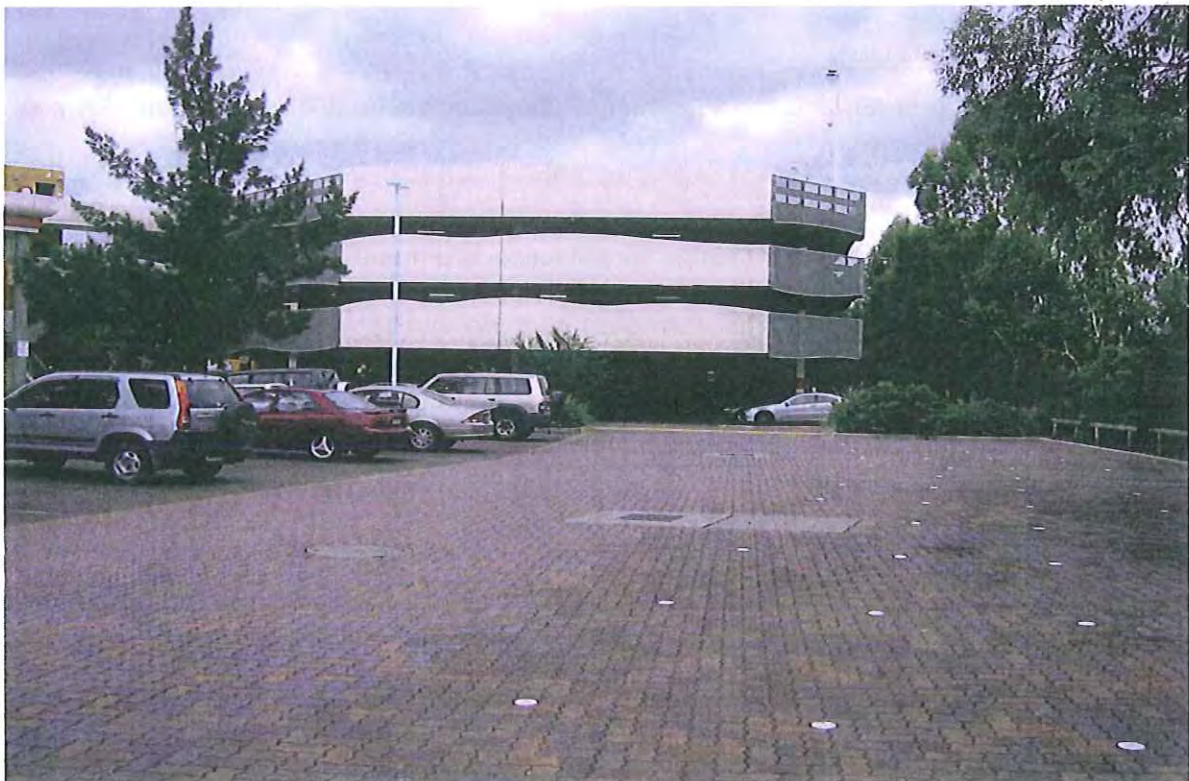
Figure 4 - Current condition of St Johns Park Bowling Club

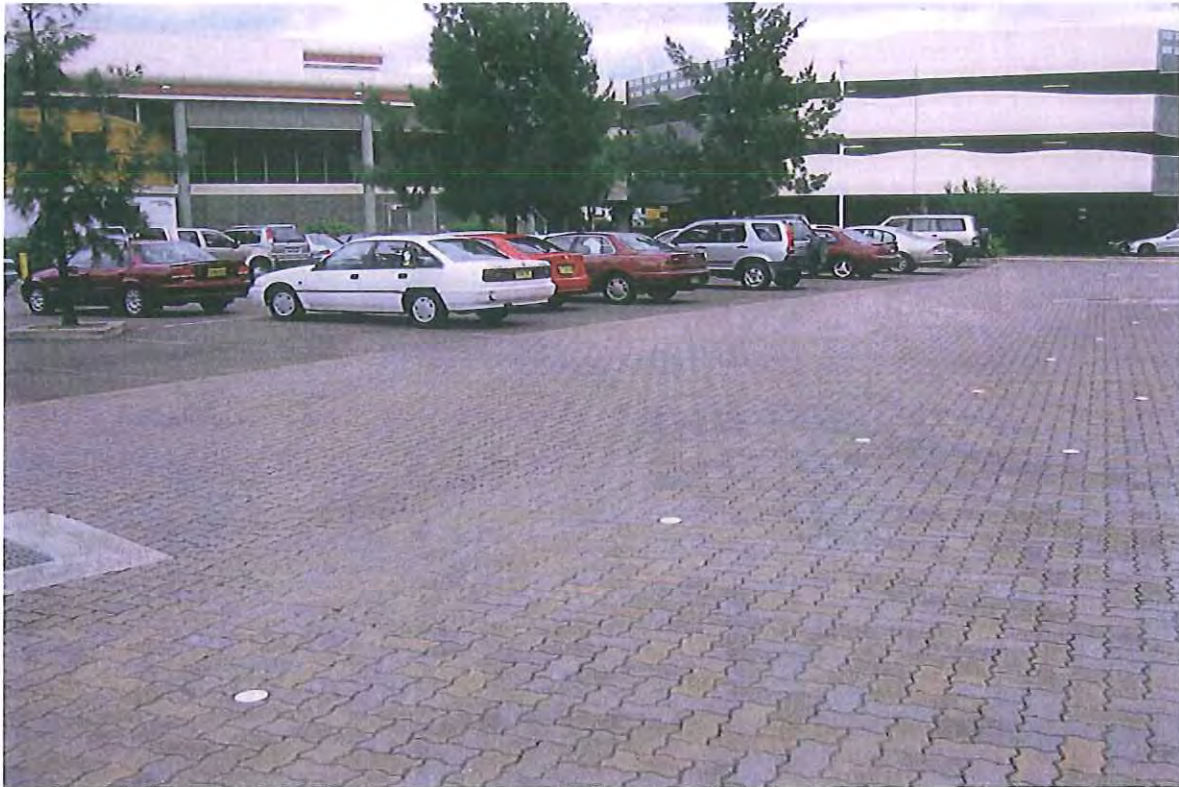
Figure 5 - Current condition of St Johns Park Bowling Club

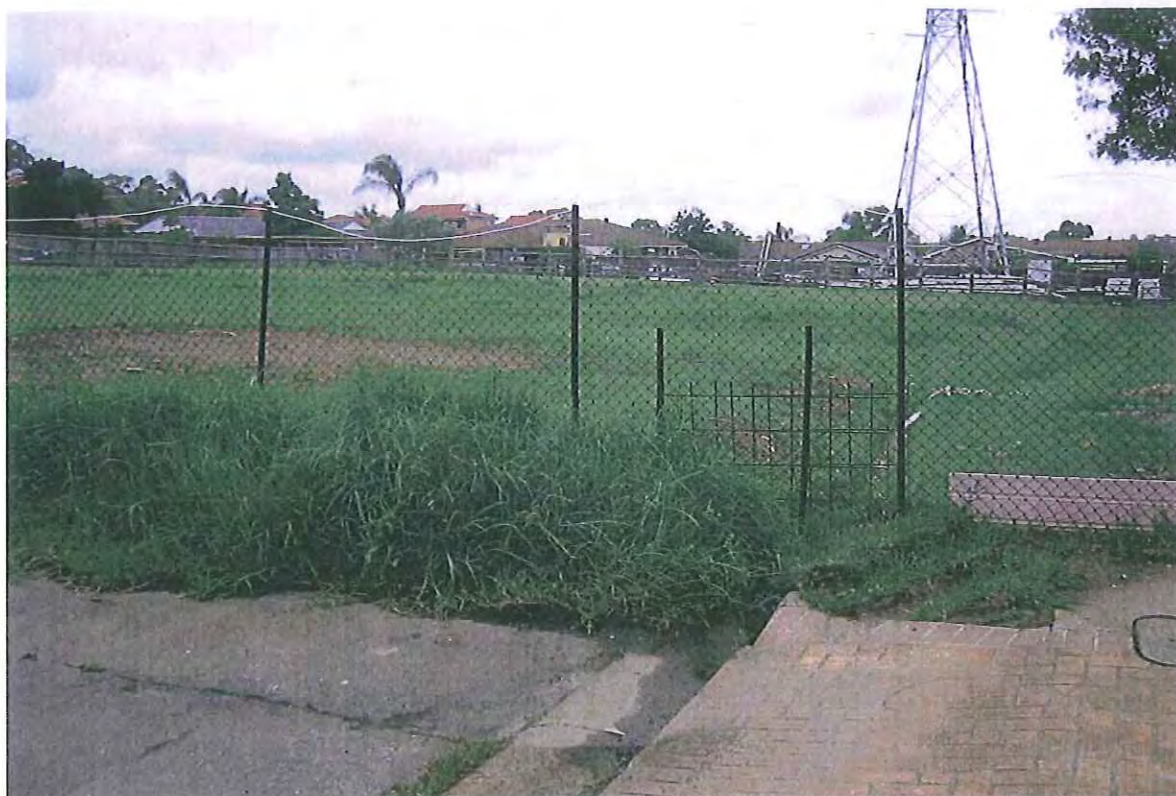
An assessment of the site conducted by DECCW on 14 February 2008 found visible evidence of asbestos, present as broken pieces of bonded asbestos sheet. Information received from James Hardie indicates that the asbestos was previously buried. However,

over time small areas of the site have eroded and some asbestos material has been uncovered.

Figure 7 - Current condition of Old Clay Pit, Edensor Park

1. Any visible asbestos should be periodically removed in accordance with recognized Occupational Health and Safety practices.
2. A management plan should be developed by an occupational hygienist with recognized experience in asbestos identification and management to ensure that the asbestos is not disturbed unless appropriate plans for investigation / remediation are developed as suitable for implementation by a site auditor accredited under the CLM Act.
3. Council should consider making appropriate notation on the relevant planning certificates (i.e. Section 149 planning certificate).

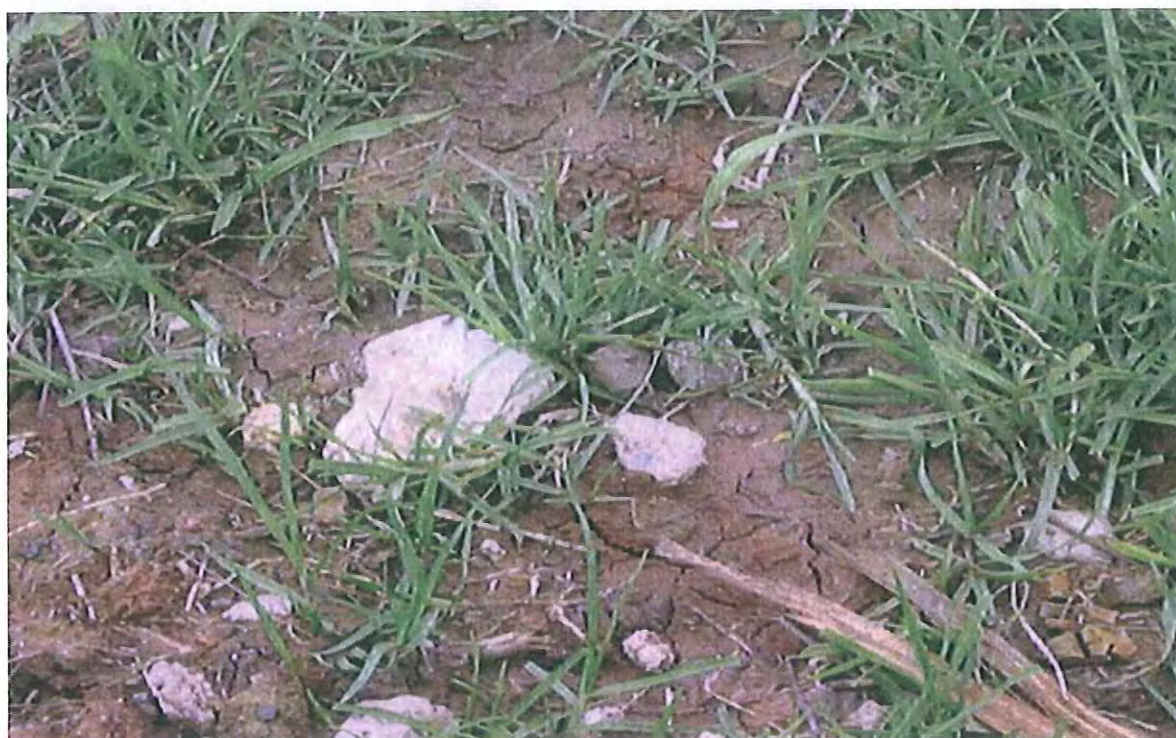
Figure 8 – Exposed pieces of broken asbestos bonded sheet at Old Clay Pit, Edensor Park

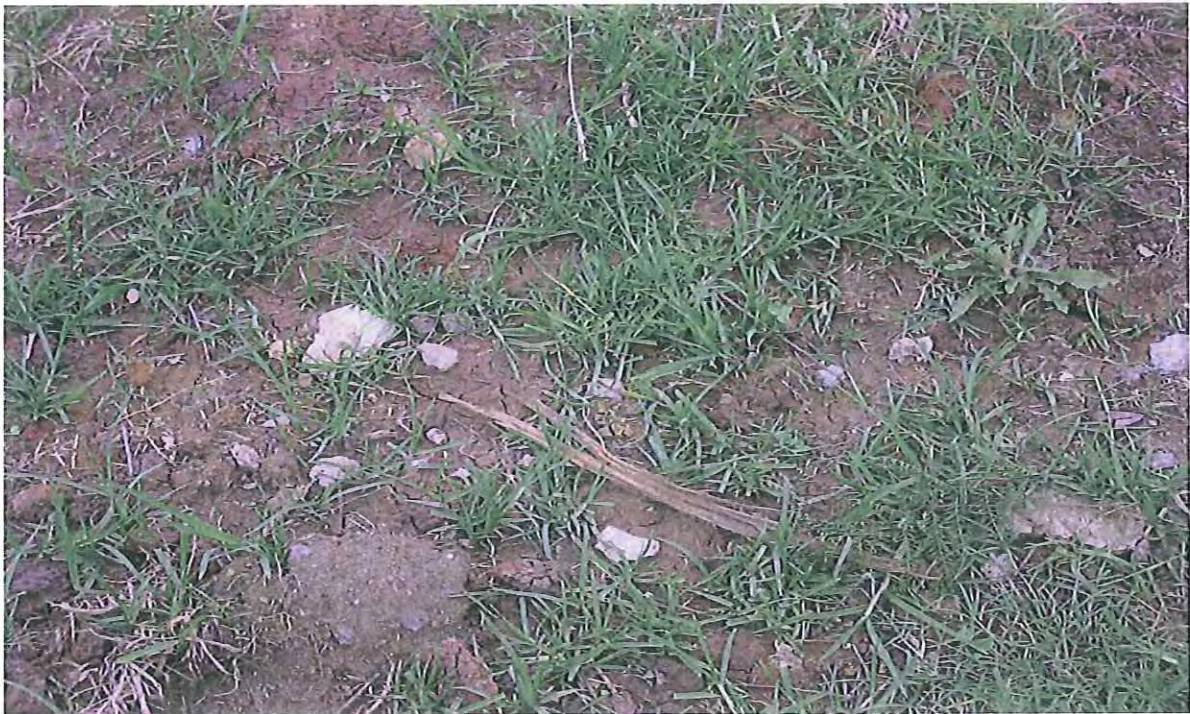
Figure 9 - Exposed pieces of broken asbestos bonded sheet at Old Clay Pit, Edensor Park

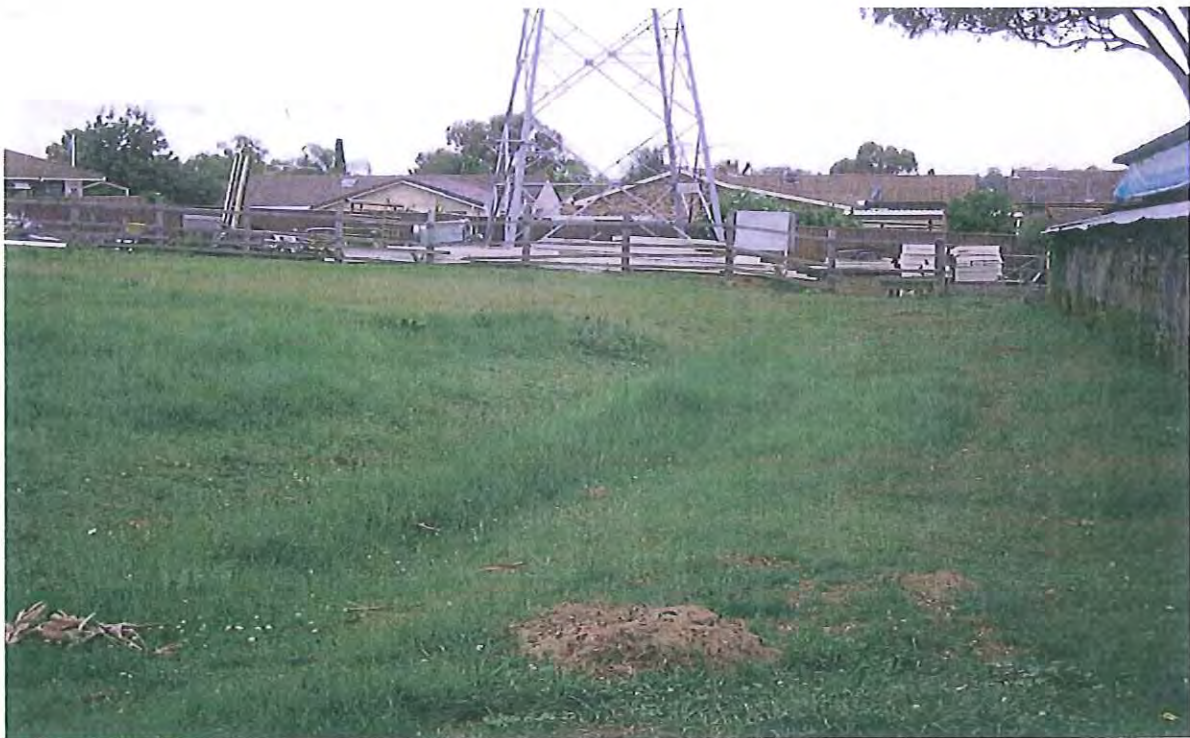
Figure 10 - Current condition of Old Clay Pit, Edensor Park

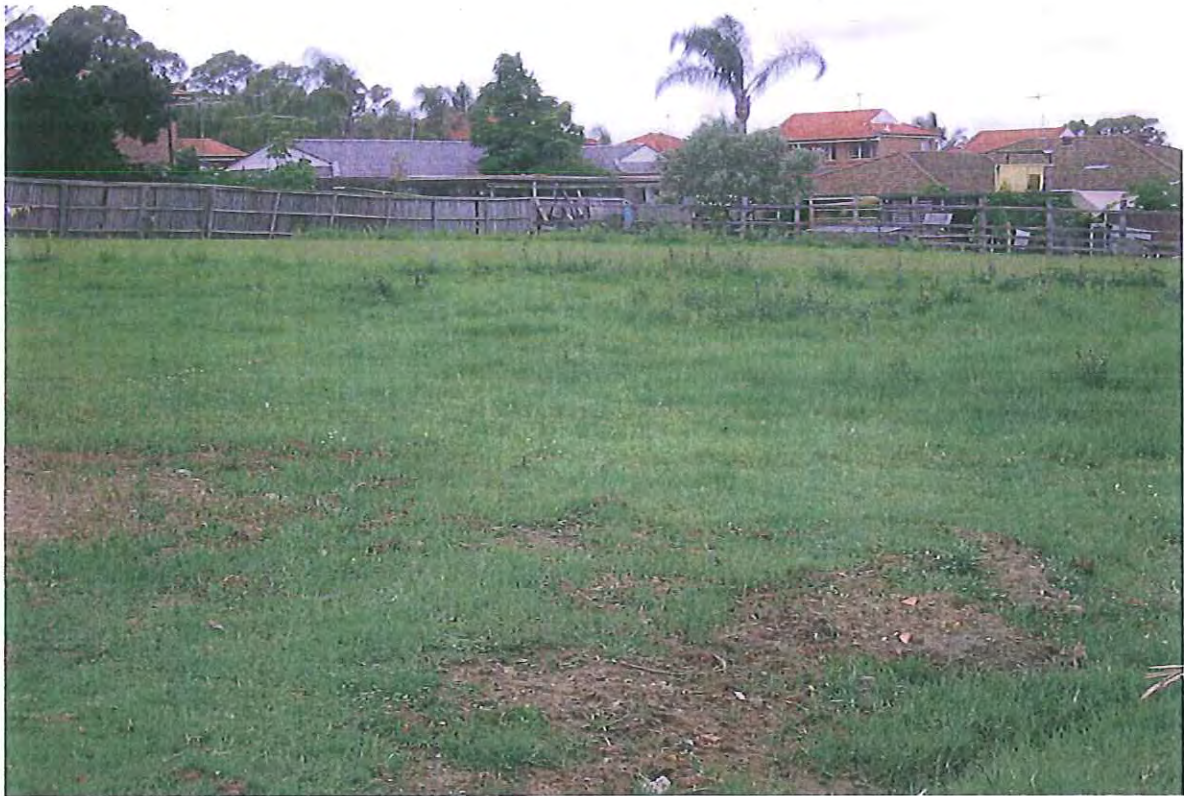
Figure 11 - Current condition of Old Clay Pit, Edensor Park

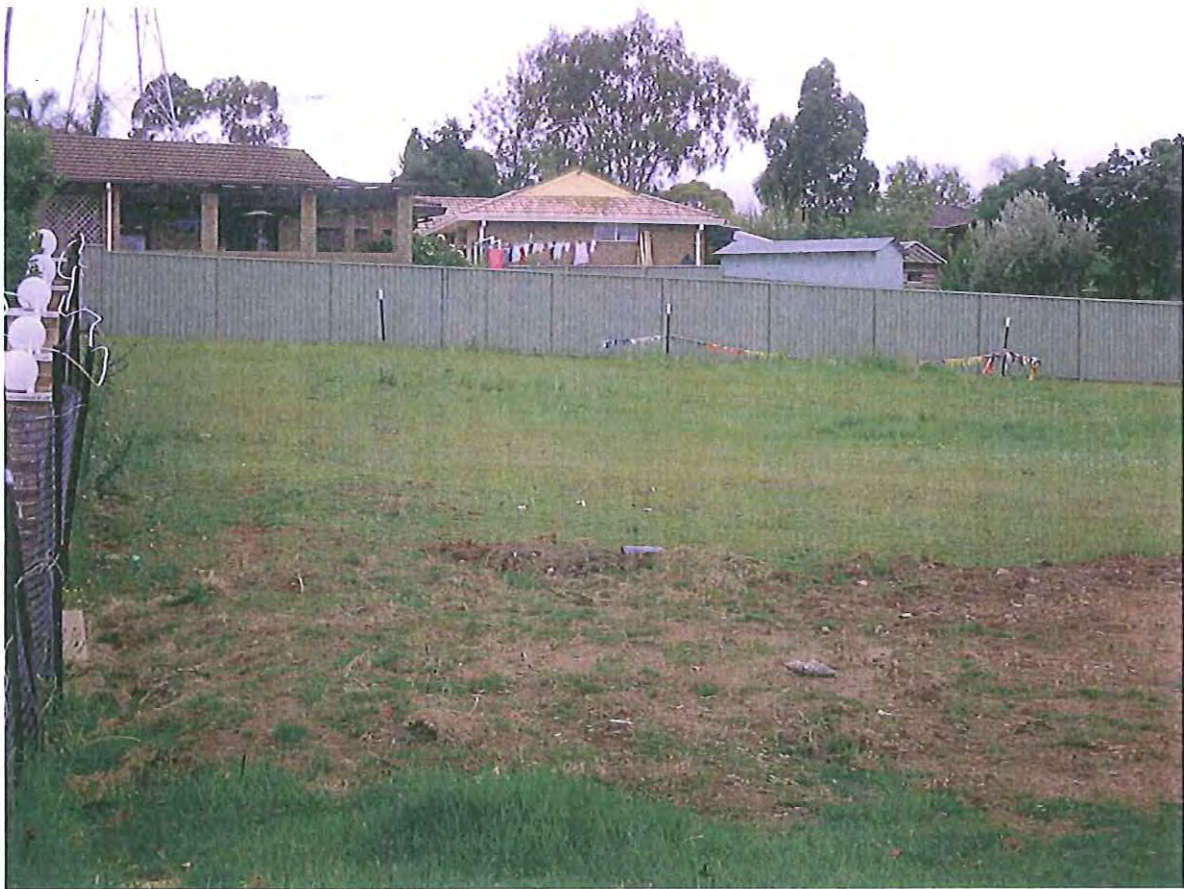
Figure 12 - Current condition of Old Clay Pit, Edensor Park

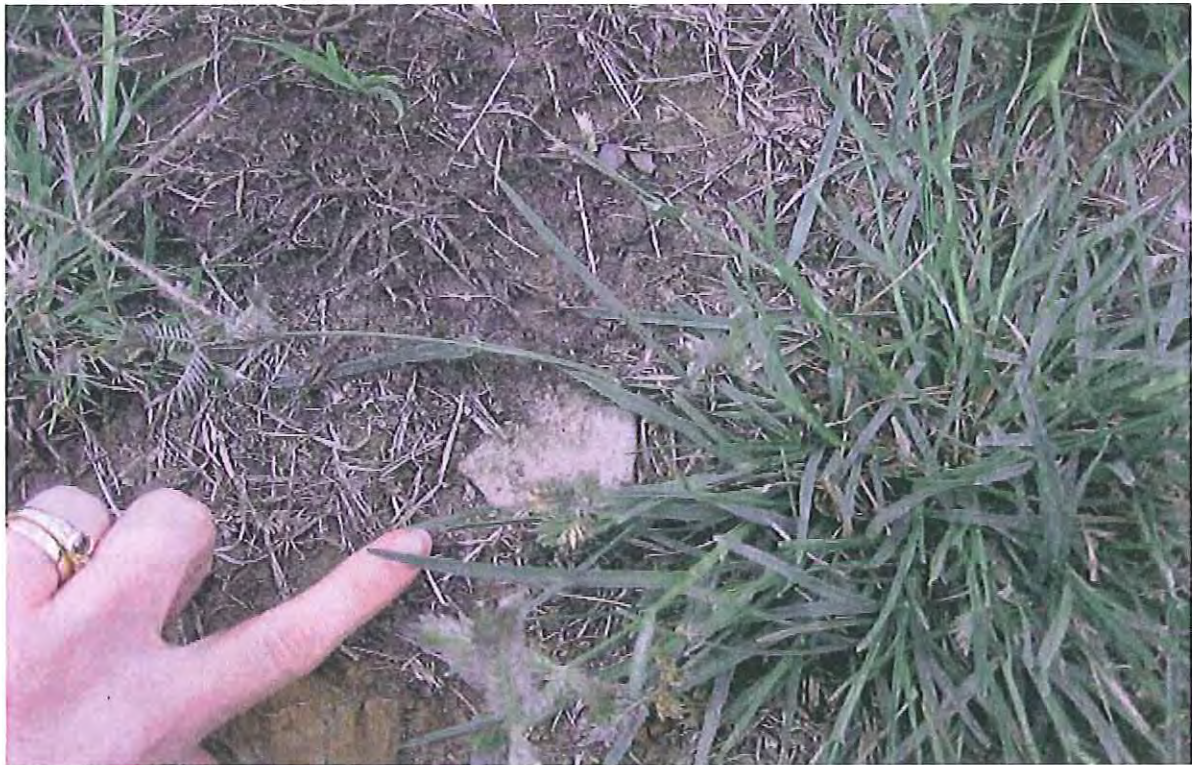
An assessment of the site conducted by DECCW on 14 February 2008 found visible evidence of asbestos, present as broken pieces of bonded asbestos sheet. Information

received from James Hardie indicates that the asbestos was previously buried. However, over time small areas of the site have eroded and some asbestos material has been uncovered.

Figure 3 - Exposed pieces of broken asbestos bonded sheet at Hyland Road Park

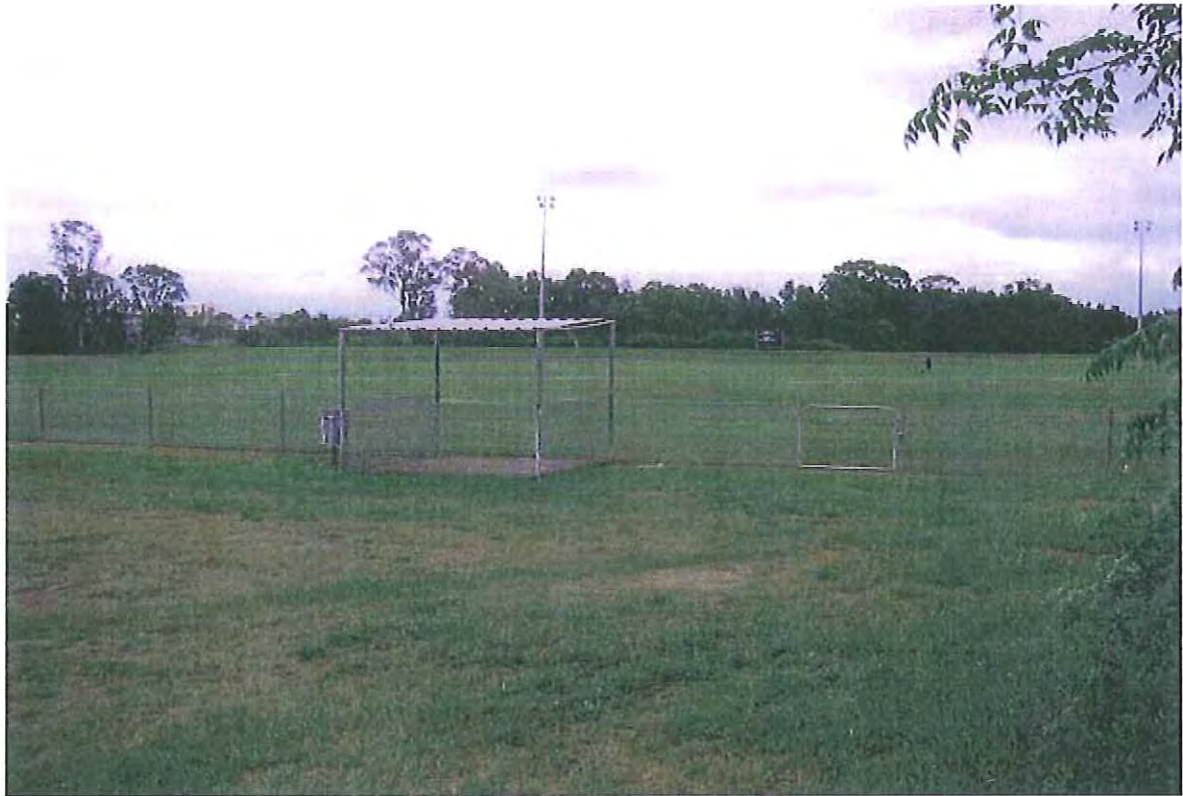
Figure 4 - Current condition of Hyland Road Park, Greystanes

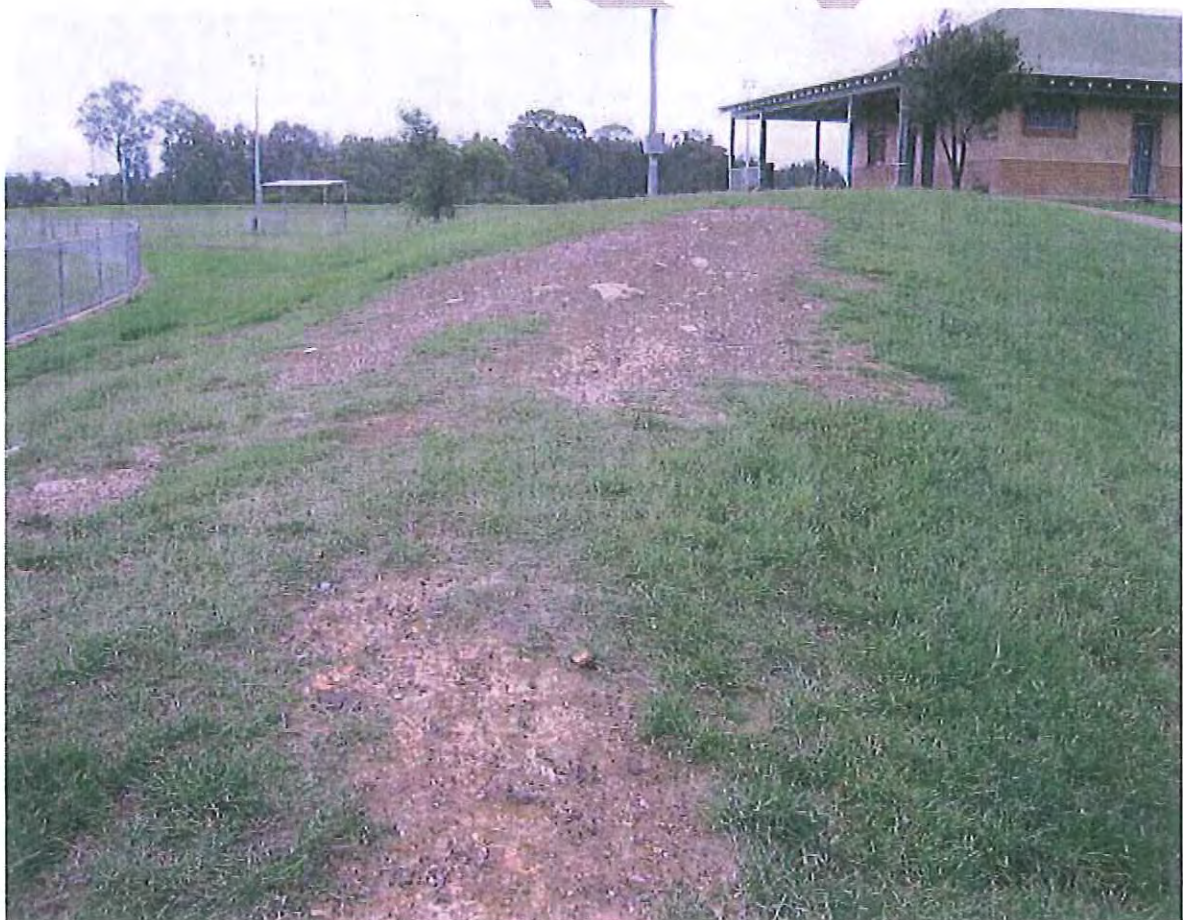
Figure 5 - Current condition of Hyland Road Park, Greystanes

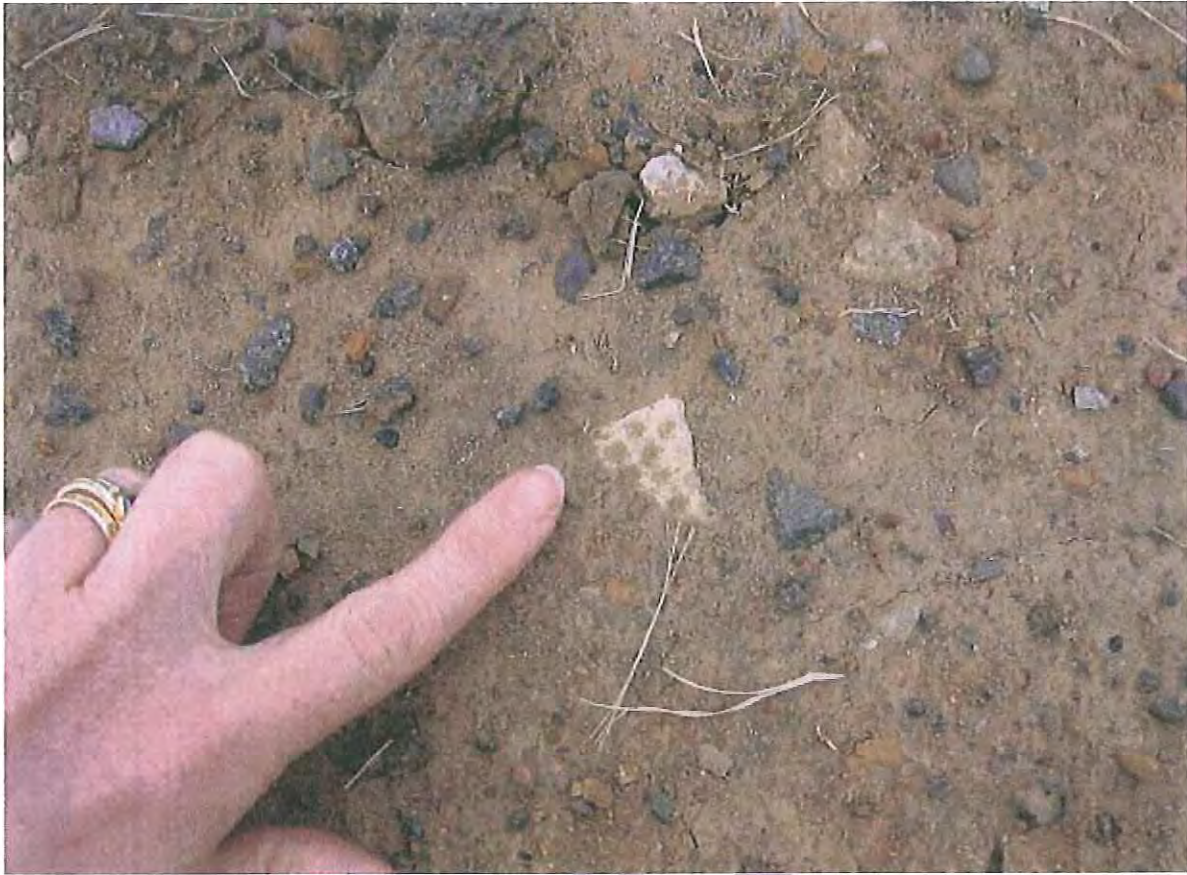
Figure 6 - Exposed pieces of broken asbestos bonded sheet at Hyland Road Park

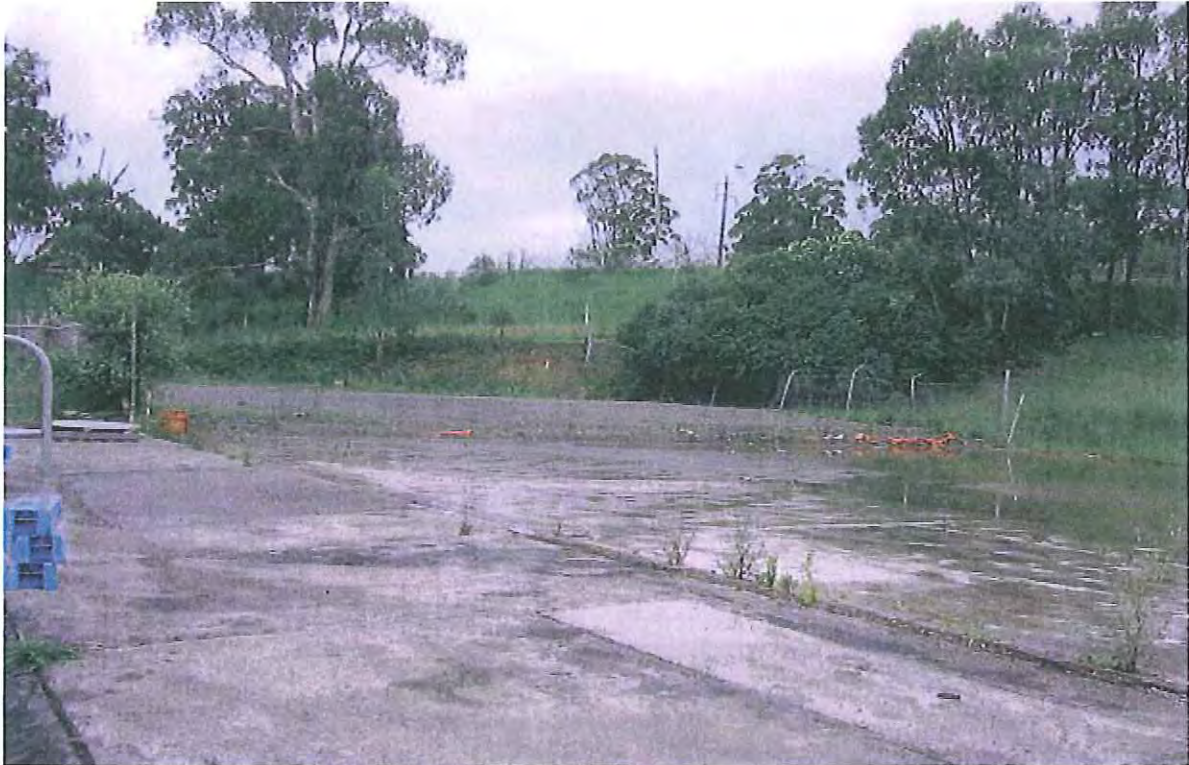
An assessment of the site conducted by DECCW on 14 February 2008 found visible evidence of asbestos, present as broken pieces of bonded asbestos sheet. The majority of the fire-damaged building has been removed.

Figure 8 - Current condition of 79 Betts Road, Smithfield

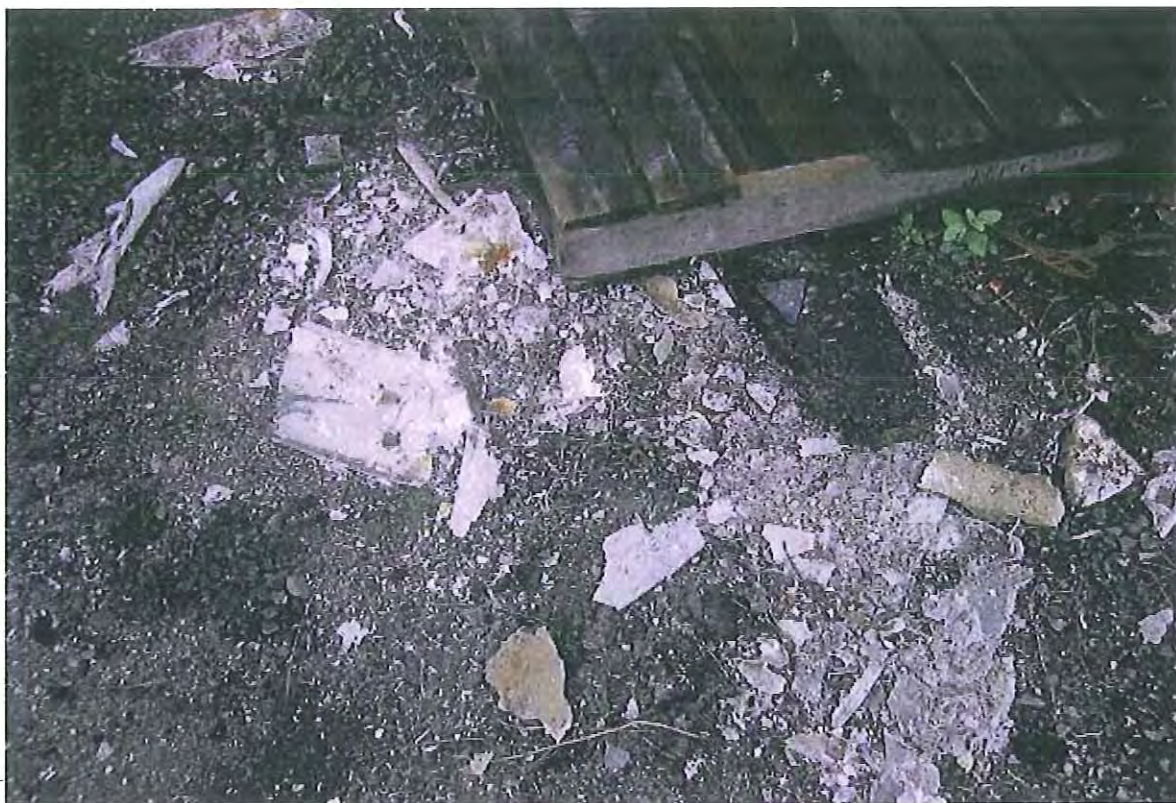
Figure 9 - Exposed pieces of broken asbestos bonded sheet at 79 Betts Road Smithfield

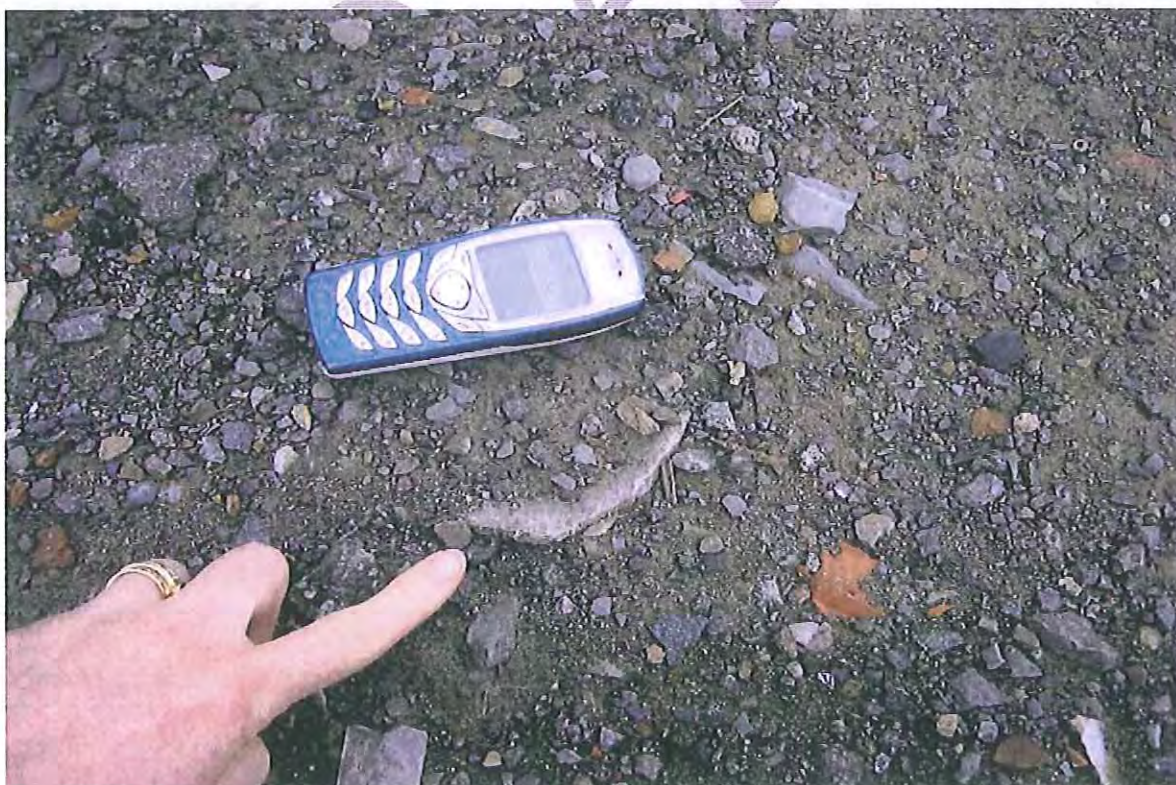
Figure 10 - Exposed pieces of broken asbestos bonded sheet at 79 Betts Road Smithfield

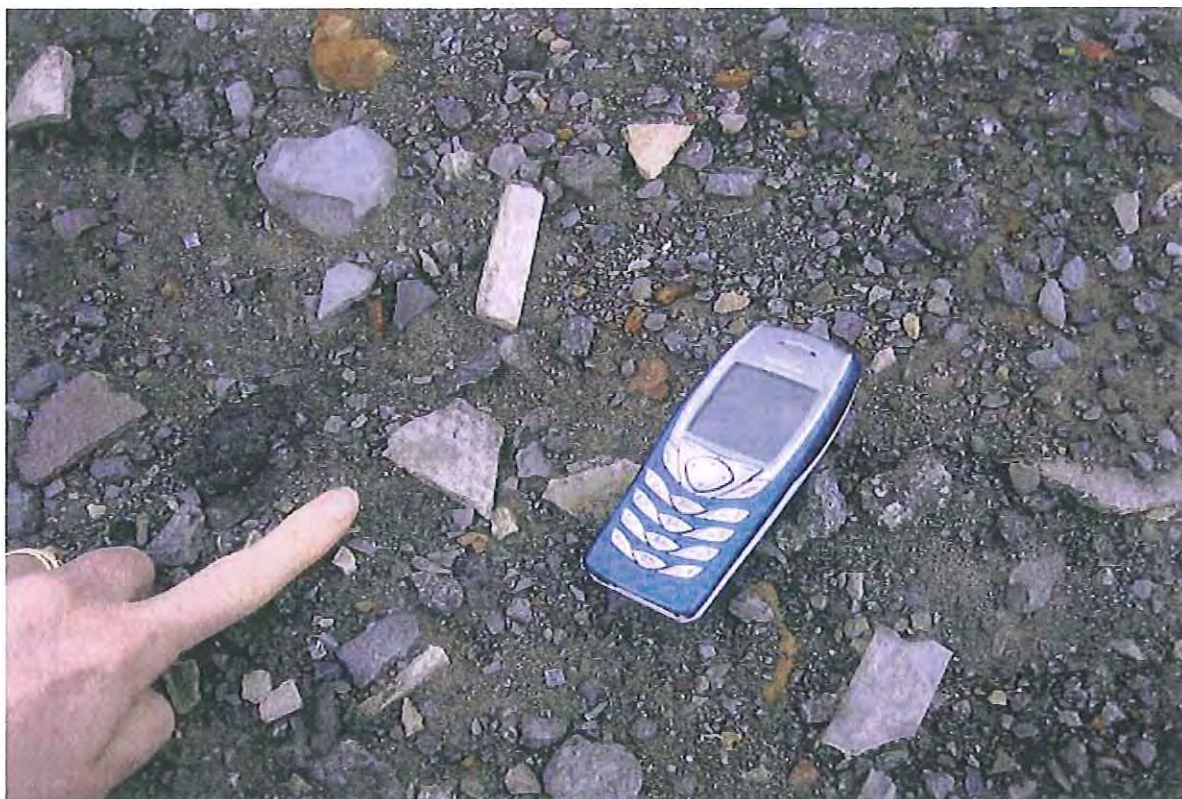
Figure 11 - Exposed pieces of broken asbestos bonded sheet at 79 Betts Road Smithfield

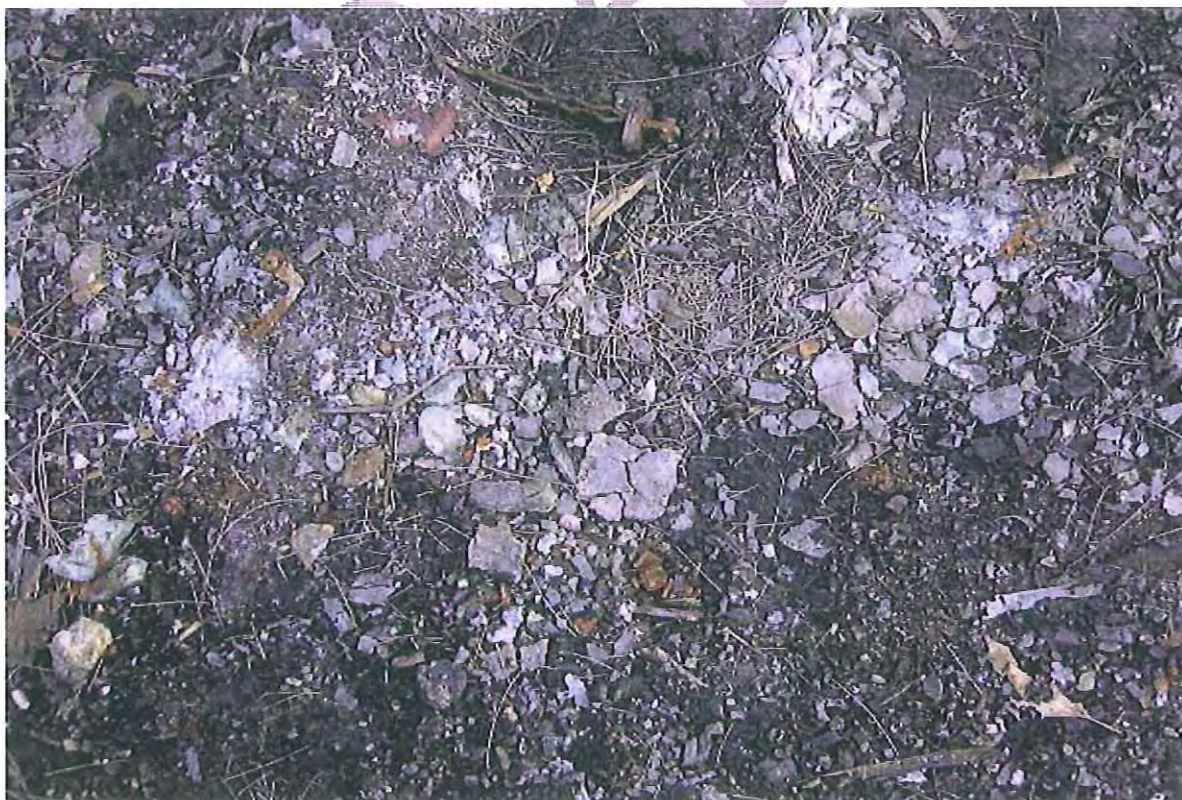
Figure 12 - Exposed pieces of broken asbestos bonded sheet at 79 Betts Road Smithfield

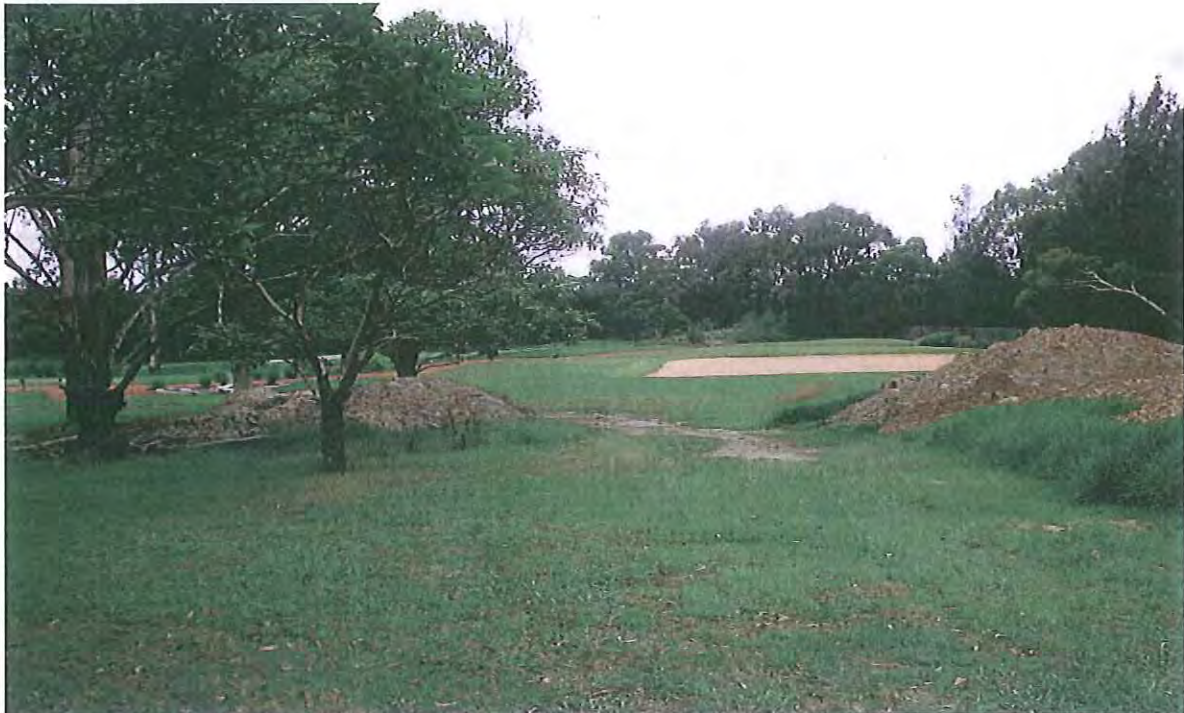
The site is currently used as a golf course, which appears to be well covered with grass and landscaping. An assessment of the site conducted by DECCW on 14 February 2008 found no visible evidence of asbestos on the open area of the site. However, redevelopment of/ on the site may disturb asbestos-containing material.

Figure 2 - Current condition of New Brighton Golf Course

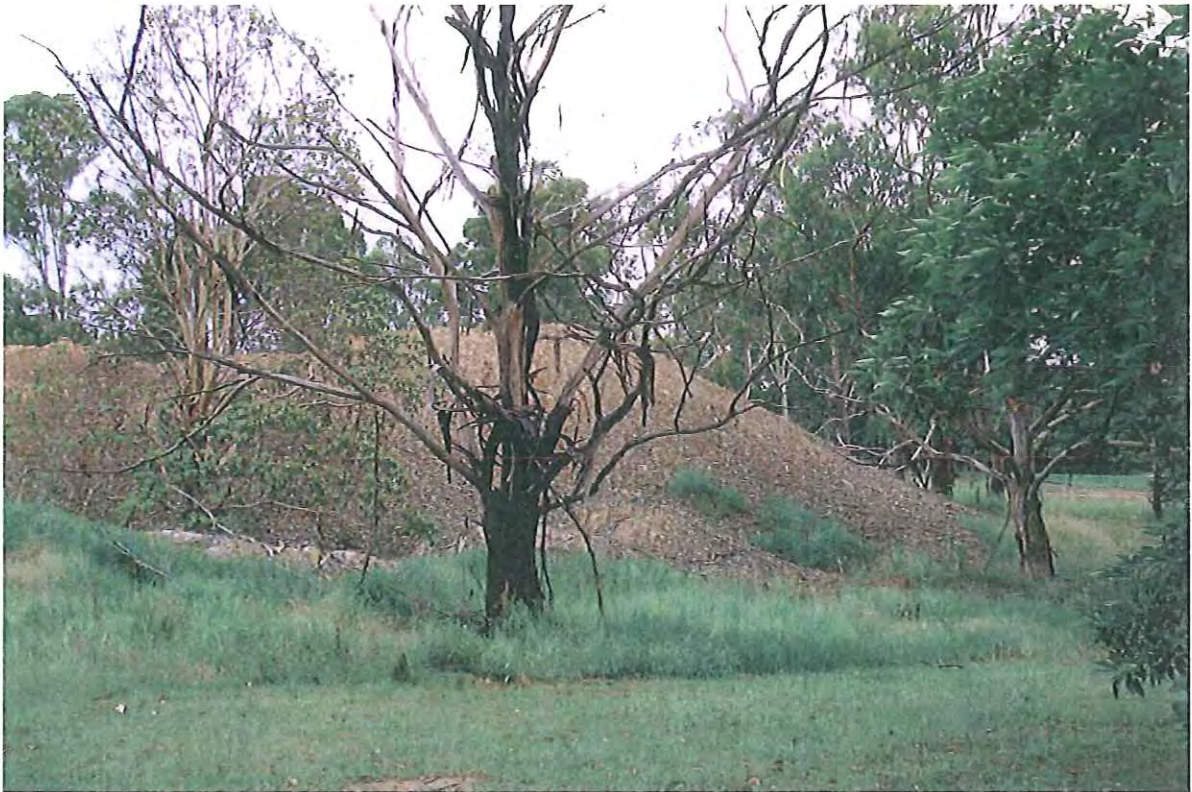
Figure 3 - Current condition of New Brighton Golf Course
