Asbestos Assessment Report

February 2010

Prepared For

Auburn City Council

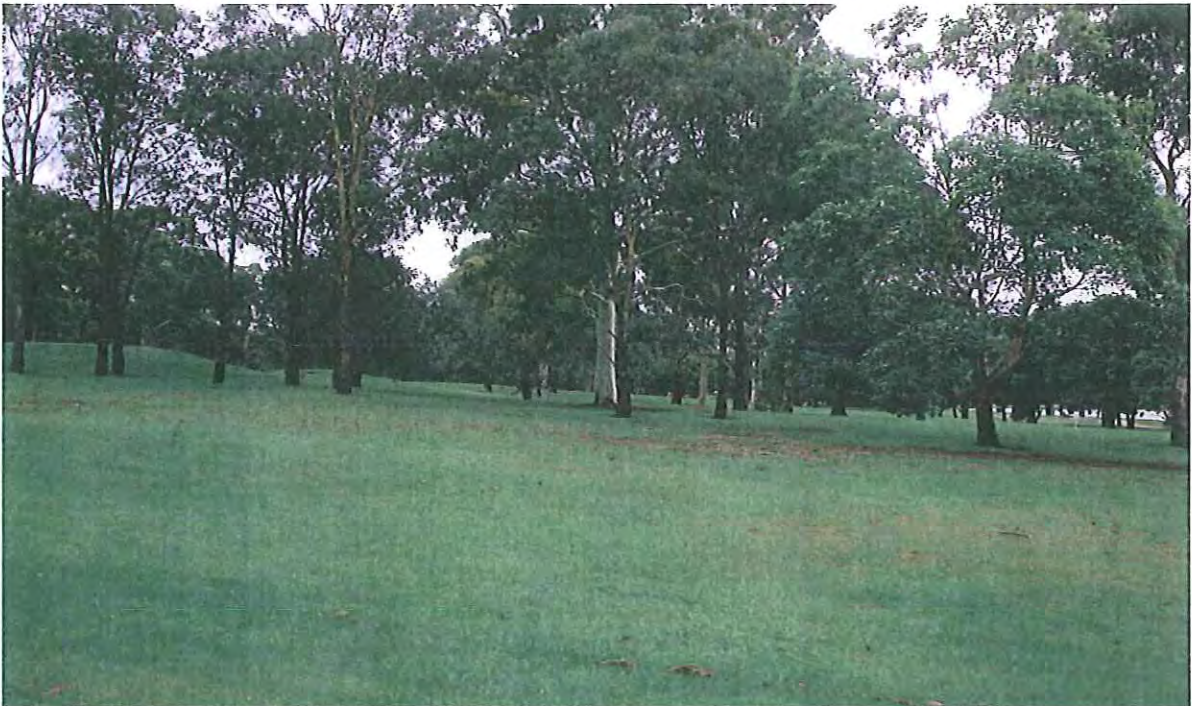
Figure 4 - Current condition of New Brighton Golf Course

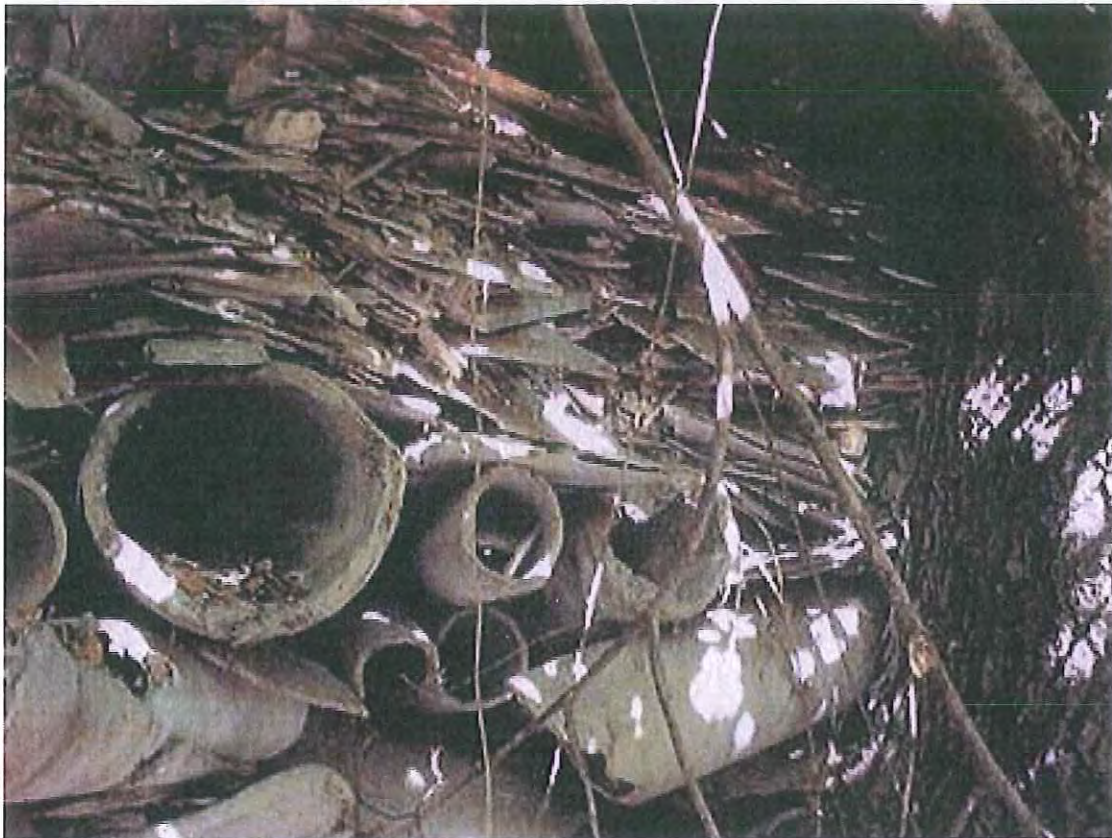
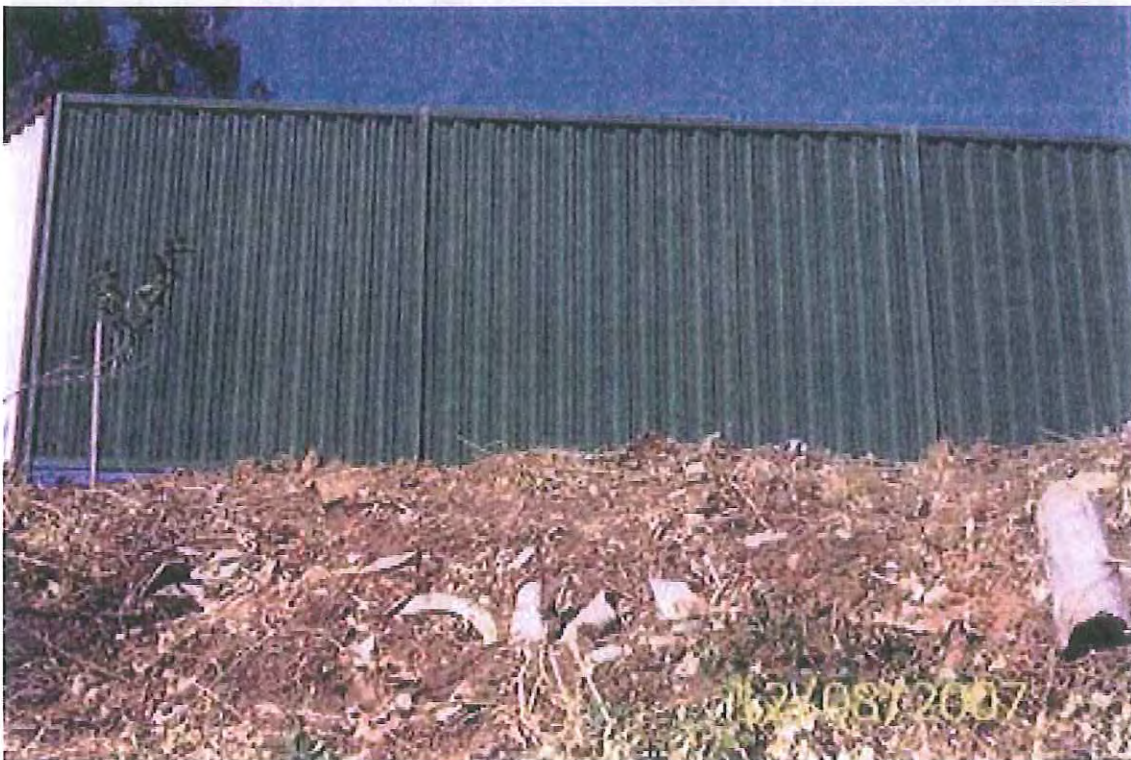
Site 6 Embankment along stormwater canal near A'Beckett Street Granville

An assessment of the site conducted by DECC in December 2007 found that the bonded asbestos cement piping and sheeting was buried into the embankment of the stormwater canal. The material is accessible to the public and will require stabilisation or removal. Redevelopment, weathering, erosion, drilling and cutting may further expose asbestos waste.

1. The visible asbestos is removed following recognised Occupational Health and Safety practices;
2. A management plan is developed by an occupational hygienist with recognised experience in asbestos identification and management to ensure that the asbestos is not disturbed unless appropriate plans for investigation/ remediation are developed and assessed as suitable for implementation by a site auditor accredited under the CLM Act (this may include clean fill to be placed across affected areas and re-grassing of the site);
3. If the various land owners cannot cooperate to formulate a Remedial Action Plan to remove or cover/ stabilise the asbestos, then DECC (as the Appropriate Regulatory Authority) will need to consider issuing a clean-up notice requiring a Remedial Action Plan; and
4. Consider making appropriate notation on the relevant planning certificates (i.e. s.149 certificate).

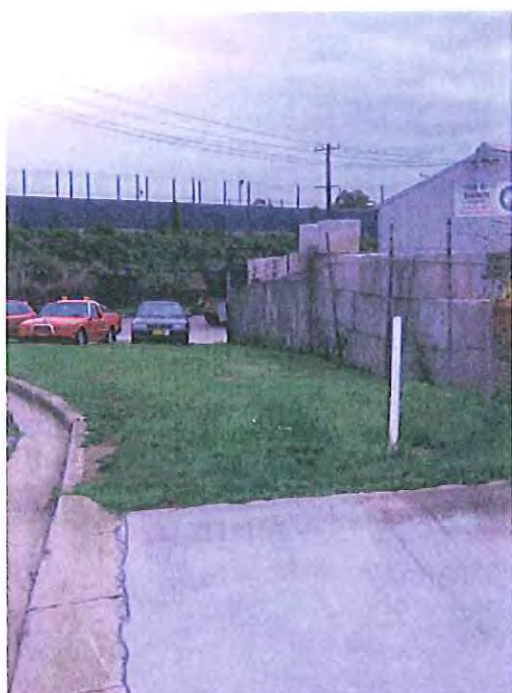
Site 7 Former Campbell's Transport site, Clyde

An assessment of the site conducted by DECC in December 2007 found that small amounts of bonded asbestos as broken asbestos sheet on the footpath between the industrial premises and Tennyson Street. It appears that although the asbestos material was buried, the cover has eroded over time and exposed the asbestos material.

1. The visible asbestos is removed following recognised Occupational Health and Safety practices;
2. A management plan is developed by an occupational hygienist with recognized experience in asbestos identification and management to ensure that the asbestos is not disturbed unless appropriate plans for investigation/ remediation are developed and assessed as suitable for implementation by a site auditor accredited under the CLM Act (this may include clean fill to be placed across affected areas and re-grassing of the site);
3. Consider making appropriate notation on the relevant planning certificates (i.e. s.149 certificate).
4. Further information is obtained to determine if the stockpiled material at the back of the Sakrete property contains asbestos. This material should then be lawfully removed and disposed.

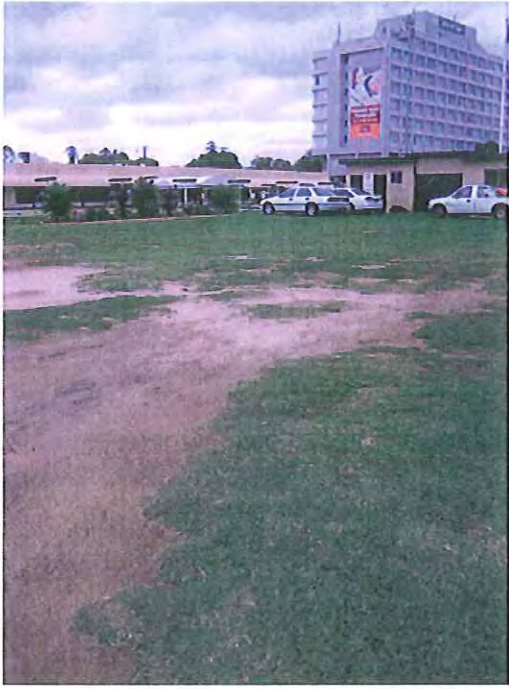
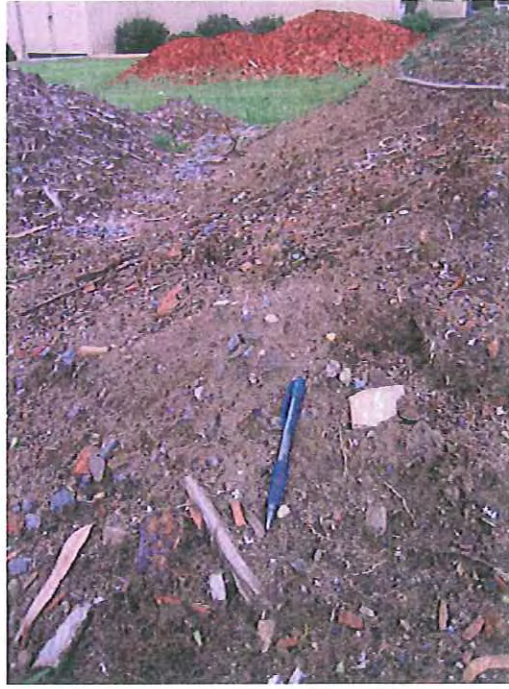
Site 8 Rosehill Bowling Club

An assessment of the site conducted by DECC in December 2007 found that small amounts of bonded asbestos as broken asbestos sheet in the grassed area next to the car park and greens. Asbestos cement fill is visible in some areas. It appears that the asbestos material was buried and the cover, which is not maintained, has eroded over time and exposed the asbestos material. Lawn mowing, redevelopment, weathering, erosion, and traffic may result in further exposure of asbestos.

1. The visible asbestos is removed following recognised Occupational Health and Safety practices;
2. A management plan is developed by an occupational hygienist with recognized experience in asbestos identification and management to ensure that the asbestos is not disturbed unless appropriate plans for investigation/ remediation are developed and assessed as suitable for implementation by a site auditor accredited under the CLM Act (this may include clean fill to be placed across affected areas and re-grassing of the site); and
3. Council considers making appropriate notation on the relevant planning certificates (i.e. s.149 certificate).

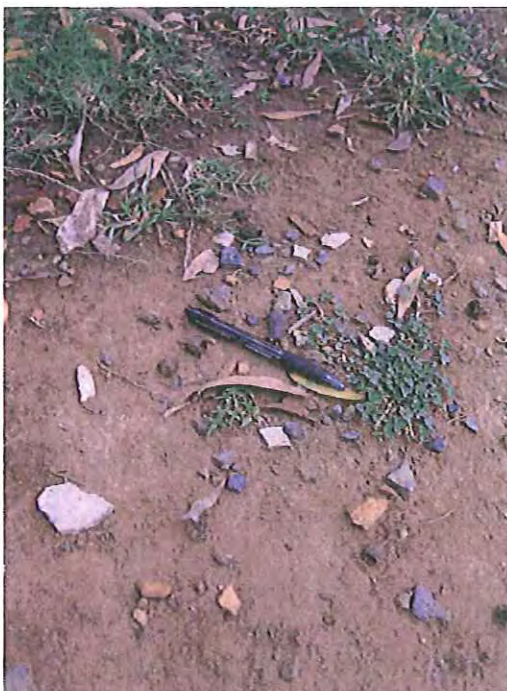
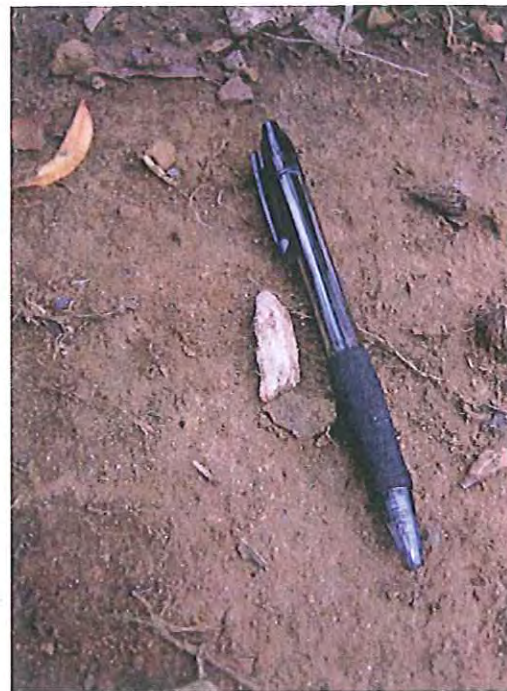
Site 13 – Doyle sports ground – Sid Teale memorial park

An assessment of the site conducted by DECC in December 2007 found the presence of small amounts of asbestos mainly in bonded form as broken asbestos sheets, located near the garden area at the corner of Isabella and Buller Streets. Although the asbestos material was initially buried, the cover has eroded over time and exposed the asbestos material.

1. The visible asbestos is removed following recognised Occupational Health and Safety practises;
2. A management plan is developed by an occupational hygienist with recognized experience in asbestos identification and management to ensure that the asbestos is not disturbed unless appropriate plans for investigation/ remediation are developed and assessed as suitable for implementation by a site auditor accredited under the CLM Act (this may include clean fill to be placed across affected areas and re-grassing of the site); and
3. Council considers making appropriate notation on the relevant planning certificates (i.e. s.149 certificate).

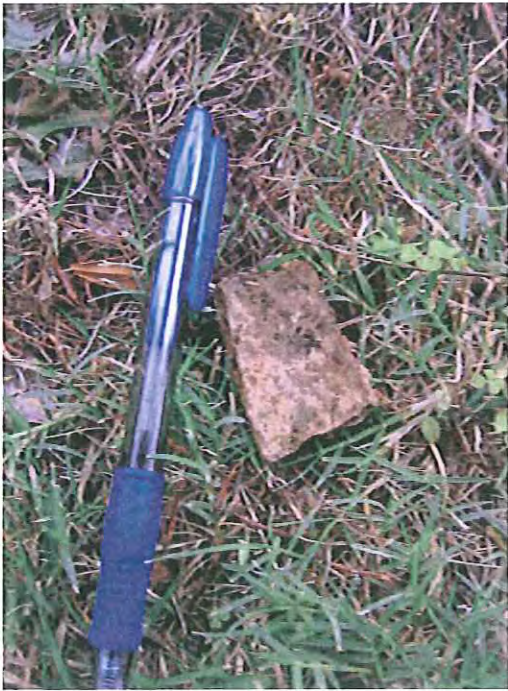
Site 18 – 14 Prince Street, Oatlands

An assessment of the site conducted by DECC in December 2007 found the presence of small amounts of asbestos mainly in bonded form as broken asbestos sheet, located in small grassed area at end of driveway. Although the asbestos was initially buried, the cover has eroded over time and exposed the asbestos material.

1. The visible asbestos is removed following recognised Occupational Health and Safety practises;
2. A management plan is developed by an occupational hygienist with recognized experience in asbestos identification and management to ensure that the asbestos is not disturbed unless appropriate plans for investigation/ remediation are developed and assessed as suitable for implementation by a site auditor accredited under the CLM Act (this may include clean fill to be placed across affected areas and re-grassing of the site); and
3. Council considers making appropriate notation on the relevant planning certificates (i.e. s.149 certificate).

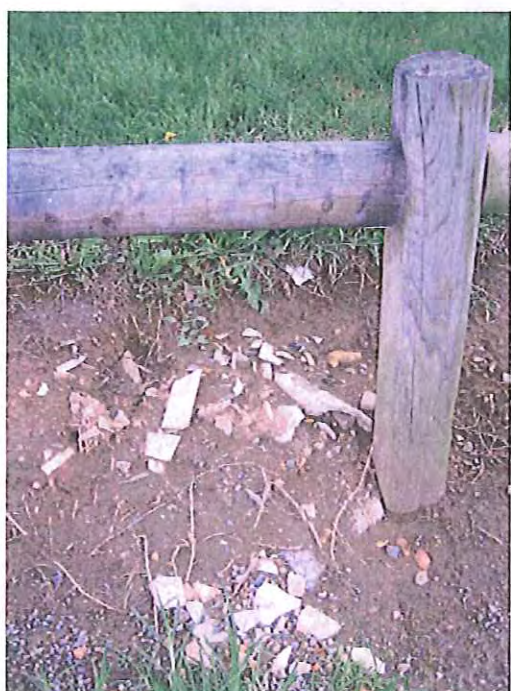
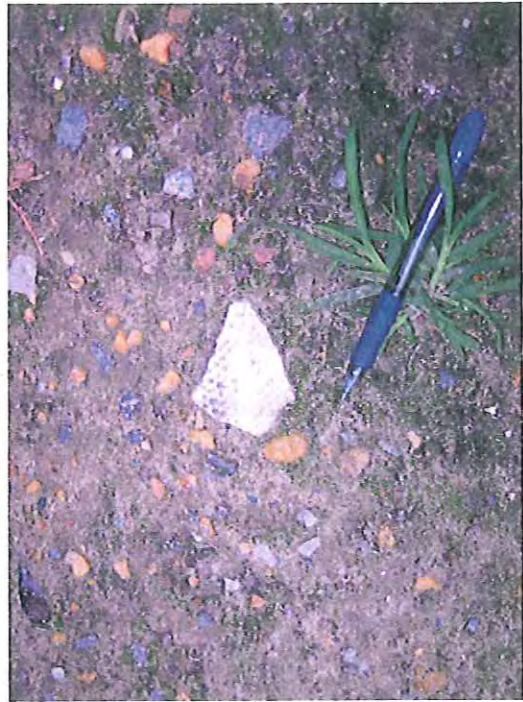
Site 19 – PH Jeffery Reserve and Barton Park

An assessment of the site conducted by DECC in December 2007 found the presence of small amounts of asbestos mainly in bonded form as broken asbestos sheets and cement pipes in Barton Park. Most of the asbestos material is located around the children's playground on Gladstone Street and around the embankment along James Ruse Drive and Web Street. Asbestos offcuts are also visible along a residential fence at 108 Isabella Street at PH Jeffery Reserve.

1. The visible asbestos is removed following recognised Occupational Health and Safety practises;
2. A management plan is developed by an occupational hygienist with recognized experience in asbestos identification and management to ensure that the asbestos is not disturbed unless appropriate plans for investigation/ remediation are developed and assessed as suitable for implementation by a site auditor accredited under the CLM Act (this may include clean fill to be placed across affected areas and re-grassing of the site); and
3. Consider making appropriate notation on the relevant planning certificates (i.e. s.149 certificate).

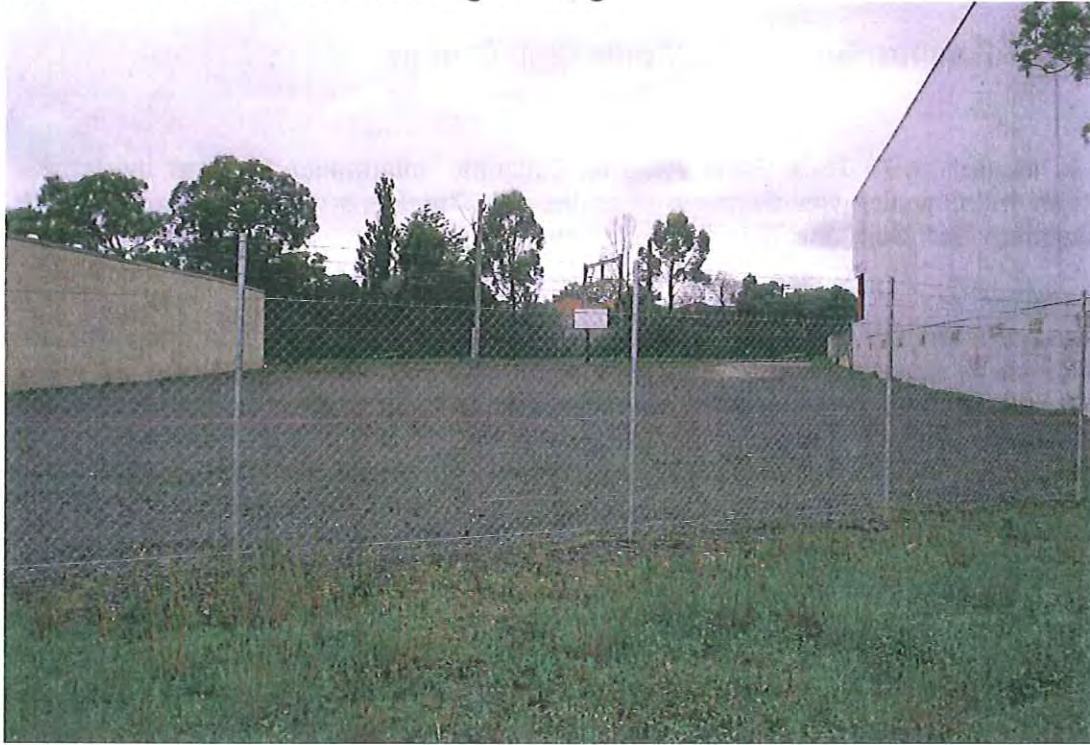
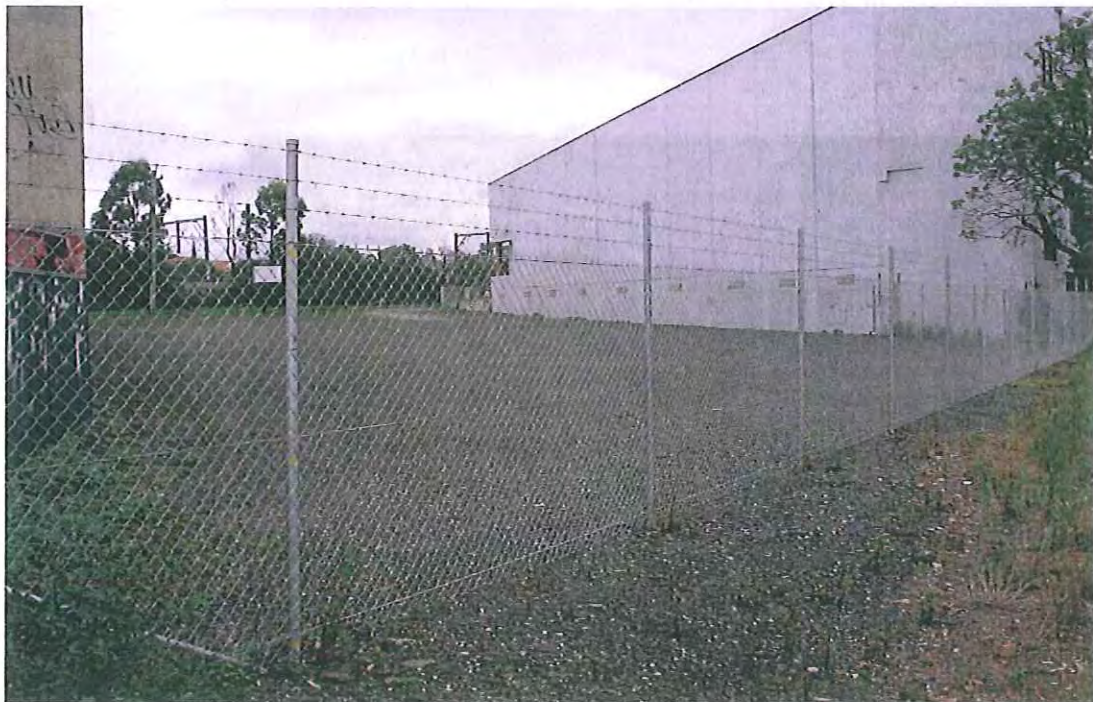
Site 20 – Vic James & Sons Engineering

An assessment of the site conducted by DECC in December 2007 found that there was no visible evidence of asbestos on the open area of the site.

1. Council considers noting factual information on the sites' history - i.e. that associated companies of James Hardie has disposed asbestos on the site on the relevant planning certificates (i.e. s.149 certificate)
2. Should the area be disturbed then appropriate asbestos management plans for the site should be developed to ensure that human health is protected.

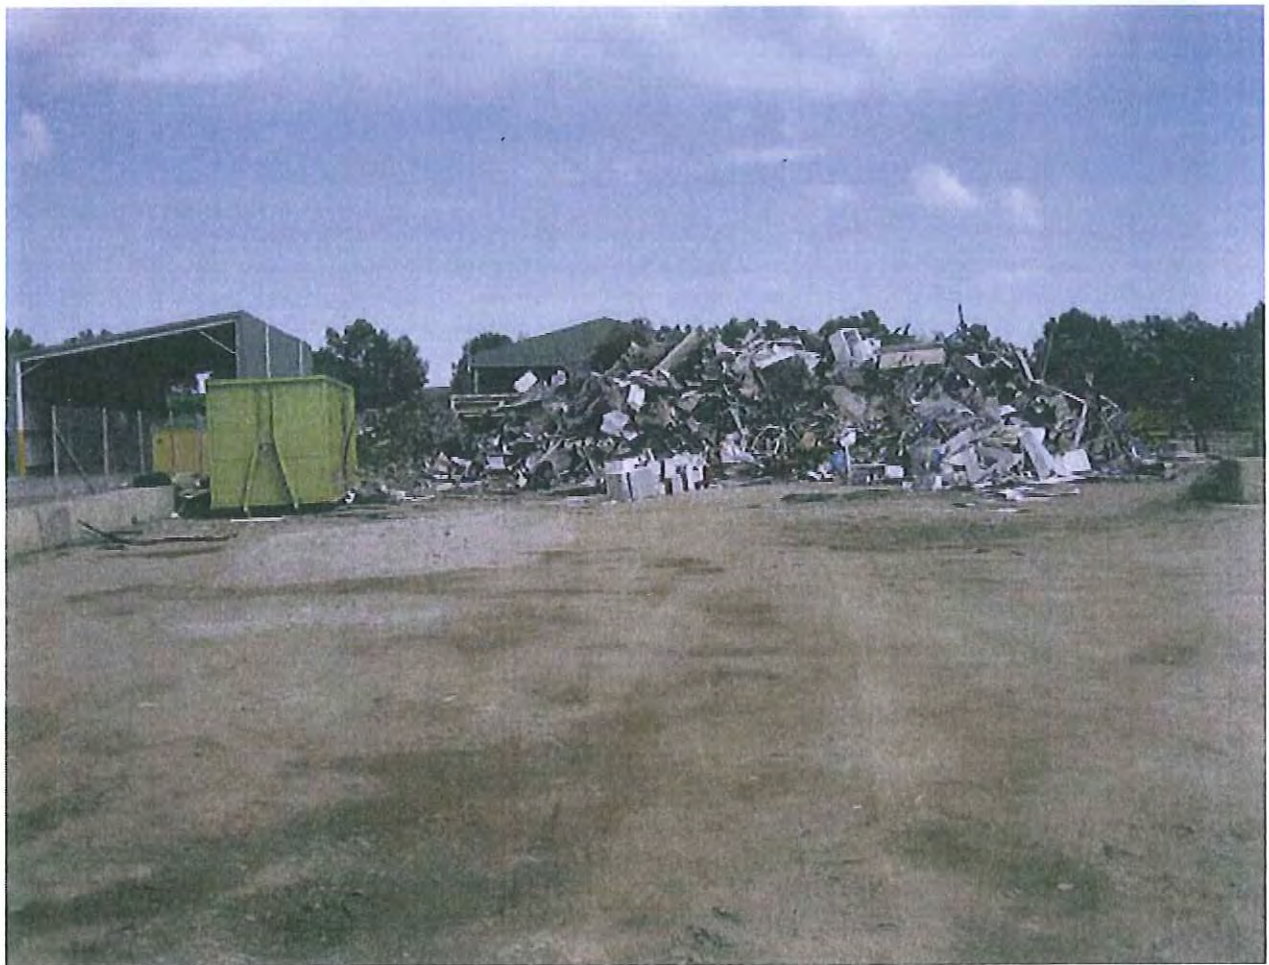
Figure 2 - Current Condition of Resource Recovery Centre, Moss Vale

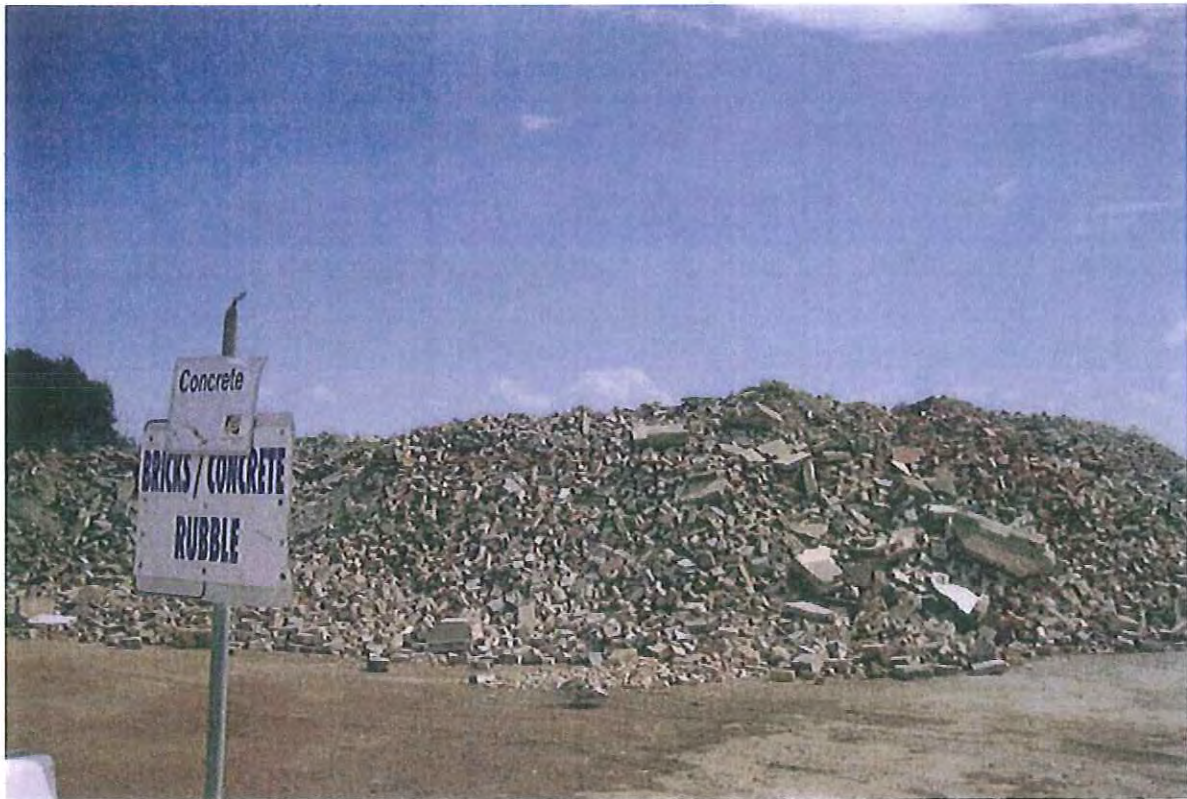
Figure 3 - Current Condition of Resource Recovery Centre, Moss Vale

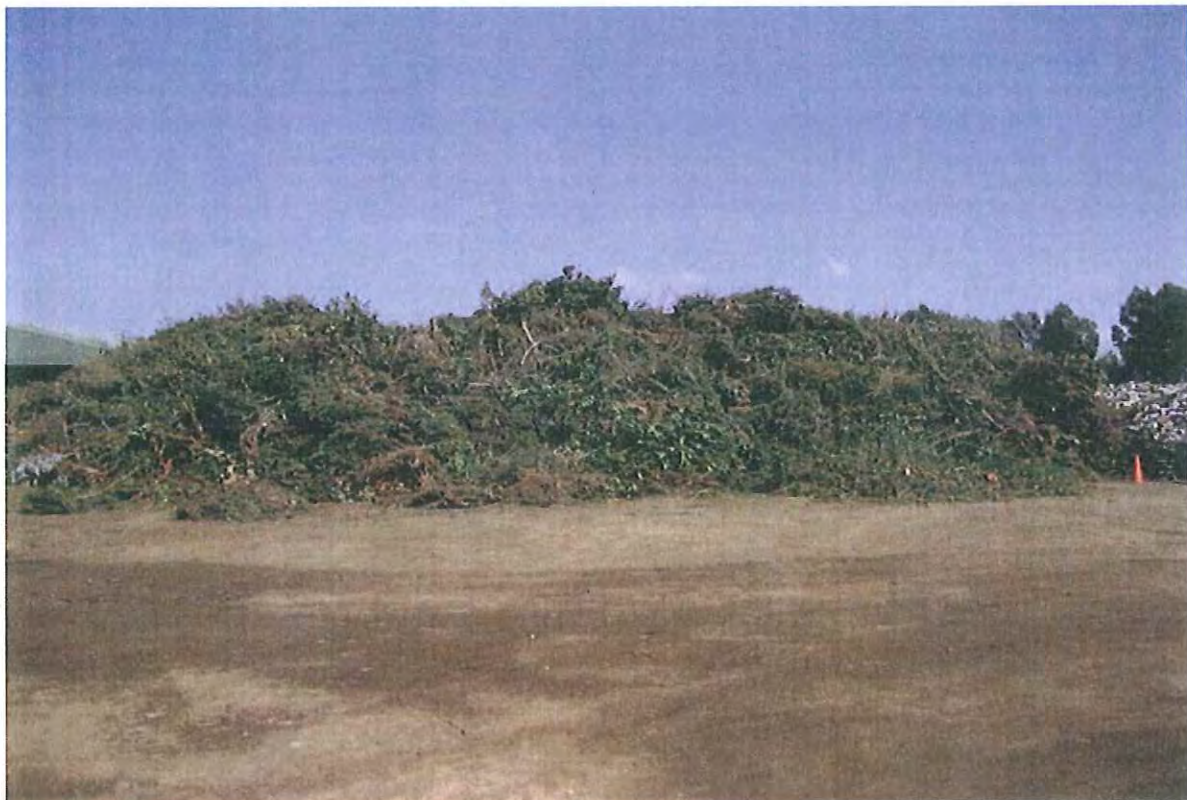
Figure 4 - Current Condition of Resource Recovery Centre, Moss Vale

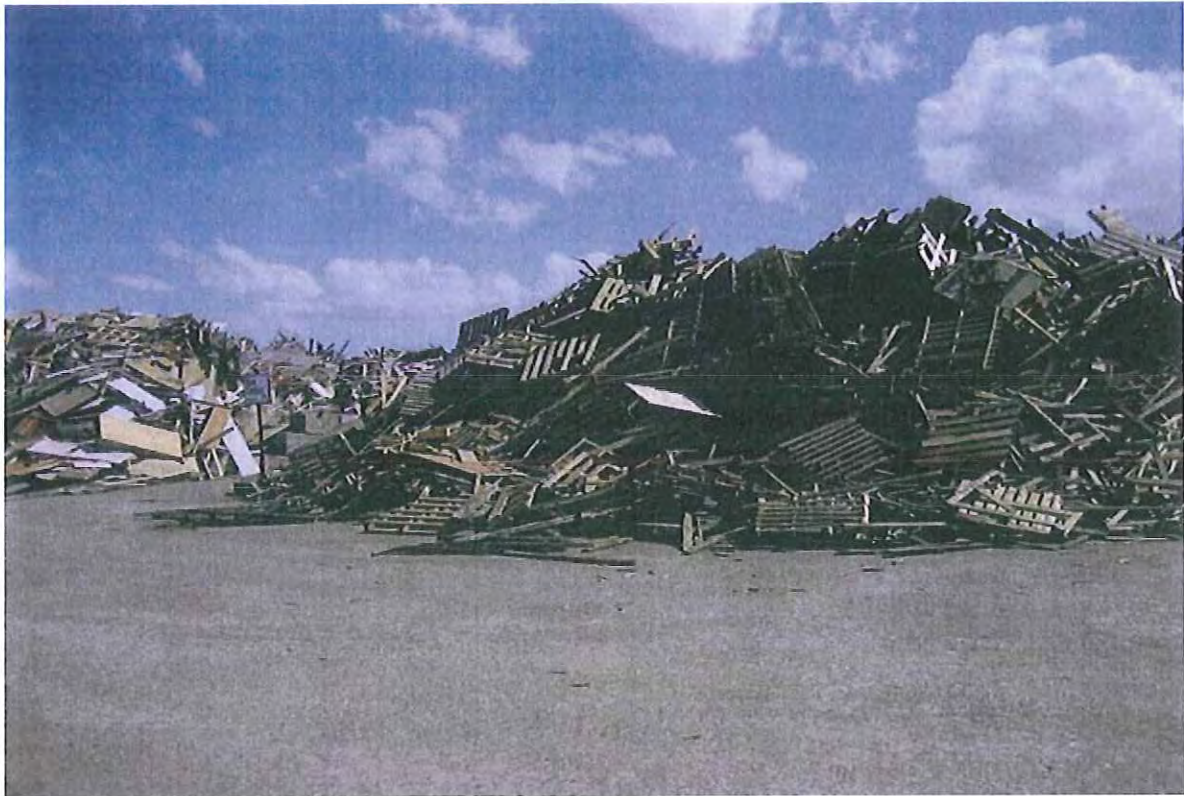
Figure 5 - Current Condition of Resource Recovery Centre, Moss Vale

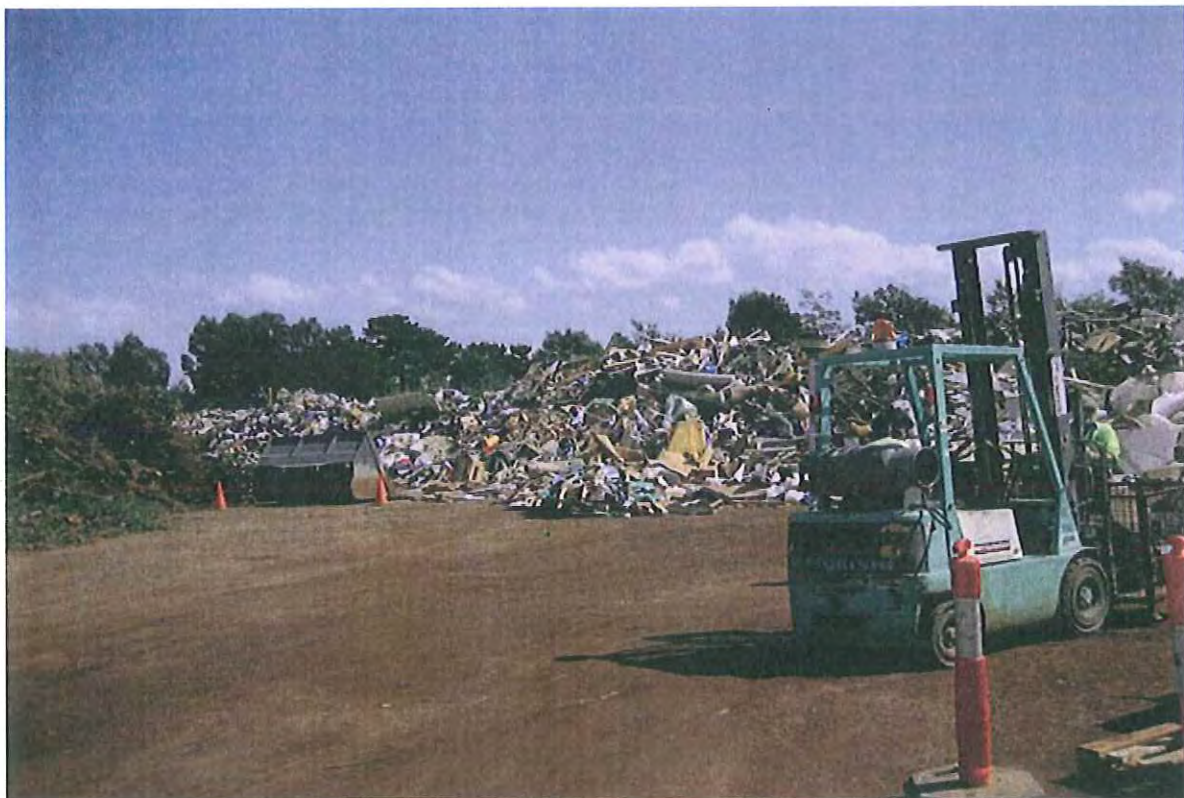
Figure 6 - Current Condition of Resource Recovery Centre, Moss Vale

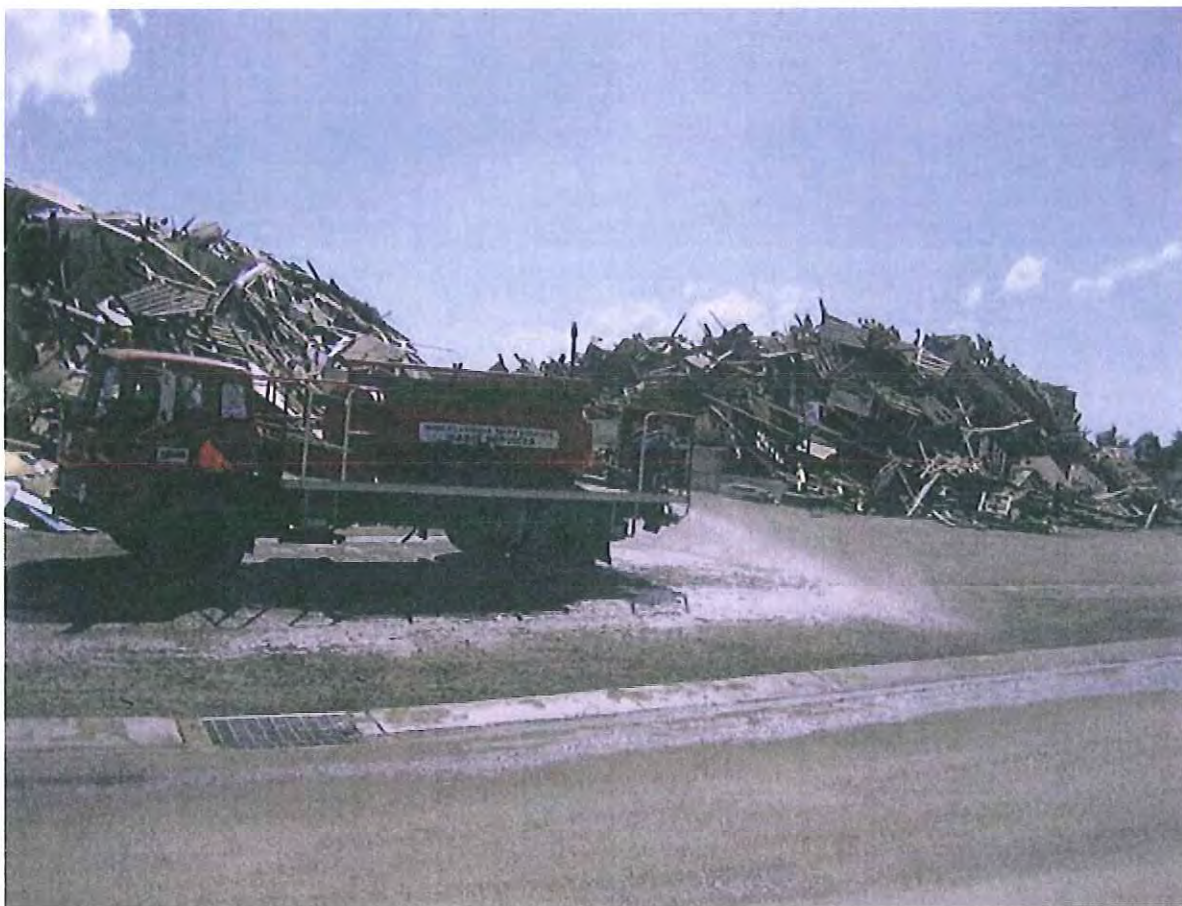
Figure 7 - Current Condition of Resource Recovery Centre, Moss Vale
