EPA AUDIT REPORT – CROWN FOREST STATE FOREST, COMPARTMENT(S)

Auditee:	Forestry Corporation NSW
Audit scope:	Corunna State Forest (see Map 1, below).
Region:	Southern
Date/Audit timing:	19 March 2019
Lead EPA auditor:	John Forcier
Assisting EPA auditors:	Jock Duncan
Justification of audit:	Post-Harvest Audit of High-Risk Forest
Audit objectives:	Undertake an assessment of post-harvest operations within the Corunna State Forest. Audit included specific Biodiversity Conservation Species Licence (BSL) and water pollution compliance conditions. The audit also assessed basal dispersal across a set of randomly generated points within the main net harvest area.
Audit criteria:	<ul style="list-style-type: none"> • Site Specific White Bellied Sea Eagle (300m EZ) • Cond 6.5 Swift Parrot • Cond 6.6 Southern Brown Bandicoot (modified management condition issued by EPA under 2.1b BCL) • Basal Area assessment • Cond 5 clause 37 5-30m drainage • Sect 120 POEO Act
Summary of Operations	<p>Compartment History and Stand Condition</p> <p>The compartment has been harvested a number of times through history, areas not harvested in the last 10 years are the areas targeted for this harvesting event.</p>

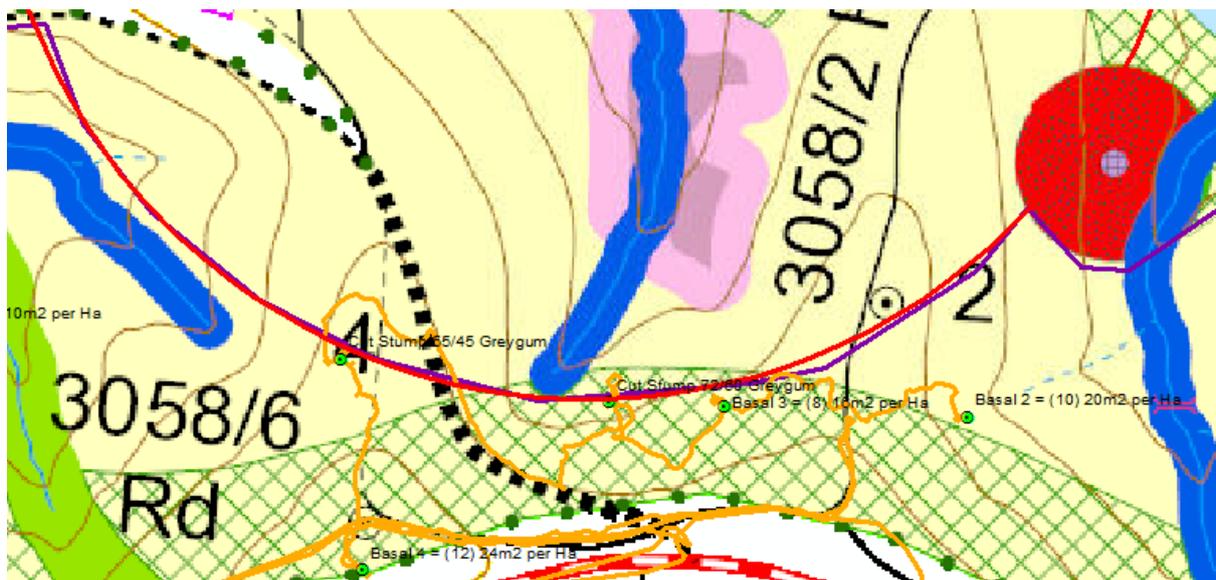
This finding is based on the assessment of 300m of boundary immediate to the net harvest area, as well as post-harvest aerial imagery of the forest.

The EPA found that FCNSW was **compliant** with the relevant conditions in the area assessed.

Above: Check of 300m White Bellied Sea Eagle EZ

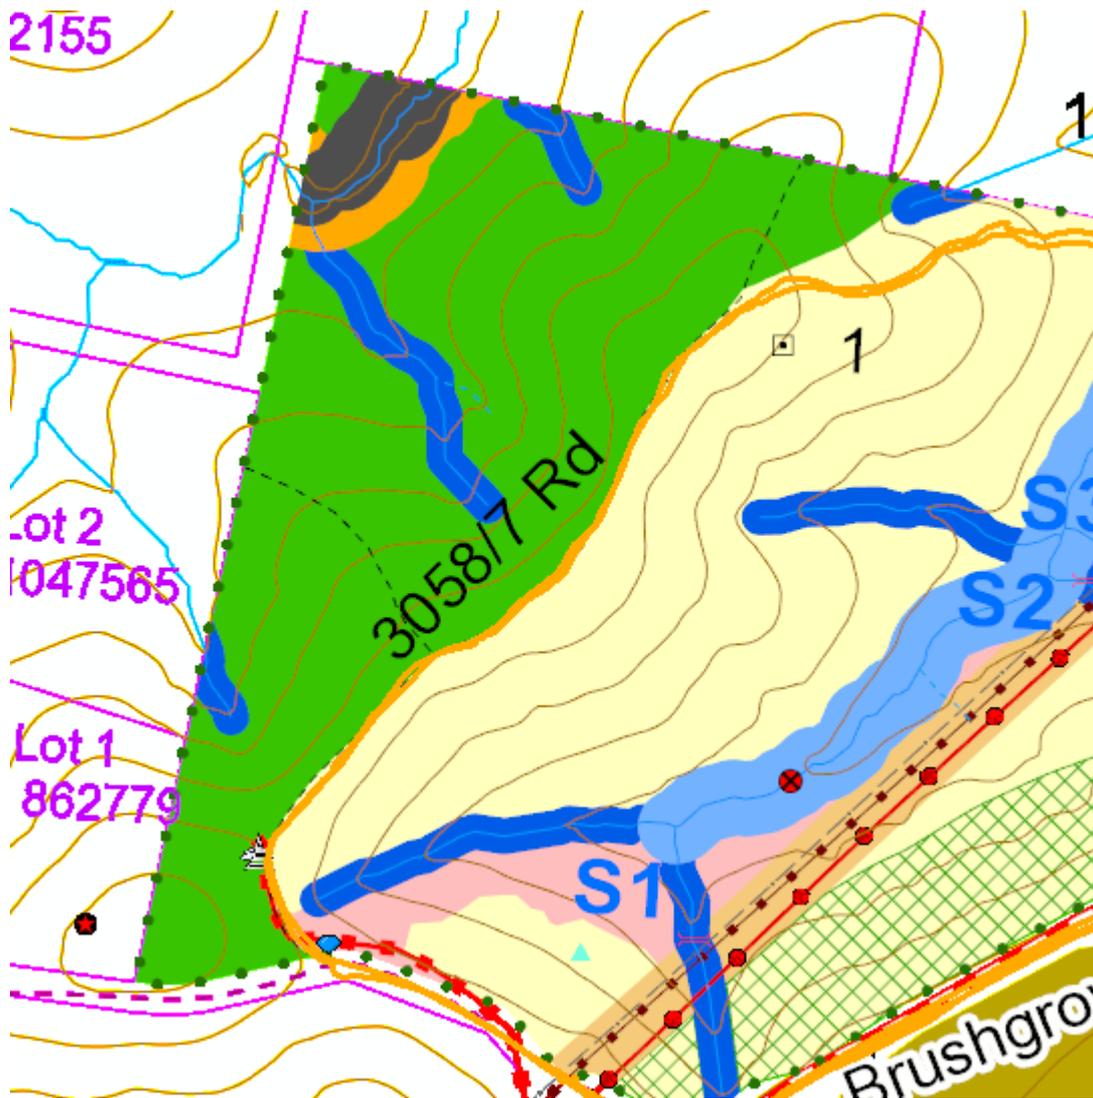
The exclusion in Corunna State Forest is formed by the extension of compartment road 3058/7 to the northern boundary of Corunna State Forest and incorporates the forest area to the west of the compartment road out to the northern, western and southern boundaries of the forest block. No harvest activity was detected within the exclusion zone.

Above: Check of Southern Brown Bandicoot EZ

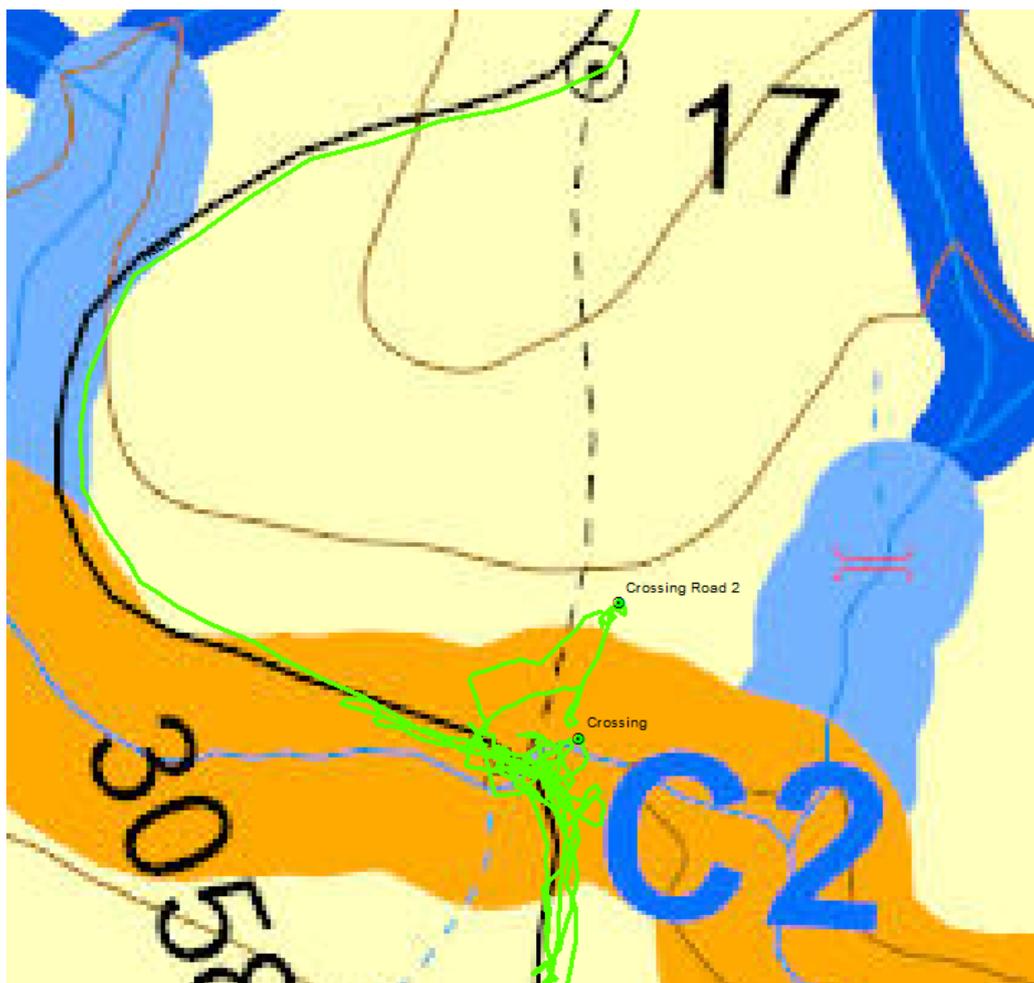
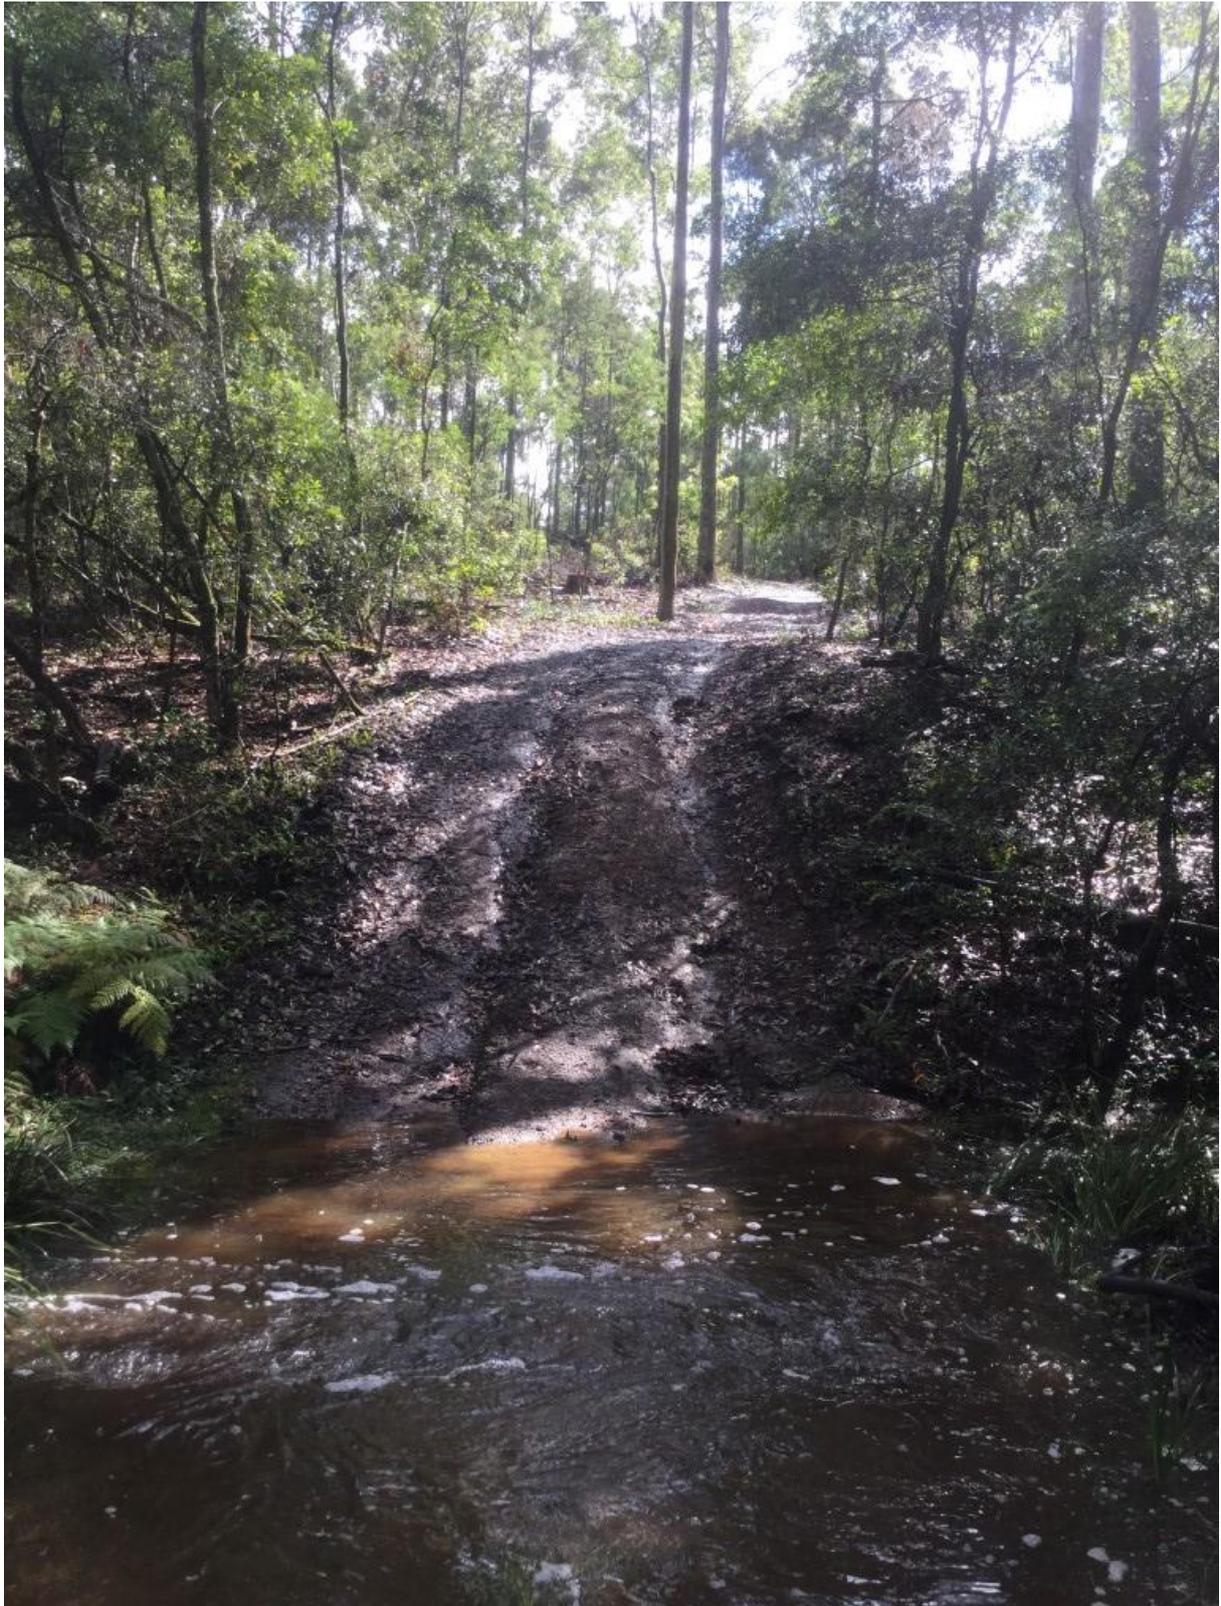
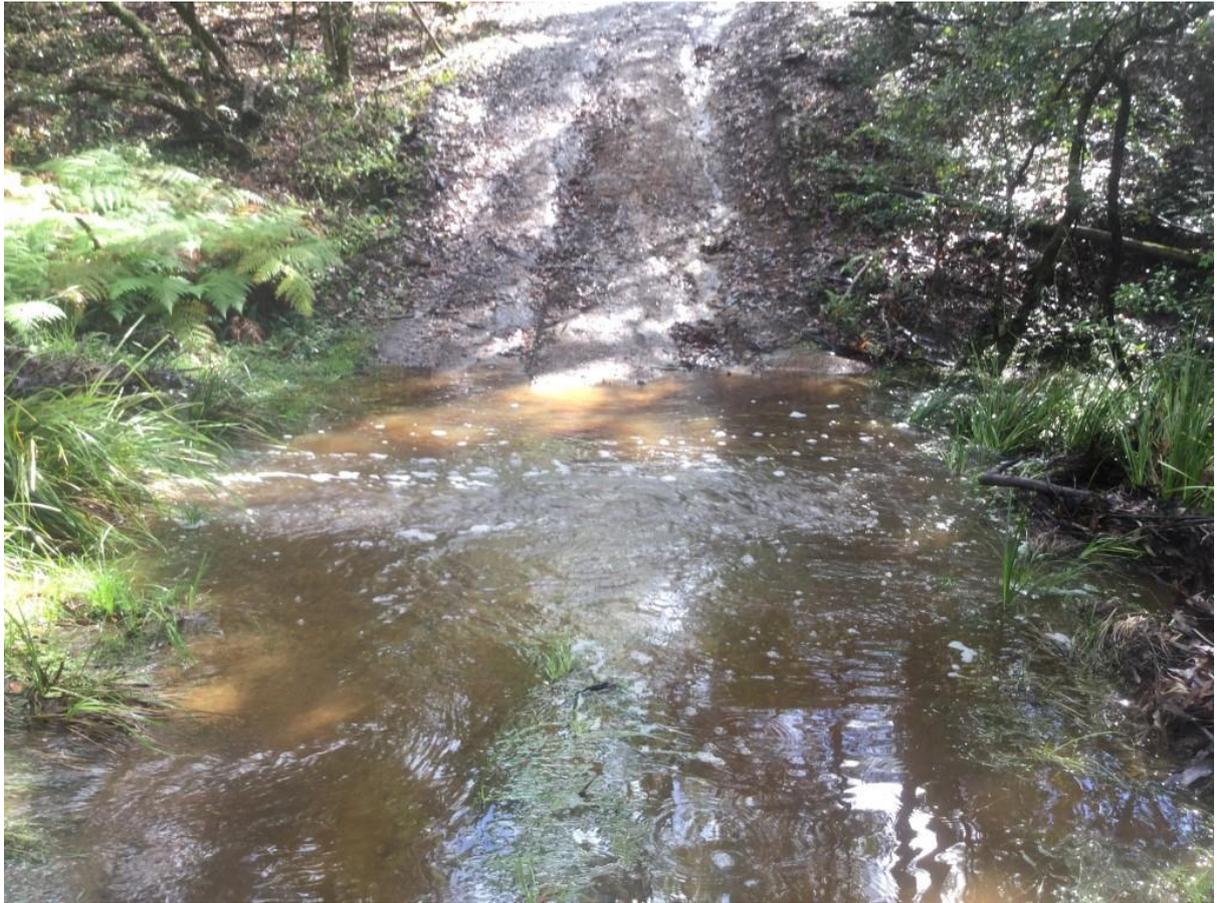
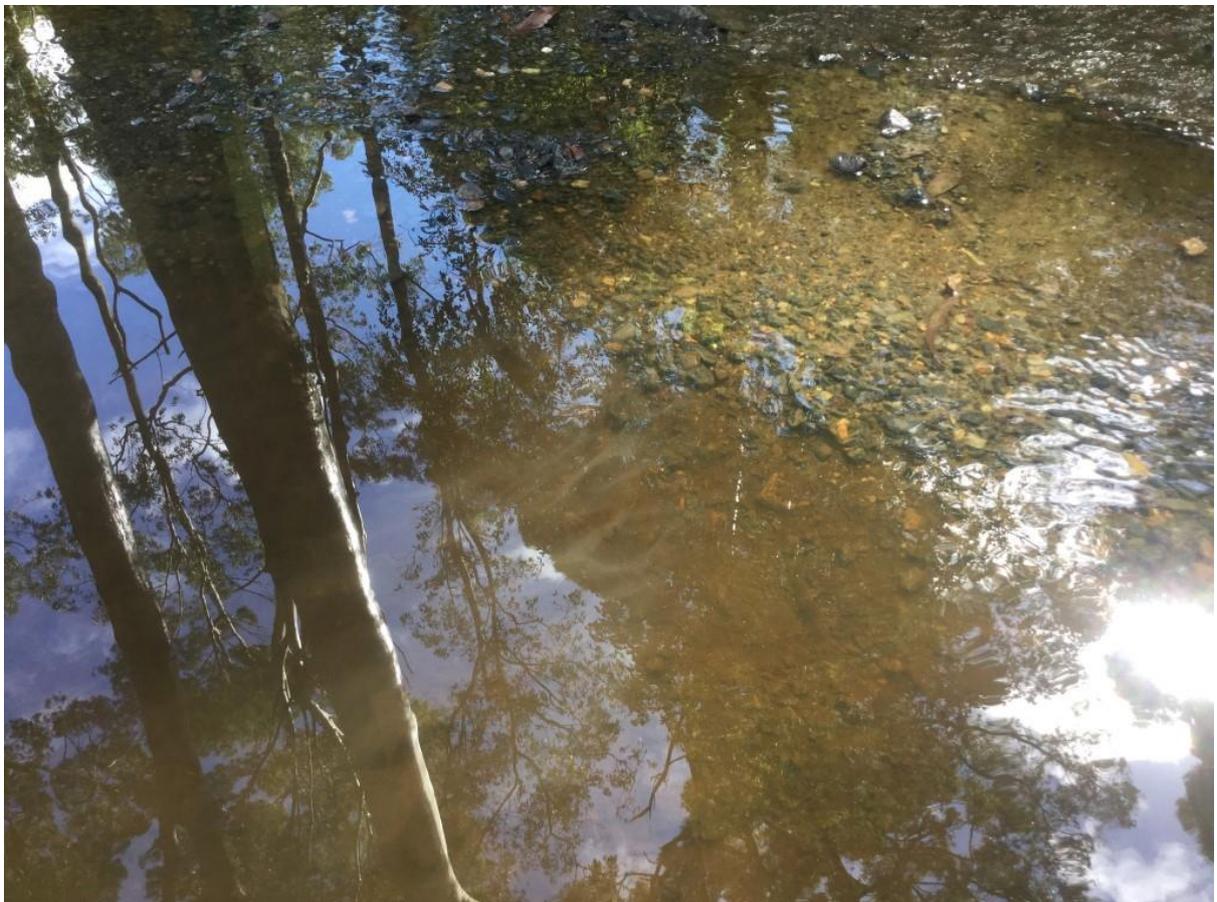
EPA officers assessed two marked crossings, C1 and C2 and an unmarked crossing adjacent to Crossing 2. Crossing 1 was found to be compliant. Crossing 2 was not compliant and polluting. The non compliances will be investigated separately.

Inspection by EPA noted that the silt traps and mitre drains have been installed, however both traps and mitres were observed to be full of sediment and no longer operating.

The unmarked crossing was located adjacent to Crossing 2, however this crossing does not appear to be mapped or authorised on the plan.

Condition No.	Compliant? Yes/No/Not determined/Not applicable	Number of non-compliance sample (sample size)	Risk Code	Action required by licensee
EPL Schedule 5	No	1/2	Likely	FCNSW must put in place satisfactory drainage between 5 and 30 meters on both sides of Crossing 2

Condition No.	Compliant? Yes/No/Not determined/Not applicable	Number of non-compliance sample (sample size)	Risk Code	Action required by licensee
S120 POEO	No	1/2	High	FCNSW must ensure drainage features on both sides of Crossing 2 prevent pollution from entering stream
