# **Macquarie River debris rafts**

## **Expert opinion: hydro-geomorphology**

Prepared for NSW Environment Protection Authority

E221304 RP#1

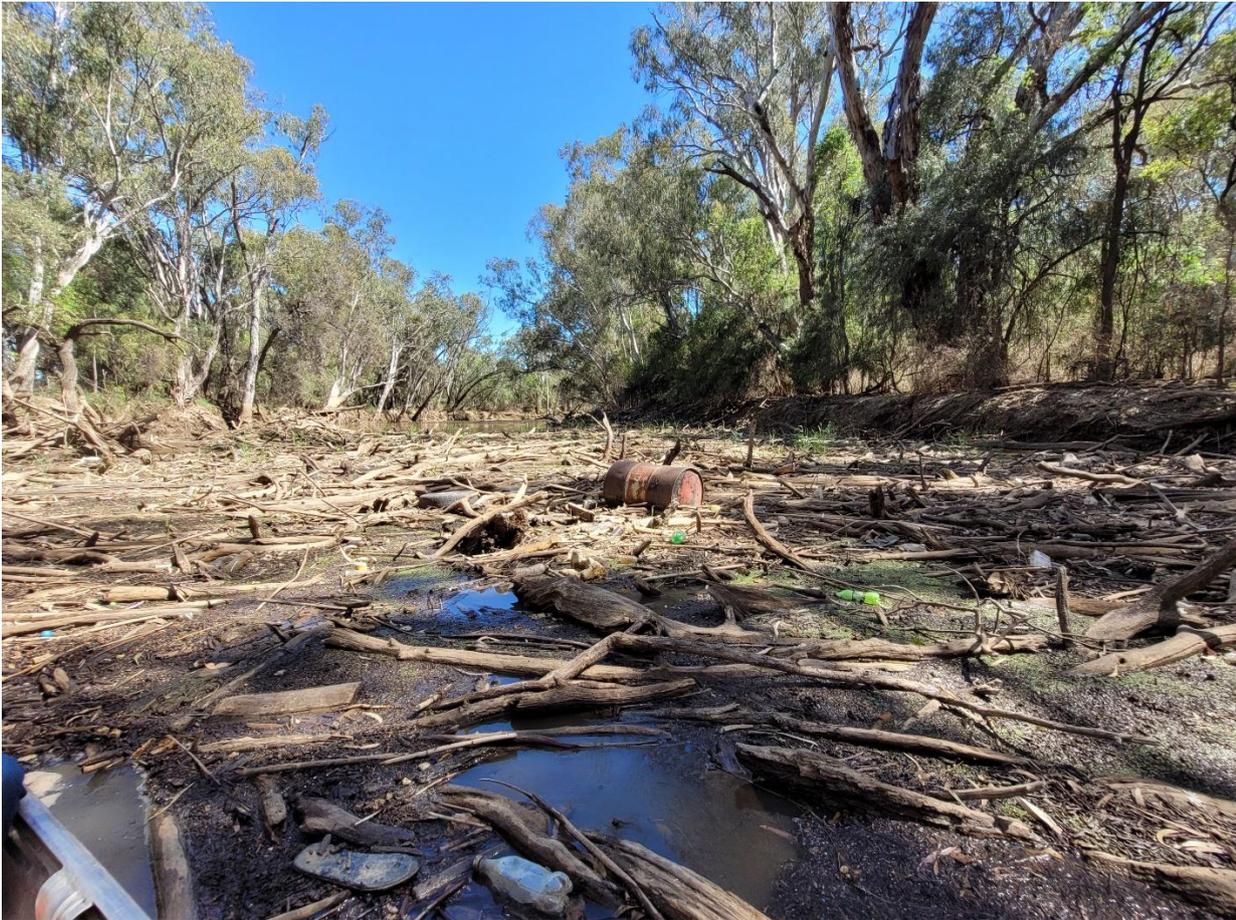
Raft 1 is located approximately 300 m downstream of the channel breakout location. It is interpreted to be a remnant from a larger raft that was observed at this location (and immediately downstream) during the 15 October 2022 SES aerial survey (see Section 2.2.3). The raft was approximately 20 m long and comprised mostly small to medium woody debris with some anthropogenic material including plastic bottles, tyres, a 44-gallon drum and a fridge. The raft appeared to be buoyant and had settled with the falling river levels. There was no significant visible change in river water levels upstream and downstream of the raft, indicating there was no significant blockage of river flows on 19 December 2022.

**Photograph 2.1** Raft 1 looking downstream (19 December 2022)

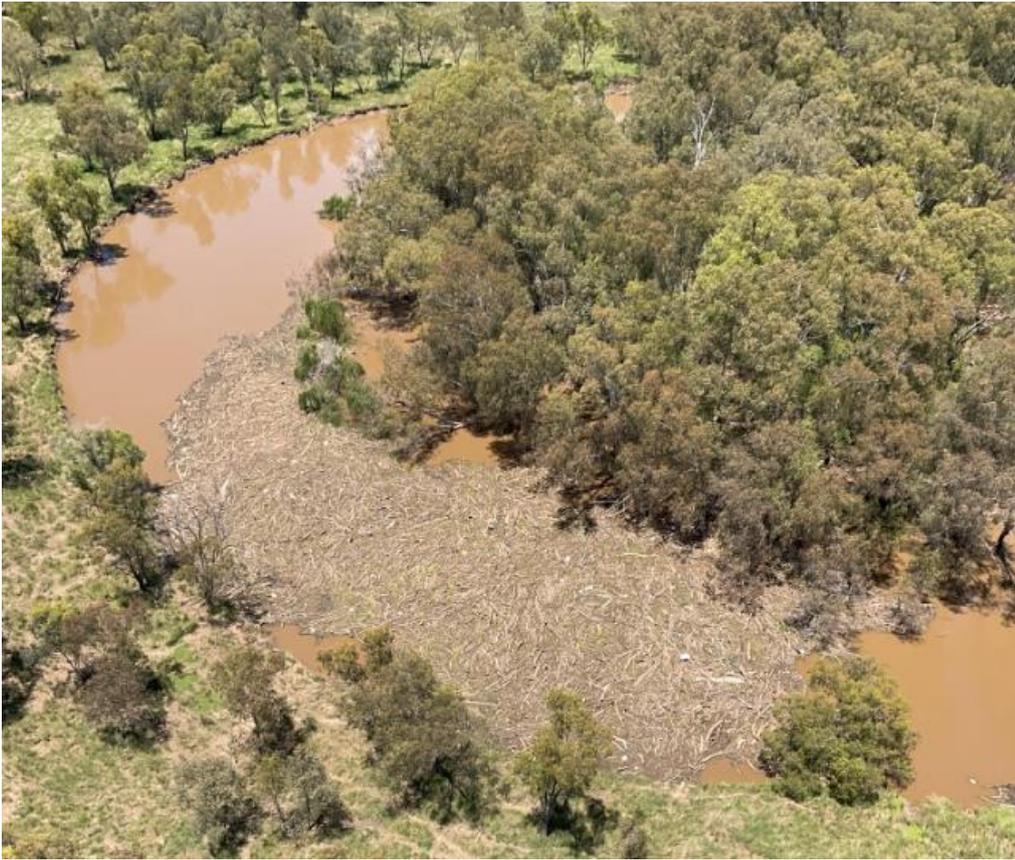
Raft 2 is located approximately 800 m downstream of Raft 1. It is interpreted that this raft formed sometime between 29 October and 18 November 2022 when the larger raft that was observed at the Raft 1 location during the 15 October 2022 SES aerial survey (see Section 2.2.3) broke up. The raft was approximately 100 m long on 4 December 2022 (measured from an aerial image – see Photograph 2.2).

**Photograph 2.2** Aerial image of Raft 2 (4 December 2022)

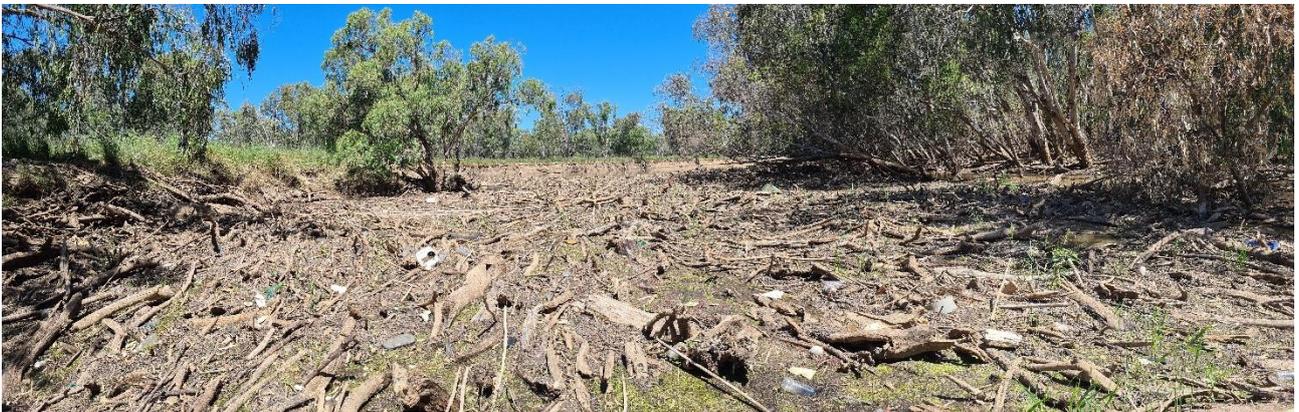
EMM did not inspect this raft. However, Ozfish provided several images which indicate the raft is similar in composition to Raft 1 and had reduced in size and moved approximately 100 m downstream since 4 December 2022. Photograph 2.3 and Photograph 2.4 are two of the images provided by Ozfish.

**Photograph 2.3** Raft 2 – looking upstream (19 December 2022)

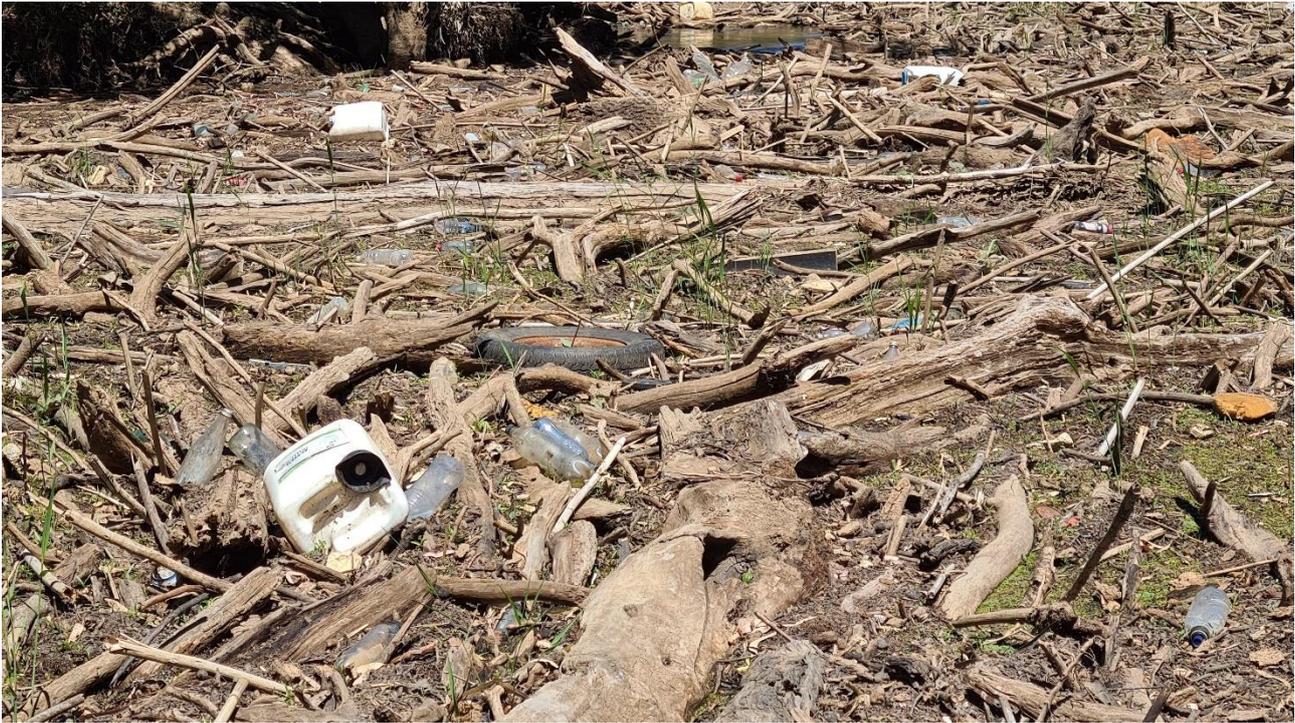
**Photograph 2.4** Raft 2 – typical composition of debris (19 December 2022)

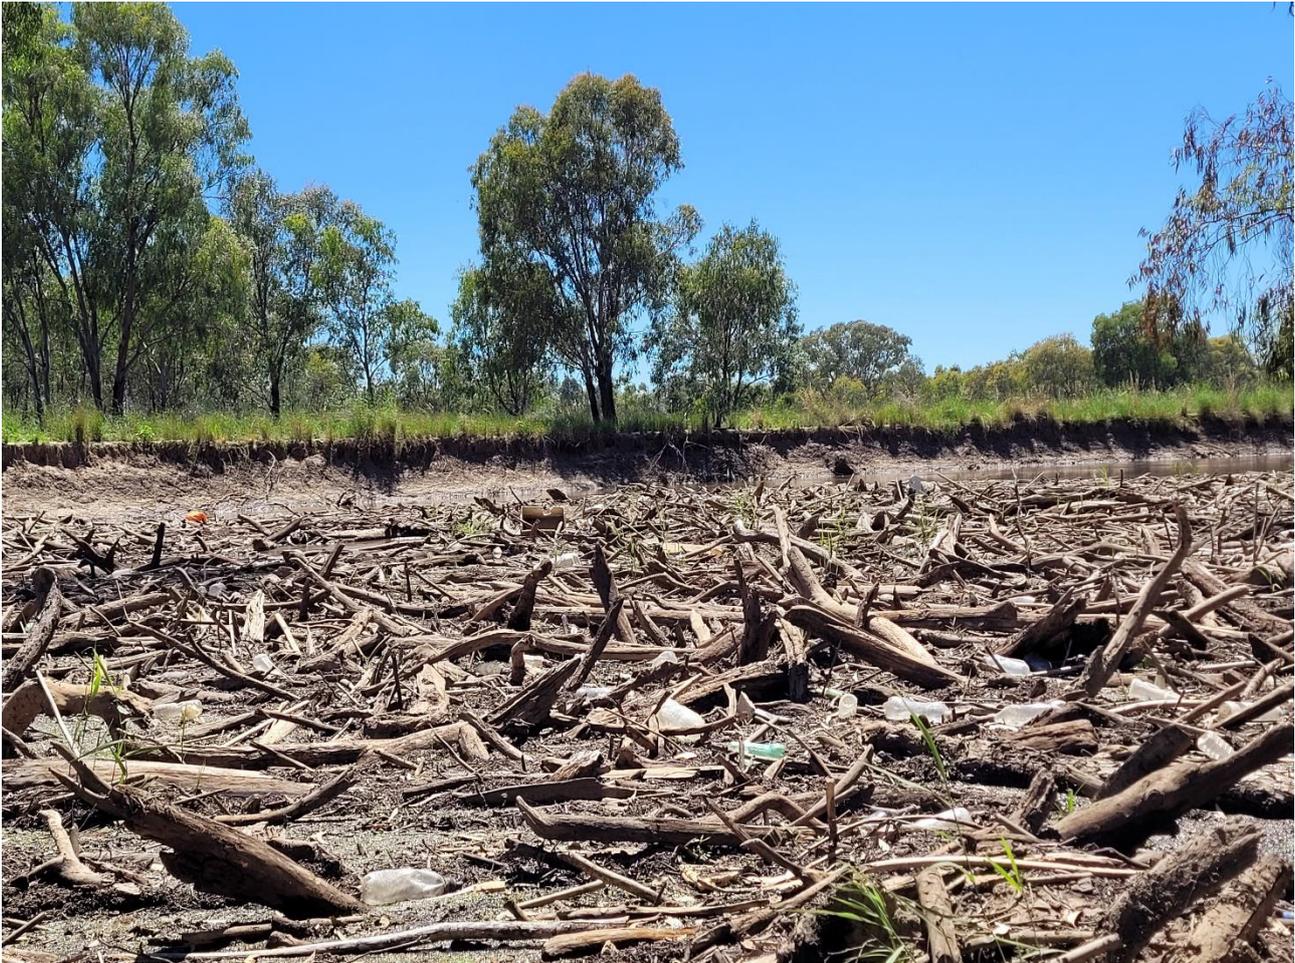
Raft 3 is estimated to be 30 m long and was similar in composition to Raft 1. Photograph 2.5 shows Raft 3 looking upstream.

**Photograph 2.5** Raft 3 looking upstream (19 December 2022)

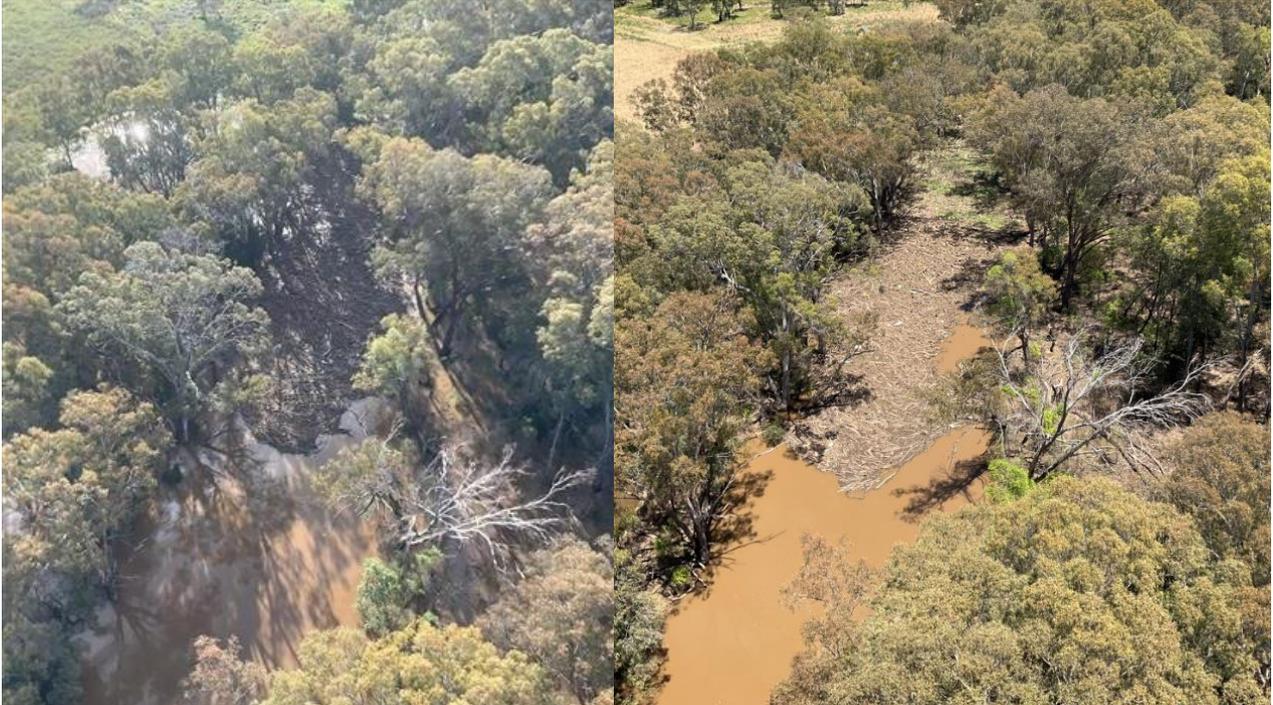
During the site inspection, there was evidence that recent out-of-channel flows occurred around the western flank of the raft through an area that comprises a shallow billabong. Water inundation of this area is also evident in Photograph 2.6 (15 December 2022 image).

**Photograph 2.6** Aerial images of upstream portion of Raft 4 from 15 October 2022 (left) and 4 December 2022 (right)

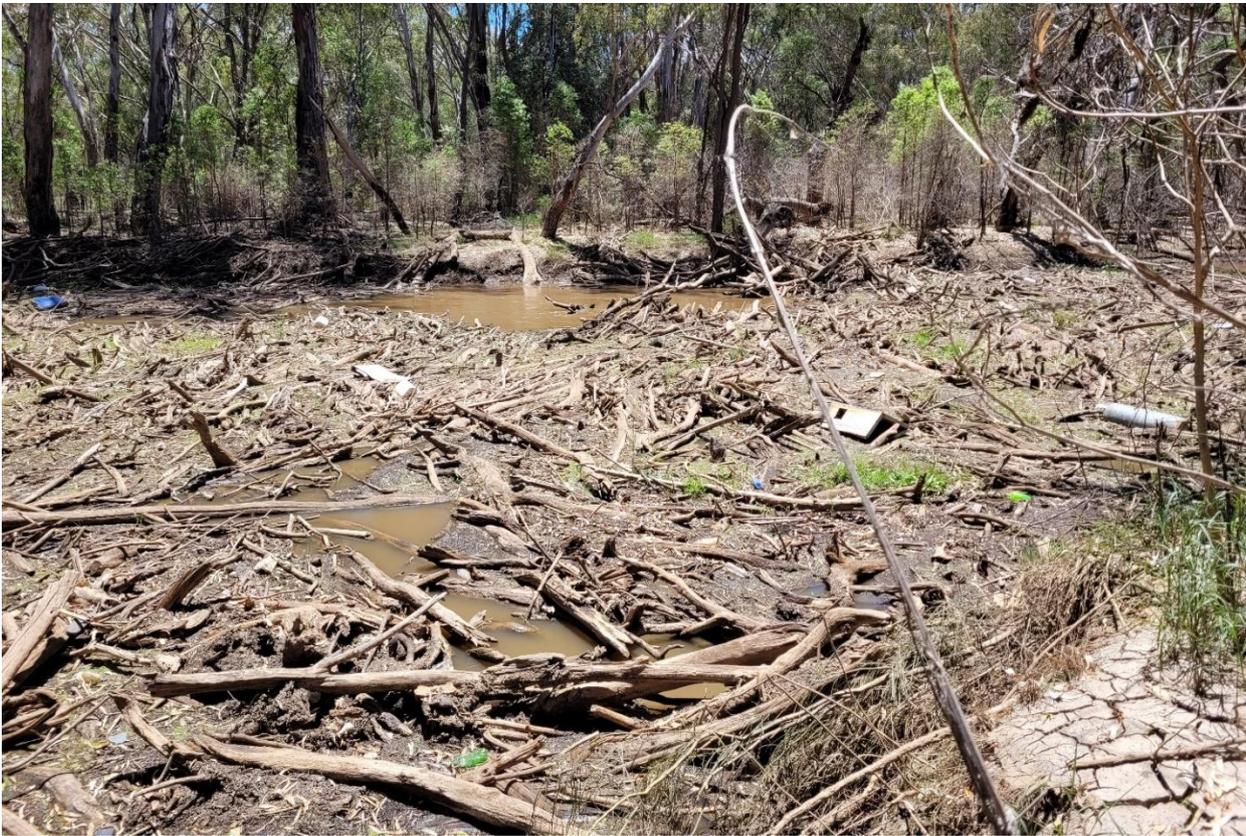
During the 19 December 2022 site inspection, the upstream portion of the raft (see Photograph 2.7) appeared to be similar to Rafts 1 to 3 (ie comprised predominantly of small to medium woody debris with some anthropogenic waste). The downstream portion (see Photograph 2.8) had more large woody debris, appeared to be more intertwined and to extend further at depth than the upstream portion. Vegetation had also established on the surface of the downstream portion of the raft (see Photograph 2.6 and Photograph 2.8), indicating that it had not broken up for some time.

**Photograph 2.7** Raft 4 – upstream portion of the raft (19 December 2022)

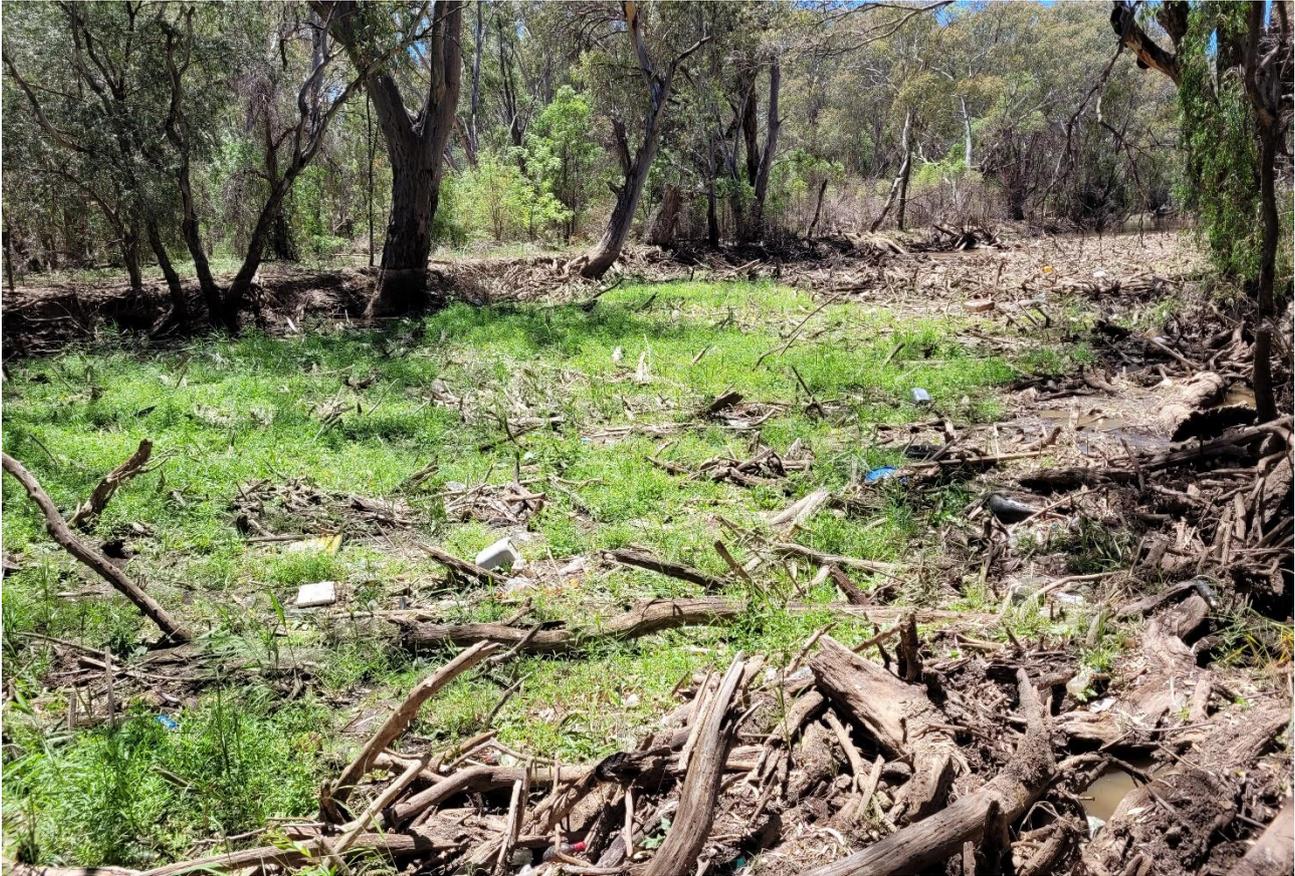
Comparison of photos of the raft taken on 15 October and 19 December 2022 confirm that the raft has settled with the falling river levels (the peak flood mark is evident on some trees in Photograph 2.8), indicating that it is buoyant.

**Photograph 2.8** Raft 4 – downstream portion of raft, looking upstream (19 December 2022)

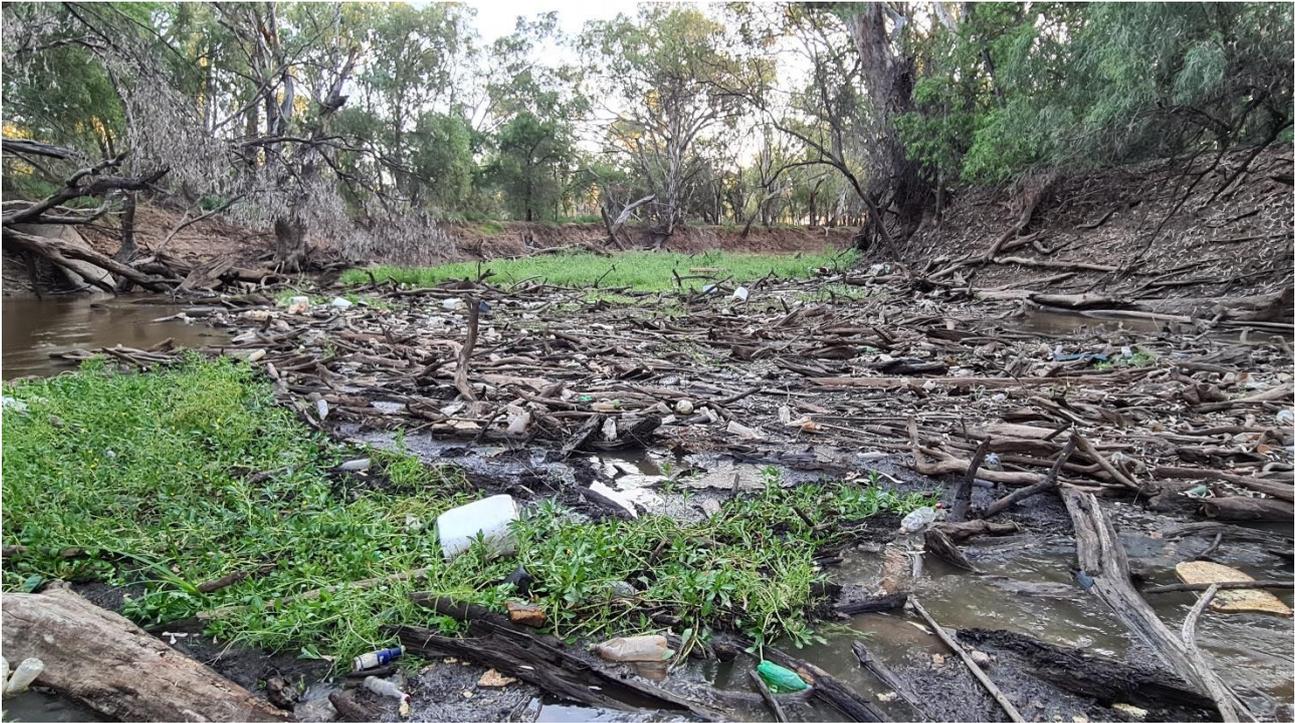
Photograph 2.9 was provided by Ozfish and shows Raft 5 looking downstream. From the photograph, Raft 5 appears to be similar in composition to Raft 1 (ie predominantly small to medium woody debris with some anthropogenic waste) and likely formed at this location due to the large tree that has fallen into the channel from the left bank. It is also noted that the river levels had receded substantially between 19 December 2022 and 4 January 2023.

**Photograph 2.9** Raft 5 looking downstream (4 January 2023)

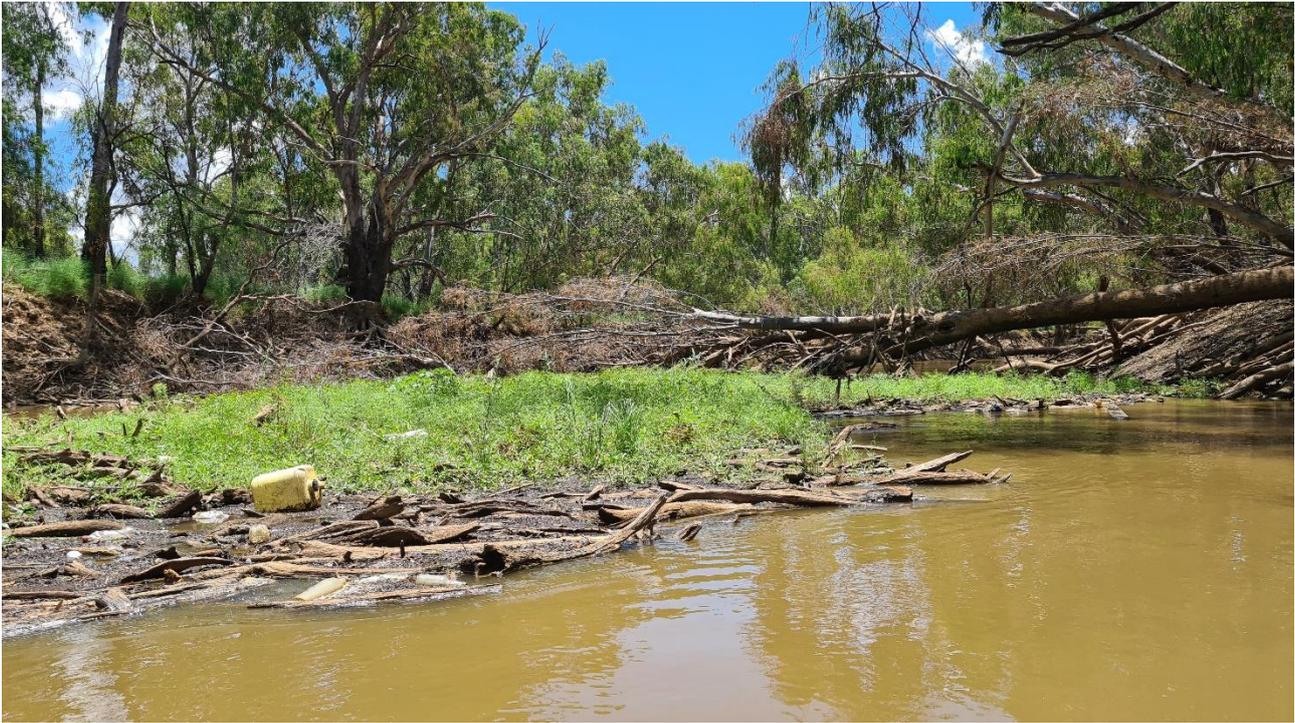
Photograph 2.10 was provided by Ozfish and shows Raft 6 looking downstream. From the photograph, Raft 6 appears to be smaller than the other rafts, but similar in composition to Raft 1 (ie predominantly small to medium woody debris with some anthropogenic waste). It likely formed at this location due to the large tree that has fallen into the channel from the right bank.

**Photograph 2.10** Raft 6 looking downstream (4 January 2023)

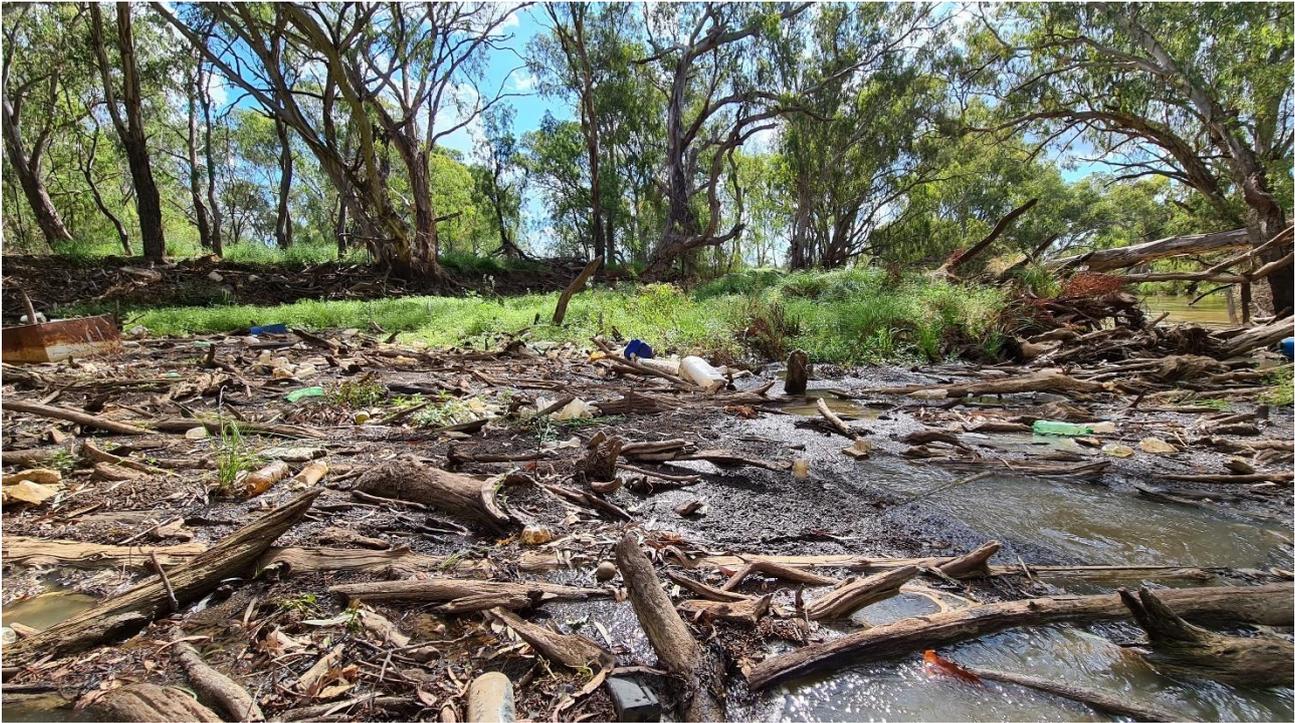
Photograph 2.11 and Photograph 2.12 were provided by Ozfish and show Raft 7 looking downstream and upstream respectively. From the photographs, Raft 7 appears to have formed behind the large tree that has fallen into the channel from the right bank. Parts of the raft do not appear to have settled with the falling river levels indicating they are not fully buoyant. Similar to Raft 4, vegetation, has also established on the surface of the downstream part of the raft. It is possible that this raft could further develop overtime.

**Photograph 2.11** Raft 7 looking downstream (4 January 2023)

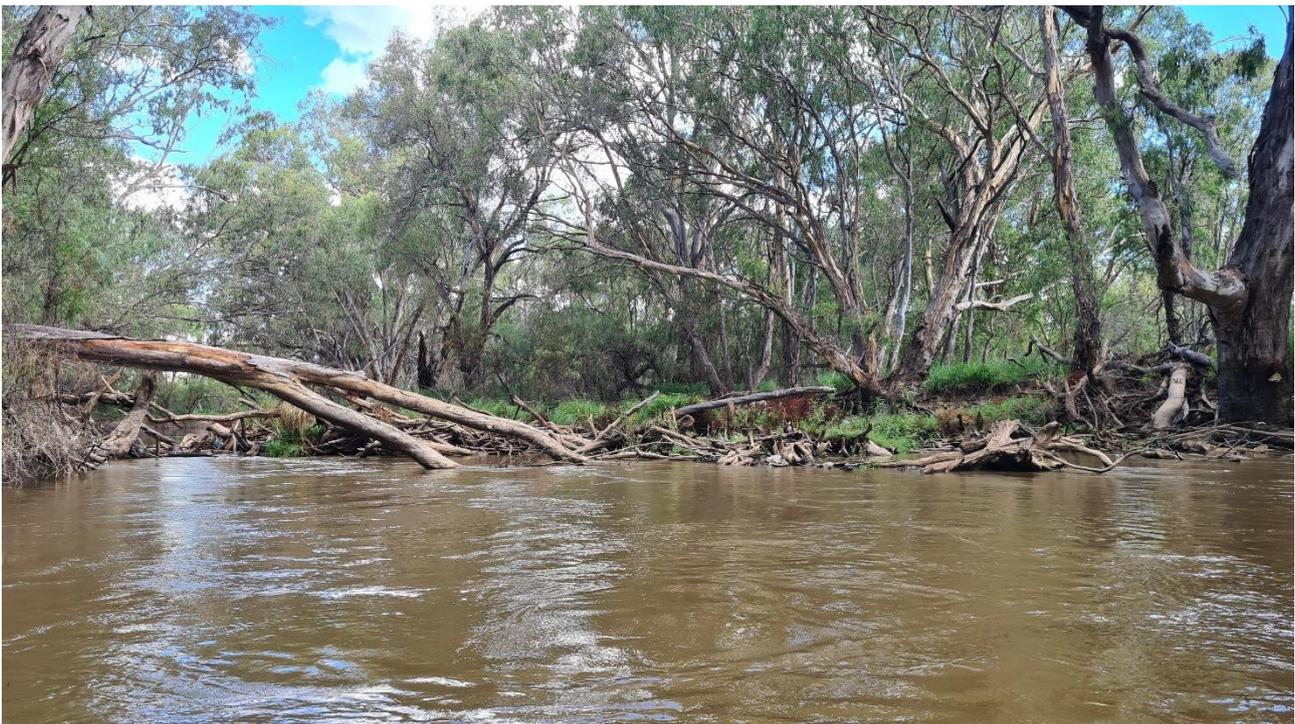
**Photograph 2.12** Raft 7 looking upstream (4 January 2023)

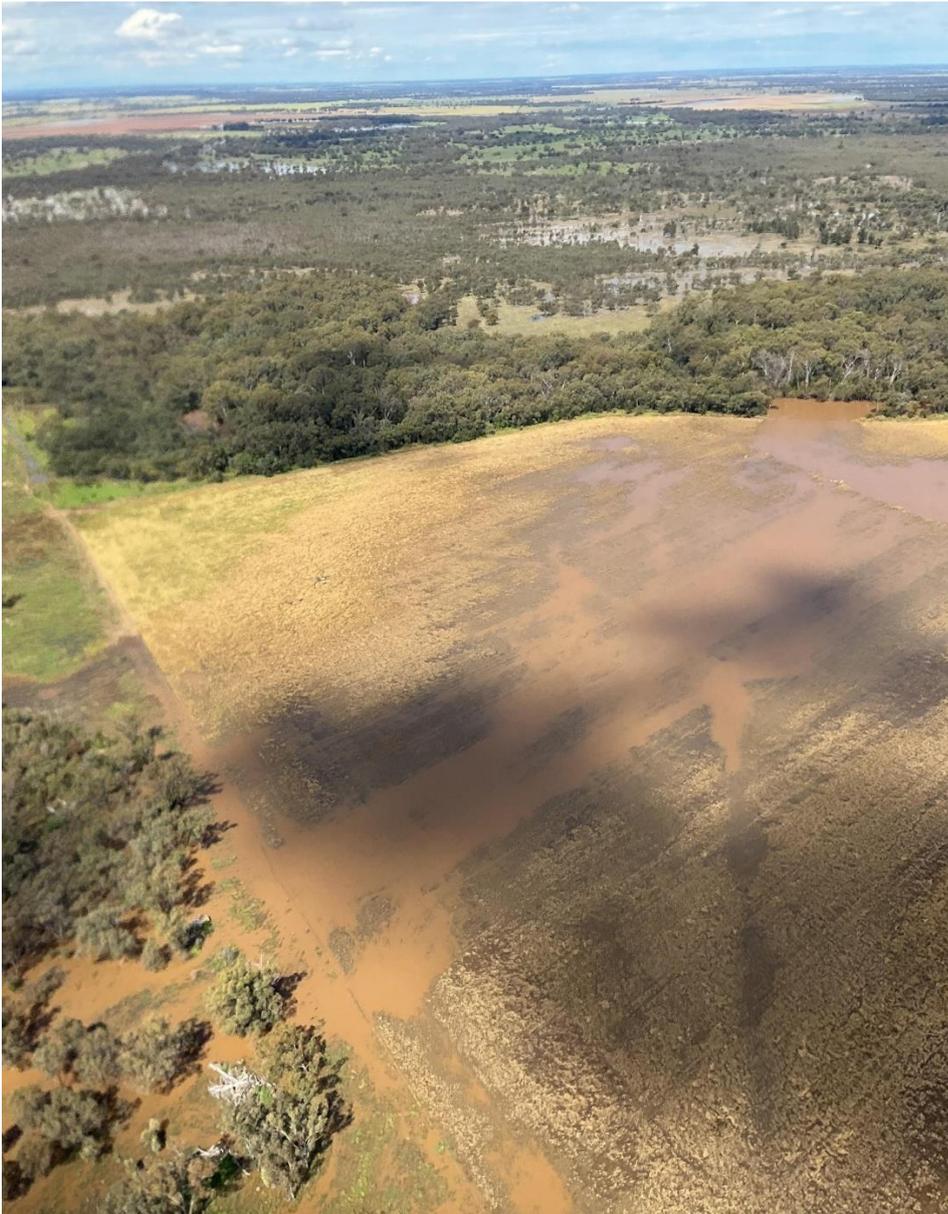
Photograph 3.2 shows floodwaters spilling from the river channel at the channel breakout.

**Photograph 3.2** Aerial image of Channel breakout – 27 October 2022

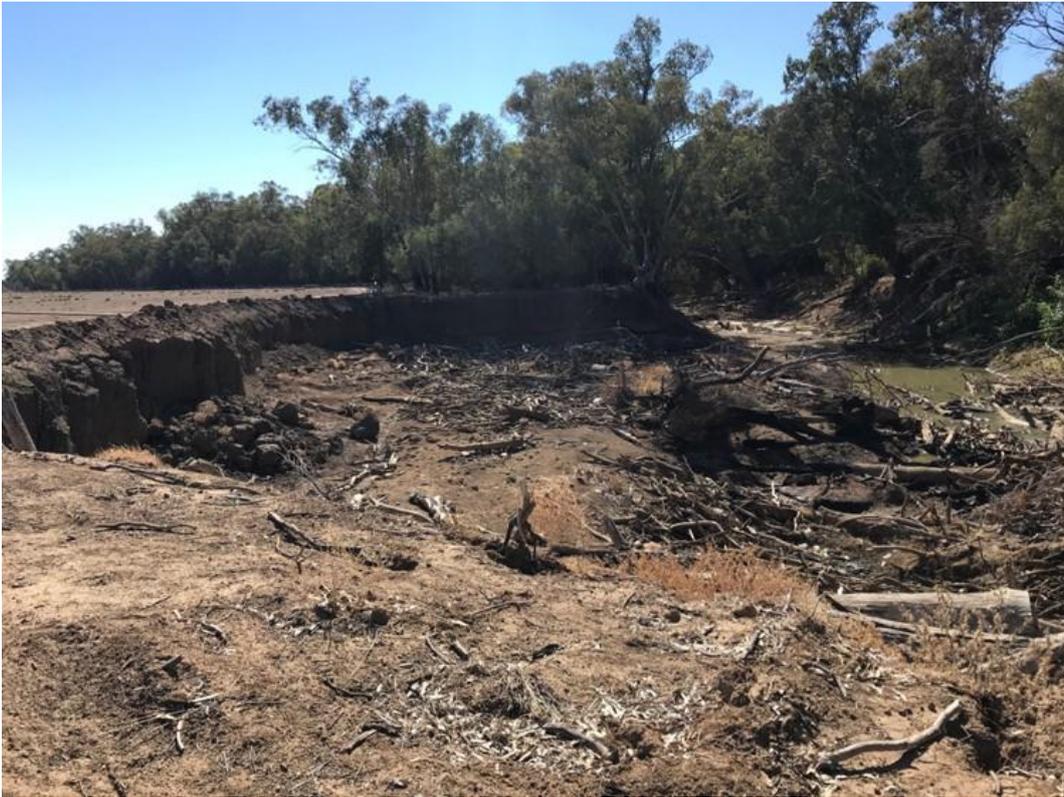
Photograph 3.3 and Photograph 3.4 were provided by a local community member and show the channel breakout in 2019 (during drought conditions). The riverbank erosion is clearly evident in Photograph 3.3 and the remnant debris from the raft are evident in both photographs.

**Photograph 3.3** Channel breakout (looking downstream) – 2019

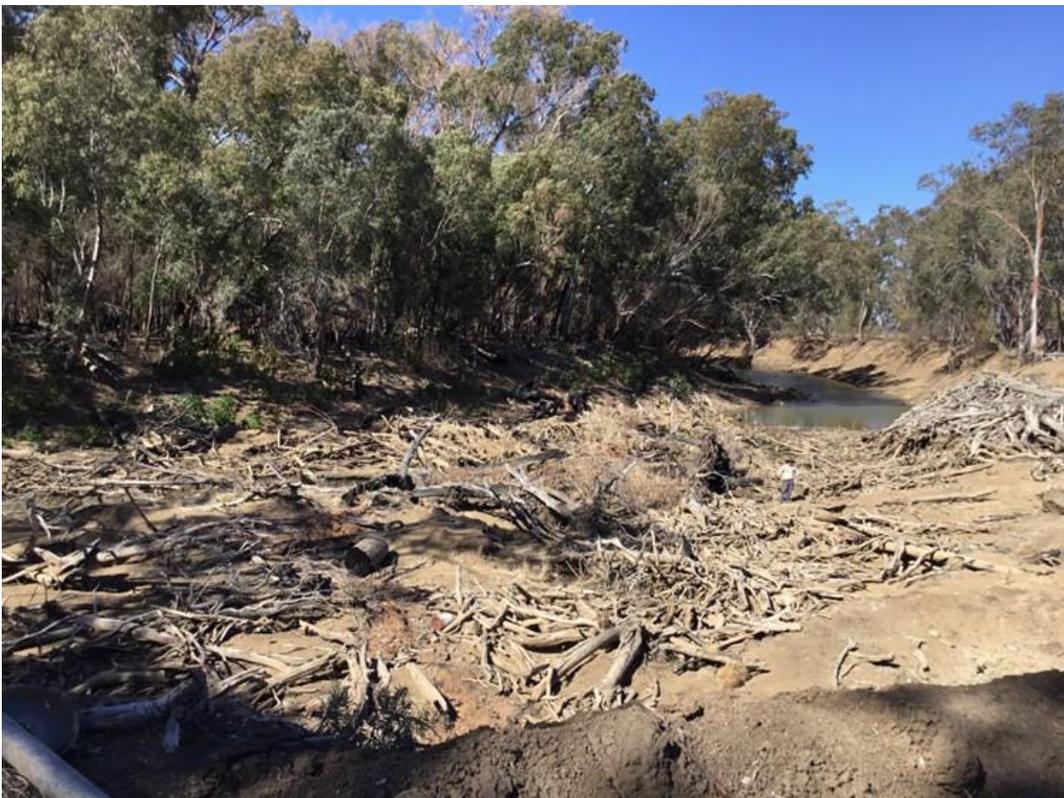
**Photograph 3.4** Channel breakout (looking upstream) – 2019

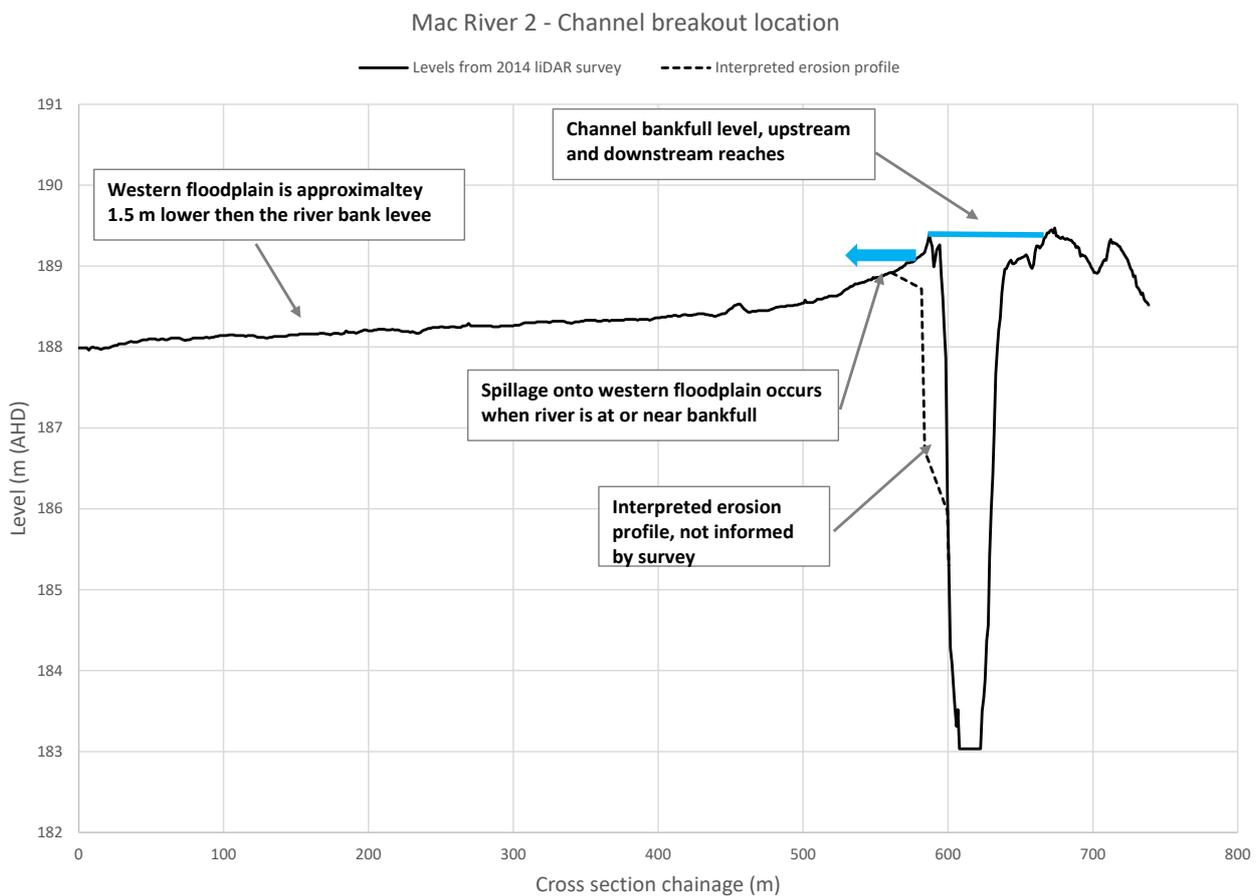
- the western floodplain is approximately 1.5 m lower than the top-of-bank (prior to erosion occurring);
- the erosion has removed the highest part of the riverbank levee which allows water to spill from the channel when the river is flowing at or near bank full; and
- the western floodplain would need to scour significantly for breakout flows to occur during lower river stages.

**Figure 3.7** River and floodplain section – channel breakout

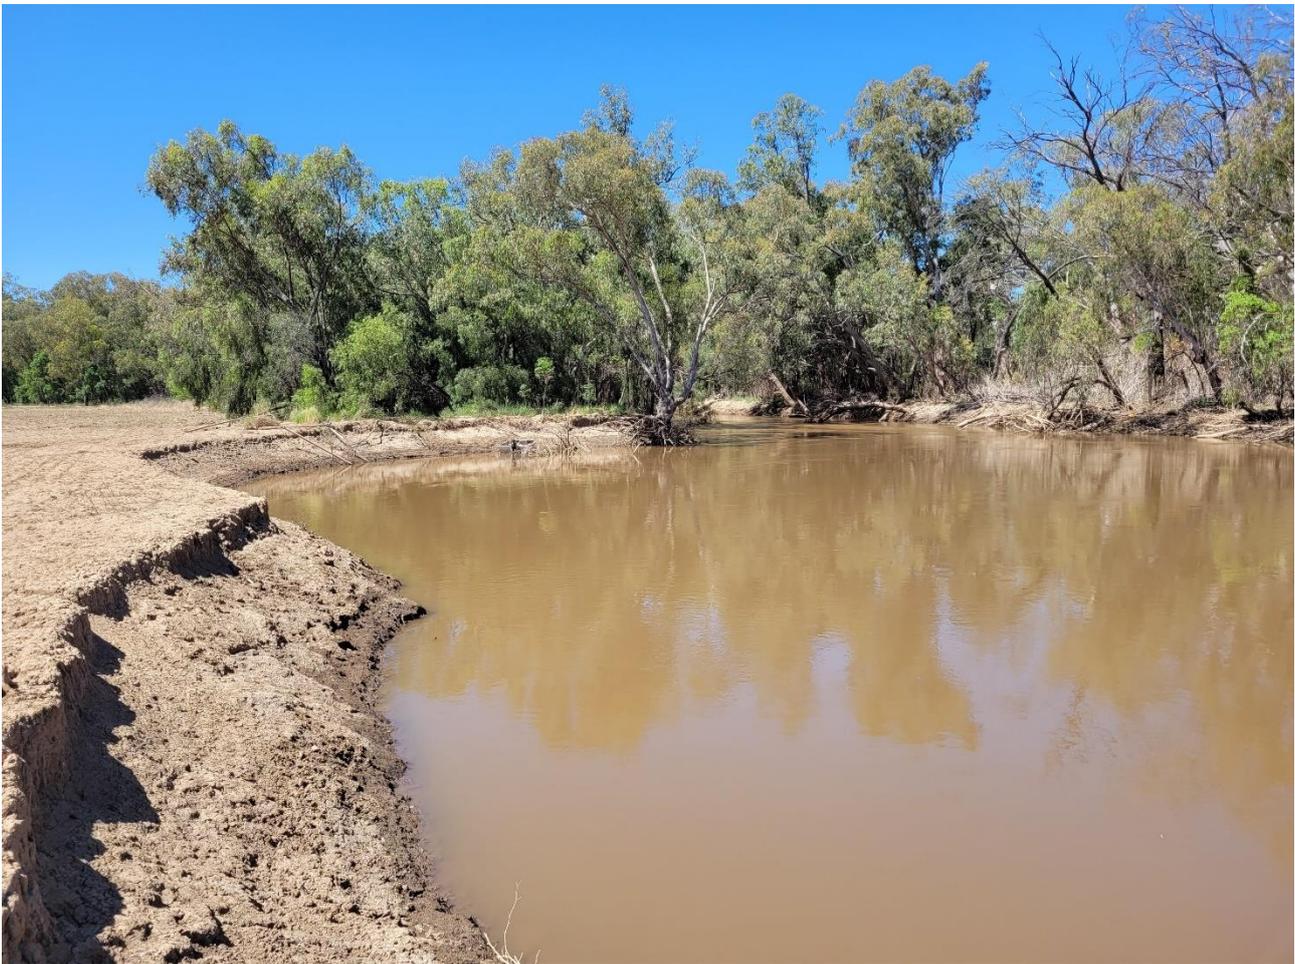
Photograph 3.5 shows the channel breakout location, looking downstream. Photograph 3.6 was taken from the western floodplain looking towards the channel breakout. The extent of the riverbank erosion and recent deposition on the floodplain are evident in the photograph.

**Photograph 3.5** Channel breakout – looking downstream (19 December 2022)

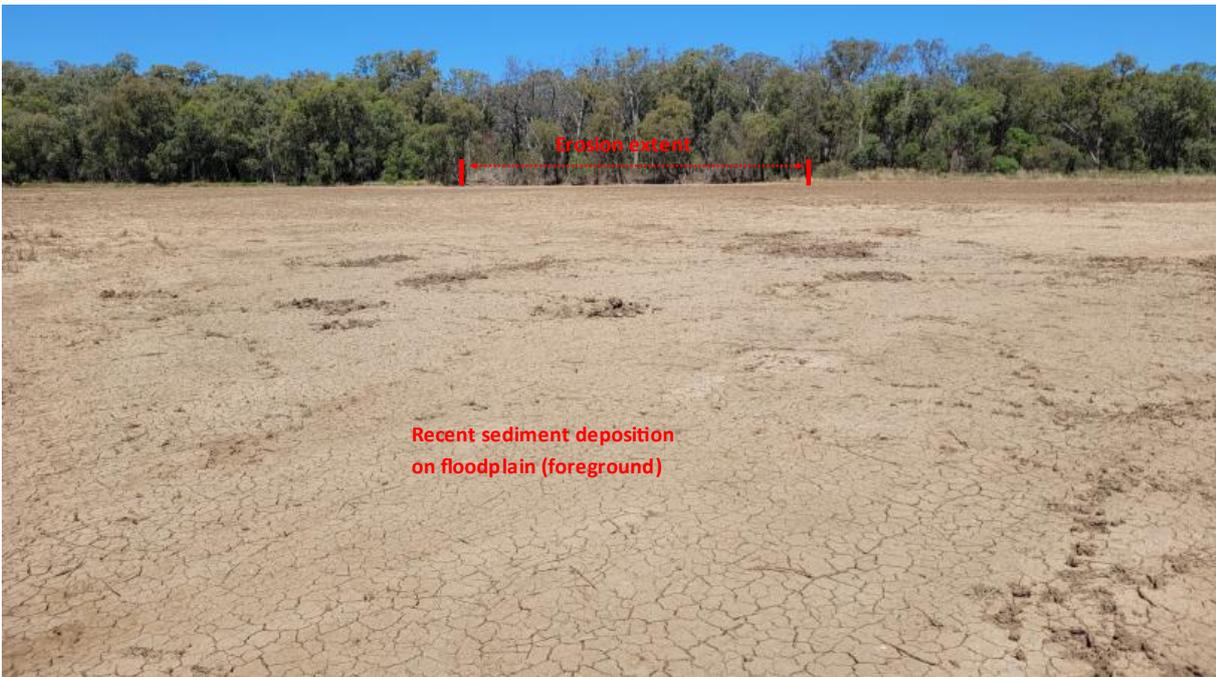
**Photograph 3.6** Channel breakout – looking to the east from the western floodplain (19 December 2022)

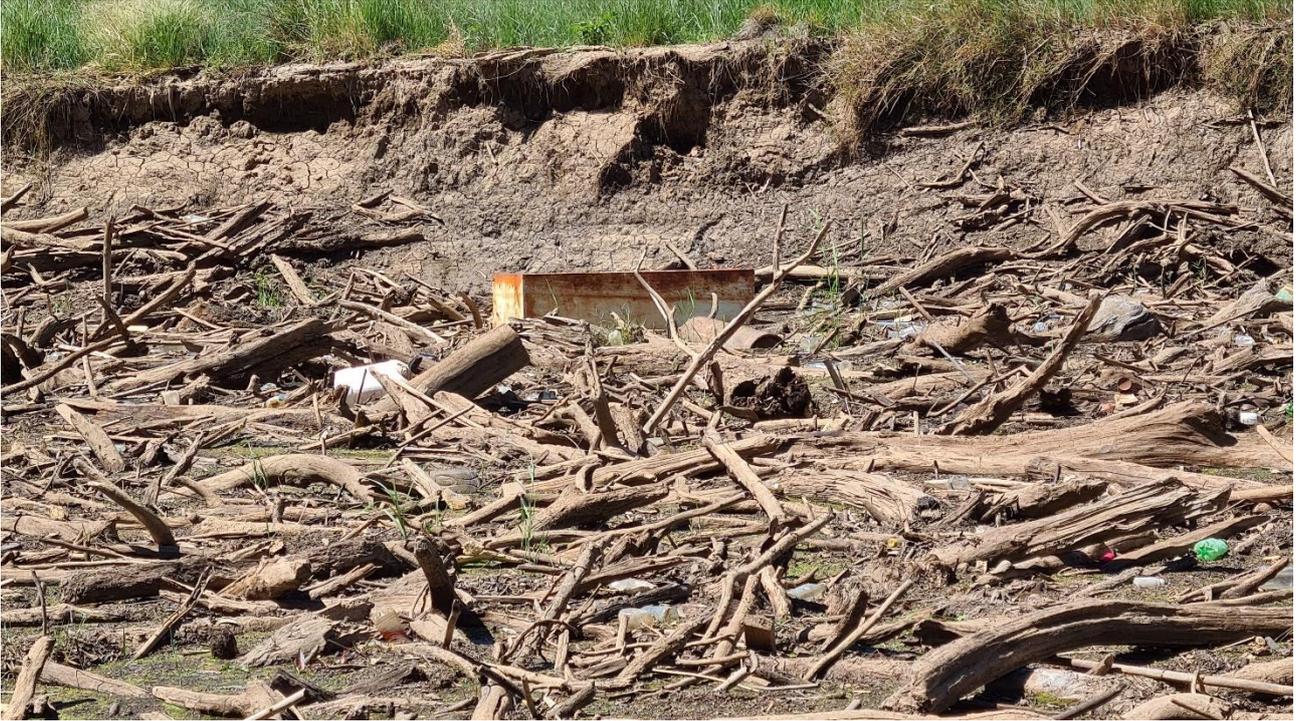
During the 19 December 2022 site inspection recent or active riverbank erosion was observed at several locations between the Bulla Bulla Creek inlet and Raft 4. Actively eroding riverbanks were observed near Rafts 2 (see Photograph 3.7 ) and 3 only (see Photograph 3.8) but not at any of the other raft locations.

**Photograph 3.7**      **Active riverbank erosion at Raft 2 (19 December 2022)**

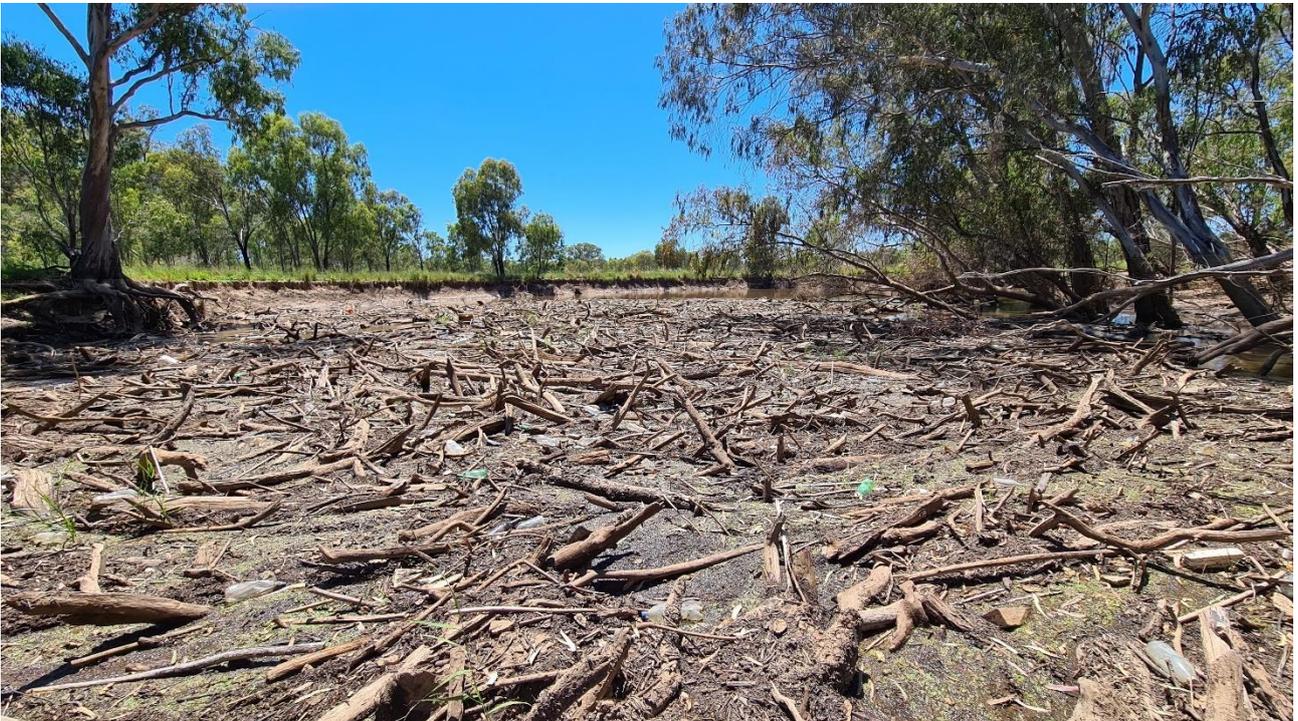
**Photograph 3.8**      **Active riverbank erosion at Raft 3 (19 December 2022)**
