# **Macquarie River debris rafts**

## **Expert opinion: hydro-geomorphology**

Prepared for NSW Environment Protection Authority

E221304 RP#1

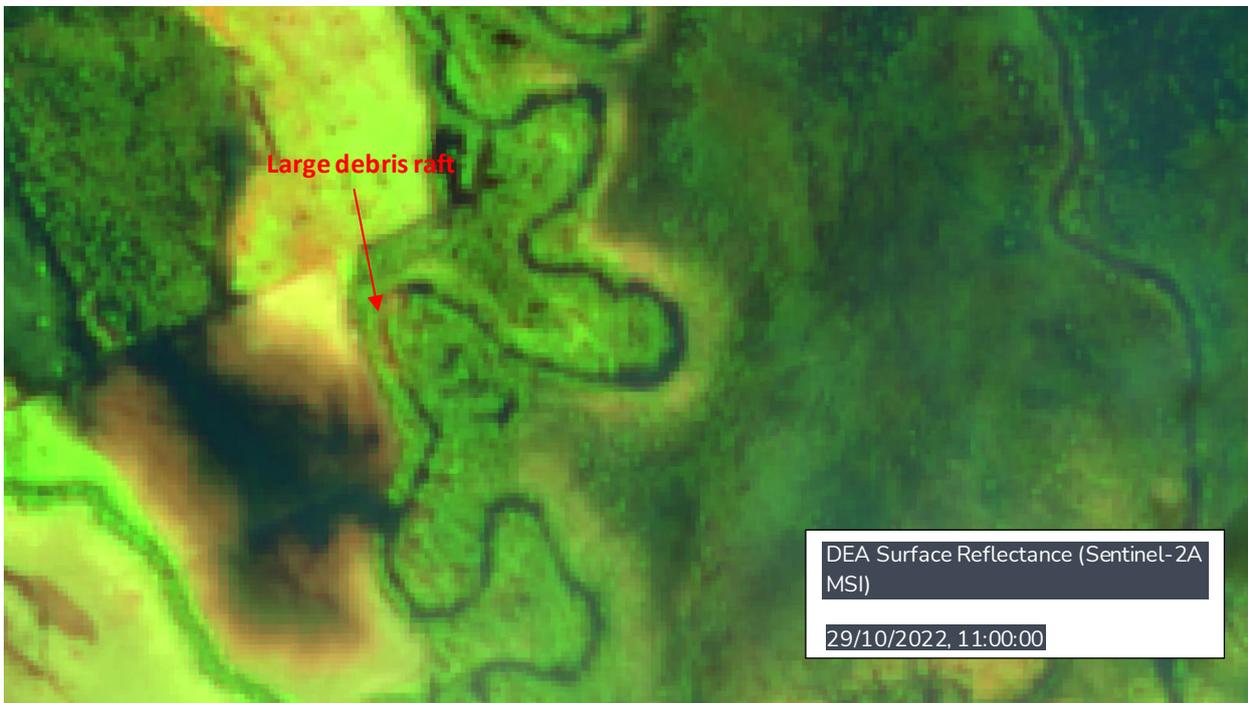
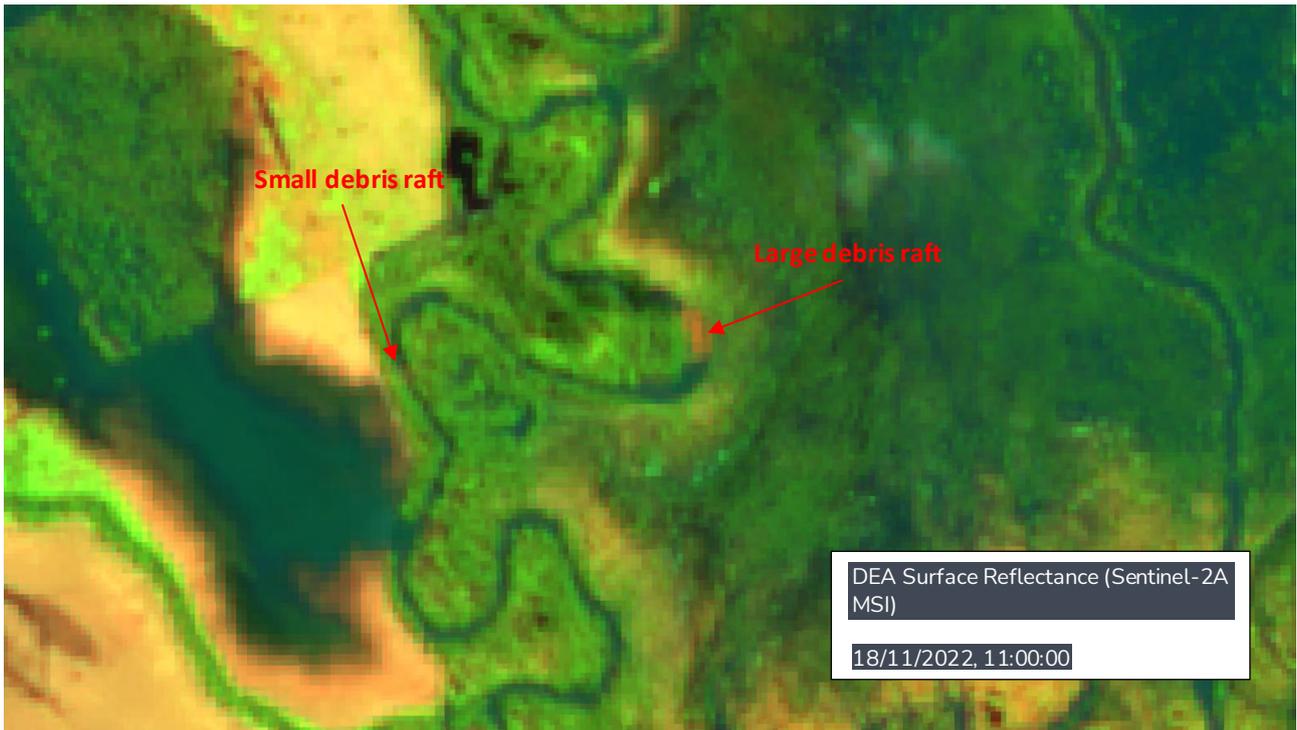
5. Satellite imagery from 29 October and 18 November 2022 indicates that the upstream raft from the 15 October survey had broken up into three smaller rafts during this period. Relevant images are provided as Figure B.11 and Figure B.12 (Appendix B).
