SURFACE & GROUNDWATER IMPACT ASSESSMENT

MANGROVE MOUNTAIN LANDFILL,
HALLARDS ROAD, CENTRAL MANGROVE, NSW.
PREPARED FOR VERDE TERRA PTY LTD
CES DOCUMENT REFERENCED: CES110703-VDT-FD

Date: 15 June 2016

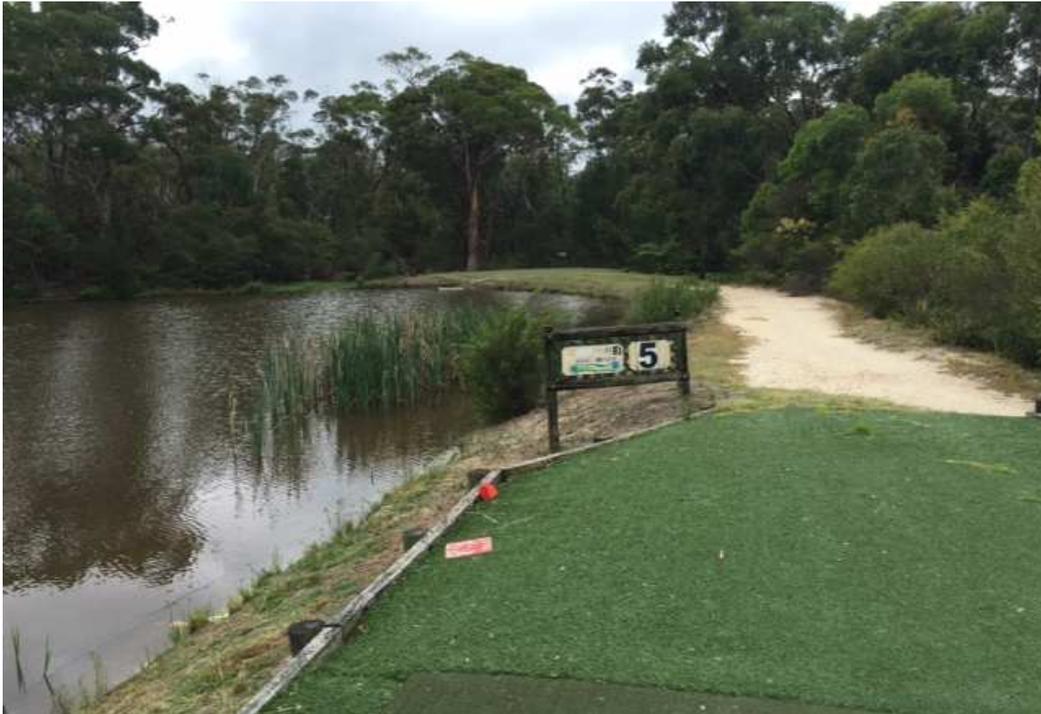
Photograph 1: Golf Course Dam in the (lowest) north east corner of the golf course

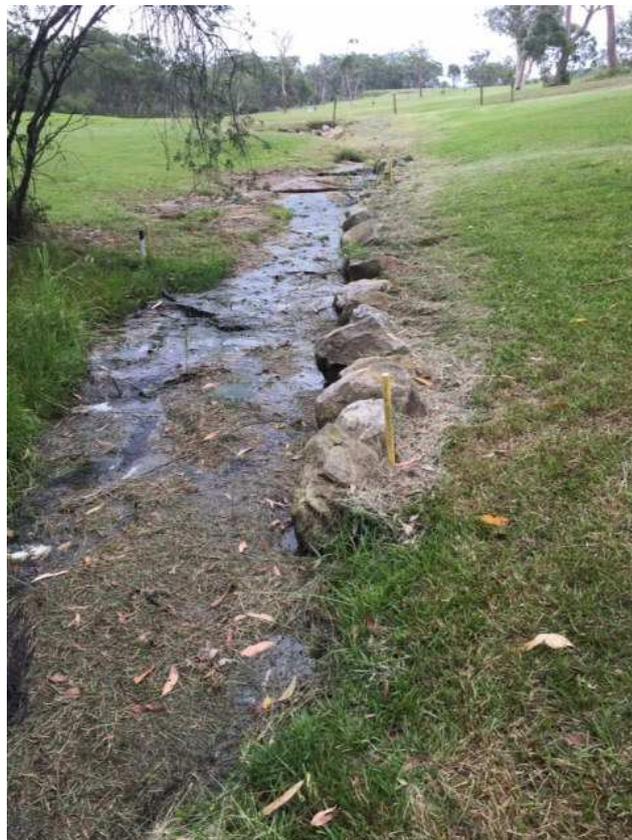
Photograph 2: Drainage from the golf course flowing to Ourimbah State Forest

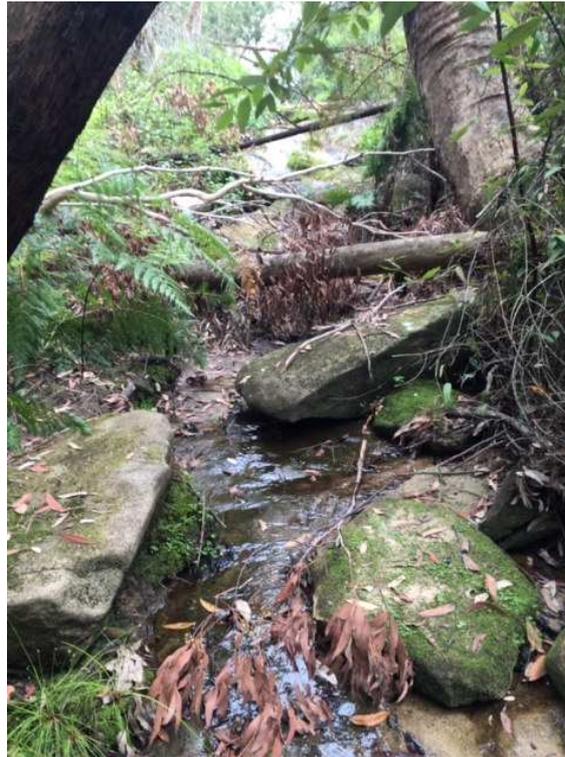
Photograph 3: Small creek line draining from the golf course through Ourimbah State Forest
(no turbidity observed)

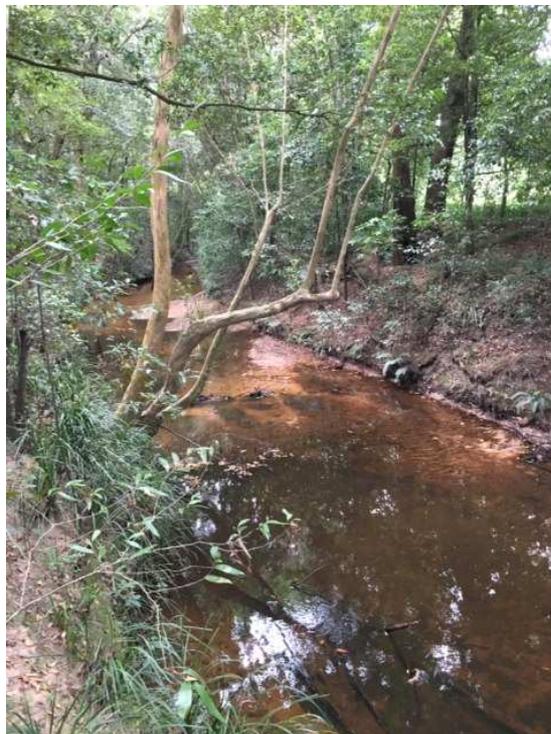
Photograph 4: Ourimbah Creek in open cleared valley, downstream from Ourimbah State Forest.
Note sediment build-up from clearing and erosion within the valley.

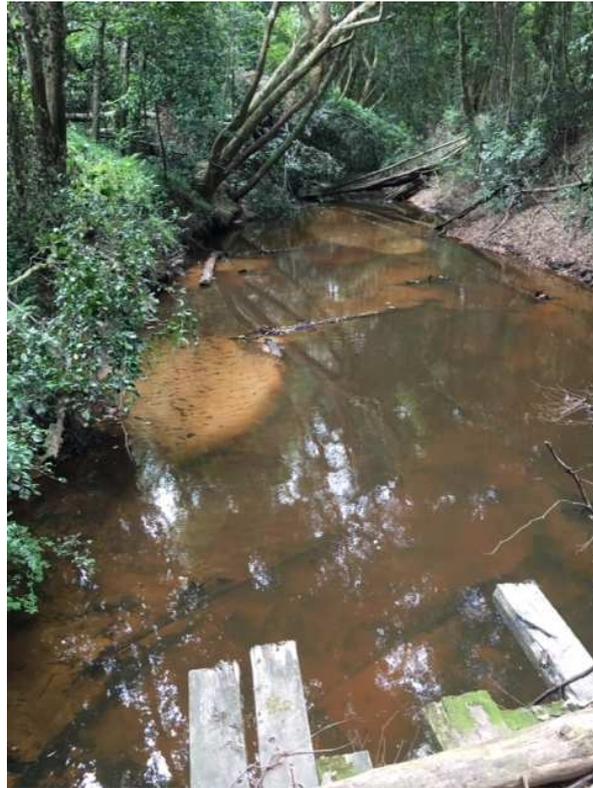
Photograph 5: Turbid middle reaches of Ourimbah Creek, showing sediment build-up and suspended sediment from local run-off.

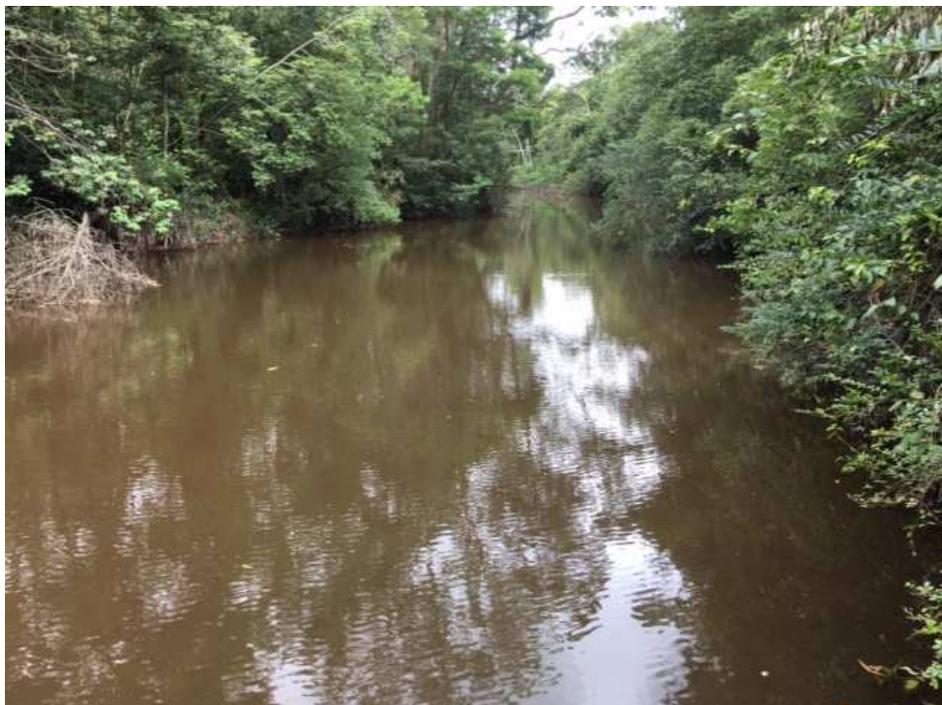
Photograph 6: Ourimbah Creek immediately upstream of the weir near F3 Motorway, showing turbidity from local run-off waters.
