Upper Belubula River catchment surface water and groundwater testing – 9 to 12 December 2024

Between 9 to 12 December 2024, the NSW Environment Protection Authority (EPA) conducted sampling in the upper Belubula River catchment area to investigate potential sources of contamination from per- and polyfluoroalkyl substances (PFAS) and various other pollutants. This report summarises the results from that sampling.

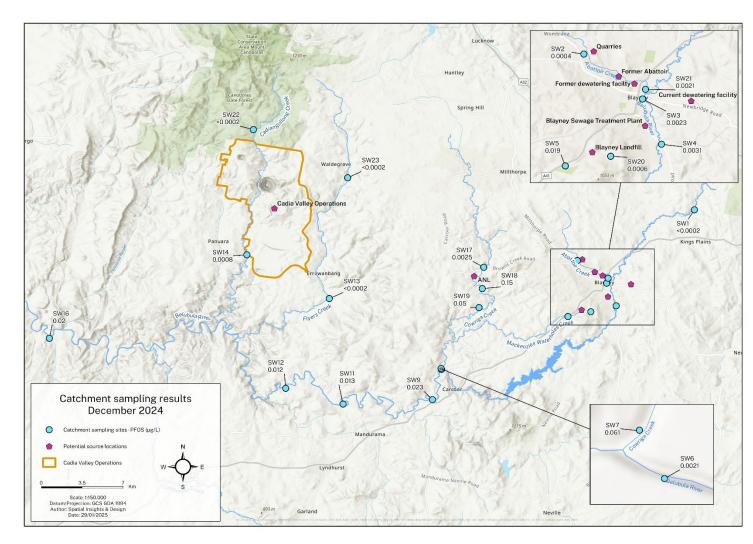
Figure 1 Overview of the Belubula River catchment surface water sampling sites. Results for PFOS concentrations are displayed at each sampling location.

Belubula River catchment sampling locations replicated the October 2024 sites, which were chosen based on locations of community concern, accessibility for sampling, previous testing and proximity to potential industrial sources of pollution. See the full list of catchment sampling locations in Table 1 and Figure 1 below.

Figure 1 displays the PFOS concentrations measured in the upper Belubula River catchment. The map includes local industry locations, including the Cadia gold mine, Cadia dewatering facilities (current and former), Blayney Council landfill, Blayney Sewage Treatment Plant, Australian Native Landscapes (a composting facility), a decommissioned abattoir and quarries.

PFAS substances, including PFOS, PFOA and perfluorohexanesulfonic acid (PFHxS), were detected in 16 of the 20 catchment sites sampled, with PFOS detected above the ecological water quality guidelines (HEPA 2025) at all 16 of those sites (Table 5).

Similar to results from the October sampling round, the sampling location in Cowriga Creek immediately downstream of the composting facility had the highest PFOS concentrations (0.15 μ g/L). These elevated levels continued down Cowriga Creek and into the Belubula River to the furthest sampling point downstream (0.012–0.061 μ g/L).

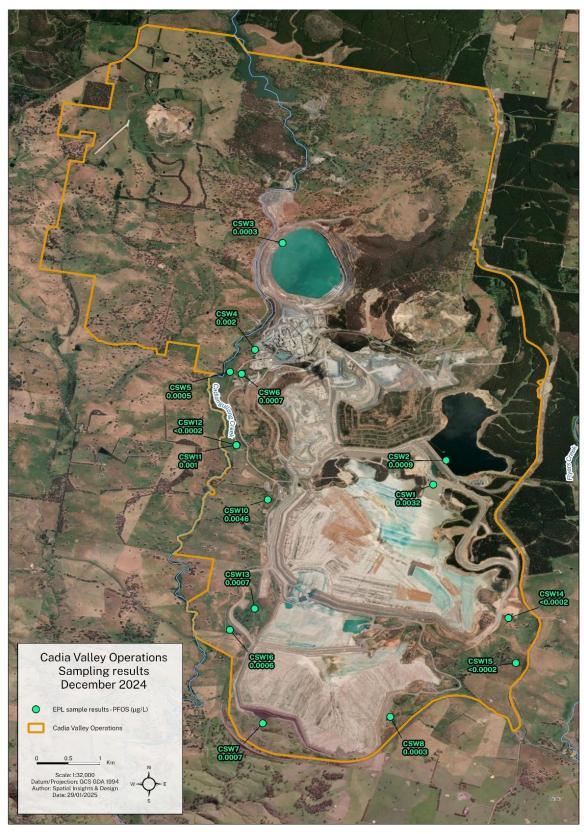
Figure 2 Overview of the Cadia Valley Operations surface water sampling sites. Results for PFOS concentrations are displayed at each sampling location.

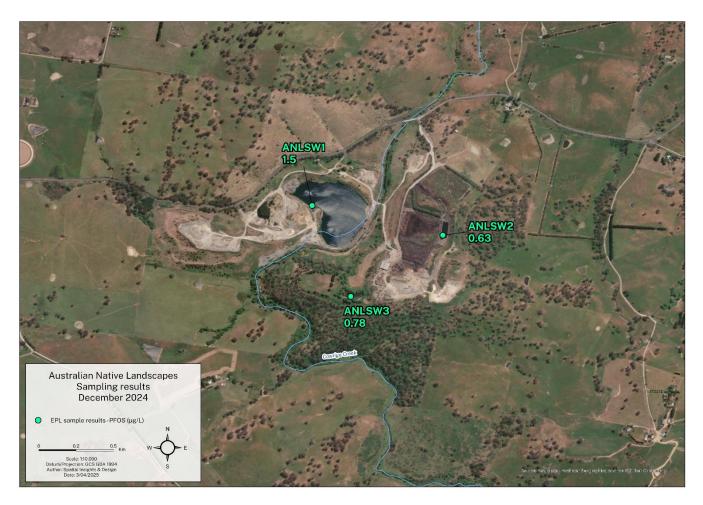
Figure 3 Overview of the Australian Native Landscapes surface water sampling sites. Results for PFOS concentrations are displayed at each sampling location.

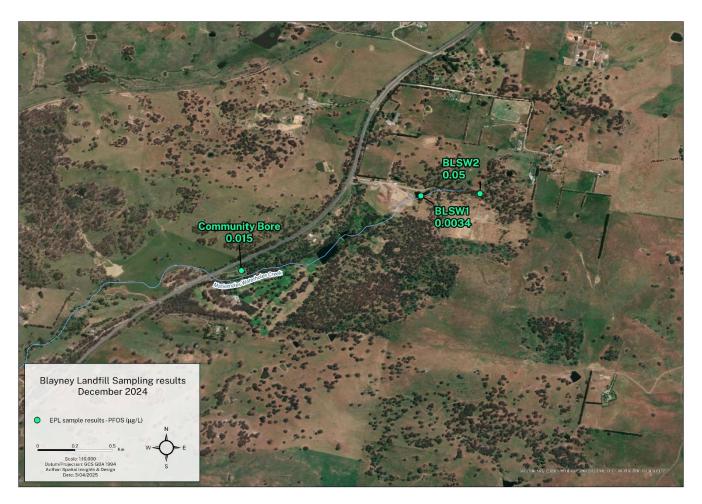
Figure 4 Overview of the Blayney landfill surface water sampling sites (including the off-site community groundwater bore). Results for PFOS concentrations are displayed at each sampling location.

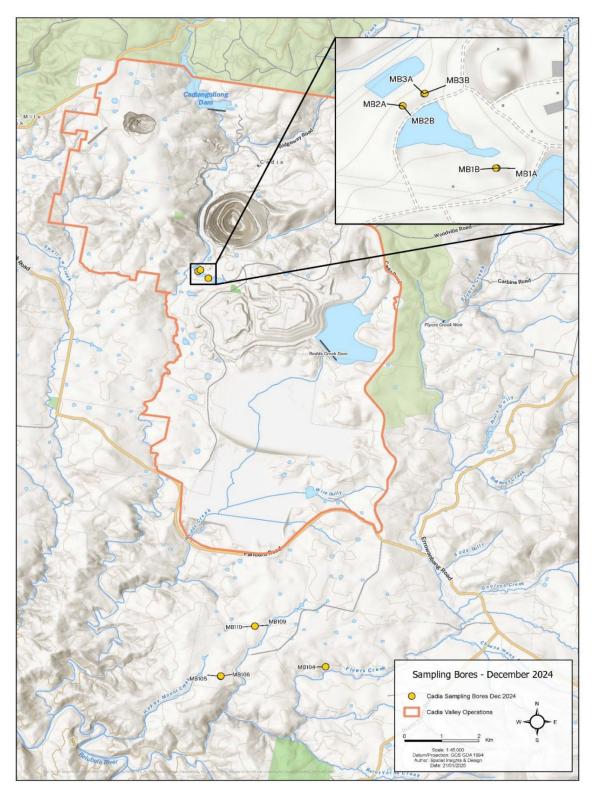
Figure 5 Groundwater sampling locations

Table 3 details the groundwater monitoring bores from which samples were collected. Samples were collected from 10 bores, while one bore (MB1B) was found to be dry. Figure 5 shows the locations of sampled monitoring bores.
