Asbestos Assessment Report

February 2010

Prepared For

Auburn City Council

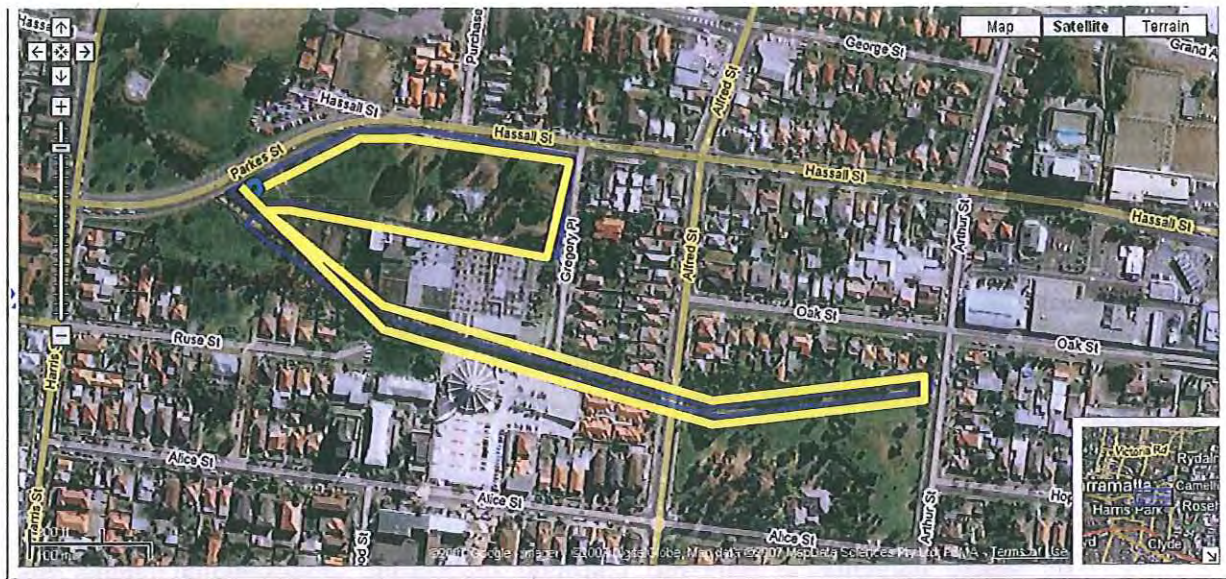
**Site 4 – Embankment along stormwater canal – 100 Hassall St Camellia
(Parramatta City Council)**
(Includes Hambledon cottage along Hassall St to James Ruse Dr)

An assessment of the site conducted by DECC in December 2007 found the presence of small amounts of asbestos mainly in bonded form as broken asbestos sheets. Although the asbestos was initially buried, the cover has eroded over time and exposed the asbestos material.

1. The visible asbestos is removed following recognised Occupational Health and Safety practices.
2. A management plan is developed by an occupational hygienist with recognized experience in asbestos identification and management to ensure that the asbestos is not disturbed unless appropriate plans for investigation/ remediation are developed and assessed as suitable for implementation by a site auditor accredited under the CLM Act (this may include clean fill to be placed across affected areas and re-grassing of the site); and
3. Council considers making appropriate notation on the relevant planning certificates (i.e. section 149 Planning Certificate).

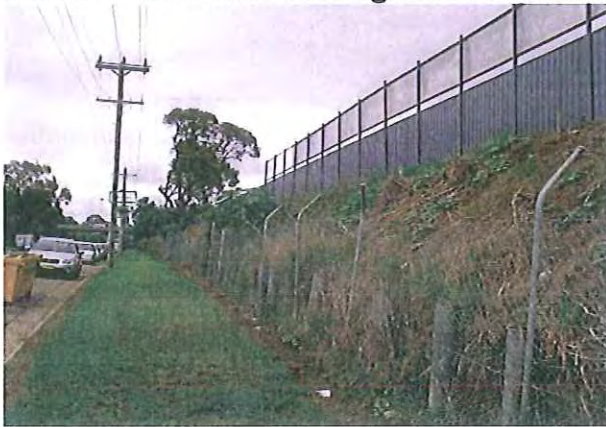
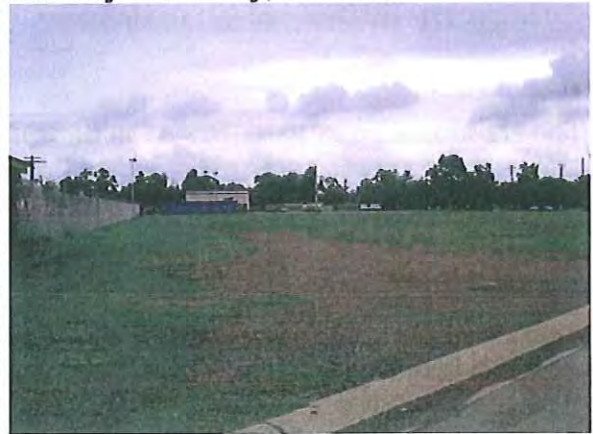
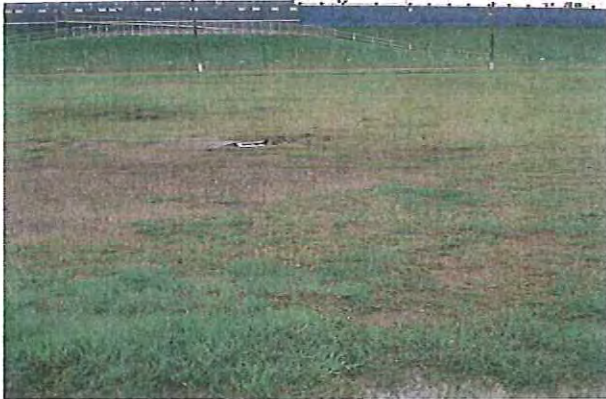
Site 14 – Granville Showground / Parramatta City Raceway, Rosehill

An assessment of the site conducted by DECC in December 2007 found that there was no visible evidence of asbestos contamination on the open area of the site.

1. Council considers noting factual information on the sites history – i.e. that associated companies of James Hardie has disposed asbestos on the site, on the relevant planning certificates (i.e. s.149 certificate)
2. Should the area be disturbed then appropriate asbestos management plans for the site should be developed to ensure that human health is protected.

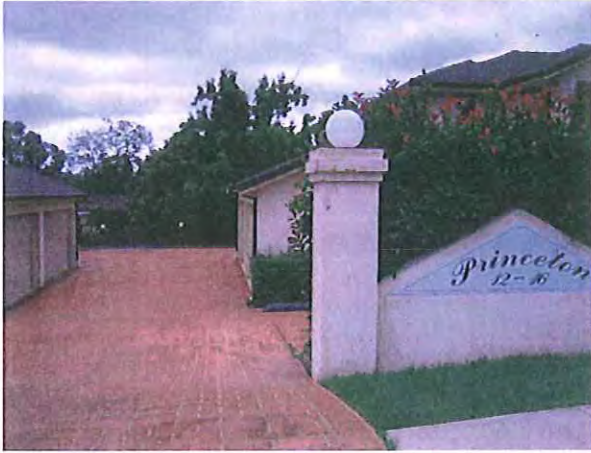
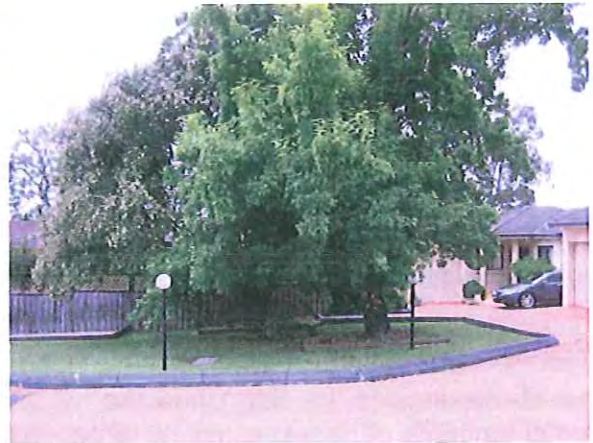
Site 18 – 14 Prince Street, Oatlands

An assessment of the site conducted by DECC in December 2007 found the presence of small amounts of asbestos mainly in bonded form as broken asbestos sheet, located in small grassed area at end of driveway. Although the asbestos was initially buried, the cover has eroded over time and exposed the asbestos material.

1. The visible asbestos is removed following recognised Occupational Health and Safety practises;
2. A management plan is developed by an occupational hygienist with recognized experience in asbestos identification and management to ensure that the asbestos is not disturbed unless appropriate plans for investigation/ remediation are developed and assessed as suitable for implementation by a site auditor accredited under the CLM Act (this may include clean fill to be placed across affected areas and re-grassing of the site); and
3. Council considers making appropriate notation on the relevant planning certificates (i.e. s.149 certificate).

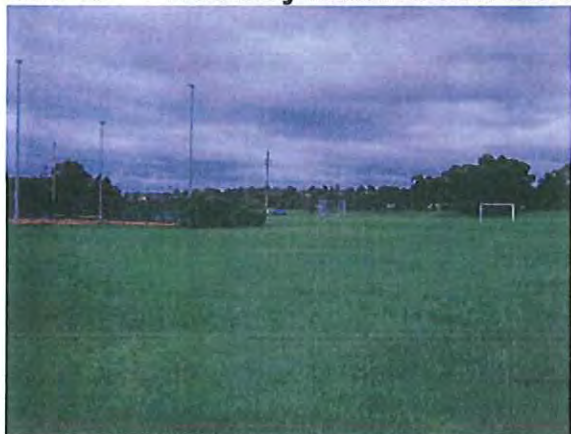
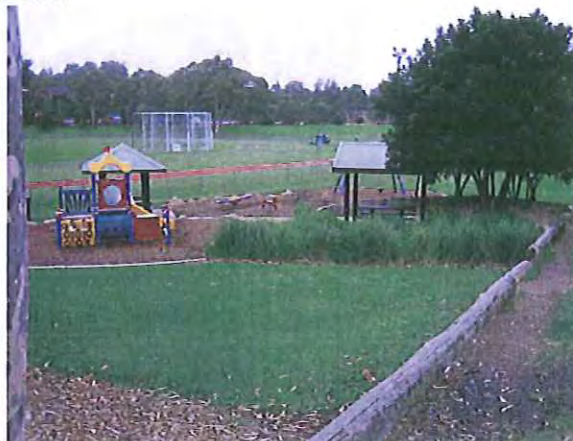
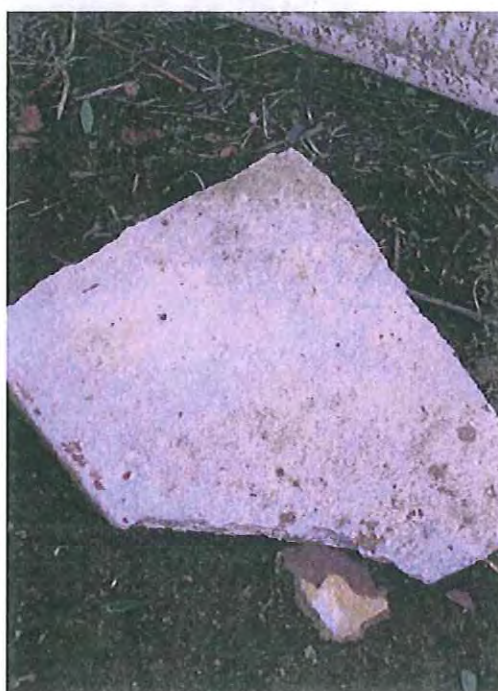
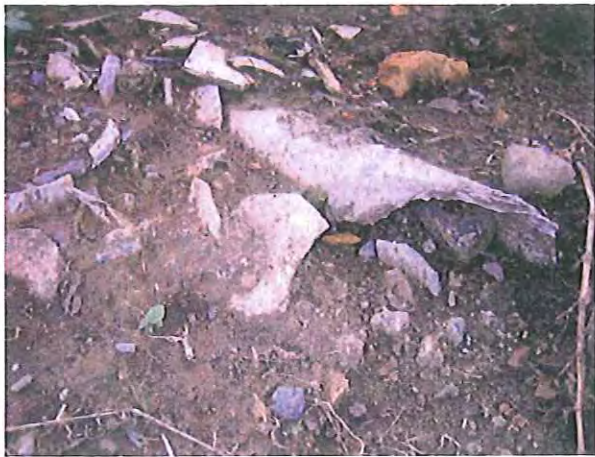
Site 19 – PH Jeffery Reserve and Barton Park

An assessment of the site conducted by DECC in December 2007 found the presence of small amounts of asbestos mainly in bonded form as broken asbestos sheets and cement pipes in Barton Park. Most of the asbestos material is located around the children's playground on Gladstone Street and around the embankment along James Ruse Drive and Web Street. Asbestos offcuts are also visible along a residential fence at 108 Isabella Street at PH Jeffery Reserve.

1. The visible asbestos is removed following recognised Occupational Health and Safety practises;
2. A management plan is developed by an occupational hygienist with recognized experience in asbestos identification and management to ensure that the asbestos is not disturbed unless appropriate plans for investigation/ remediation are developed and assessed as suitable for implementation by a site auditor accredited under the CLM Act (this may include clean fill to be placed across affected areas and re-grassing of the site); and
3. Consider making appropriate notation on the relevant planning certificates (i.e. s.149 certificate).

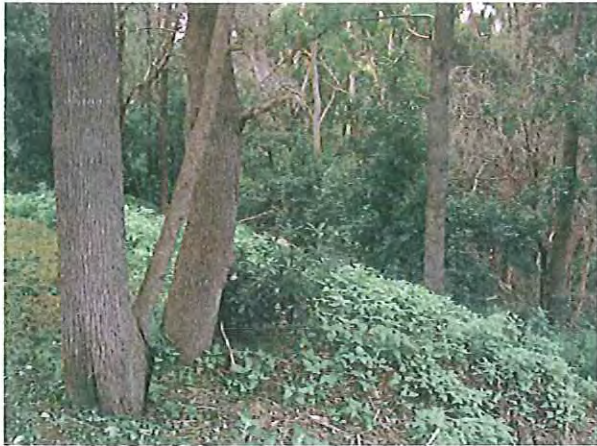
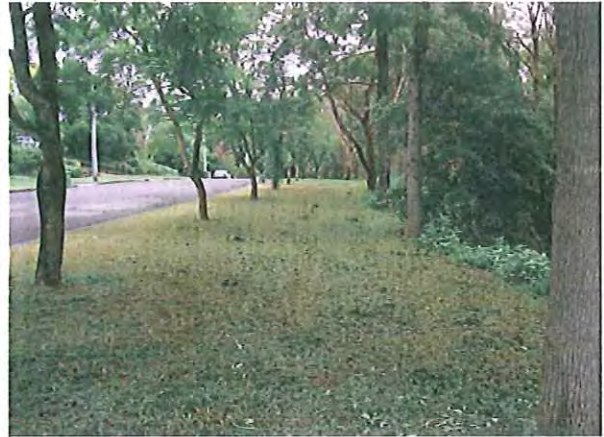
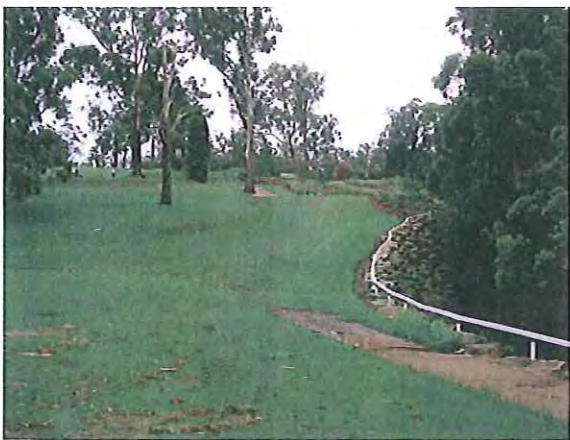
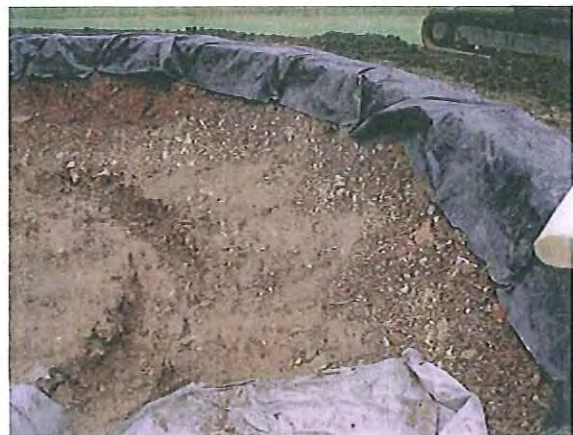
Site 23 – Eastern side of Oatlands Golf Course

An assessment of the site conducted by DECC in December 2007 found that there was no visible evidence of asbestos on the open area of the site. The area in which the asbestos has been buried is currently undergoing an excavation to install a sand bunker for the golf course. However a close inspection of the excavation did not reveal any evidence of asbestos exposure. As the area would have required a large amount of fill any asbestos that was transported to the site would have been buried deep beneath the current surface level.

1. Council considers noting factual information on the sites' history - i.e. that associated companies of James Hardie has disposed asbestos on the site, on the relevant planning certificates (i.e. s.149 certificate).
2. Should the area be disturbed then appropriate asbestos management plans for the site should be developed to ensure that human health is protected.

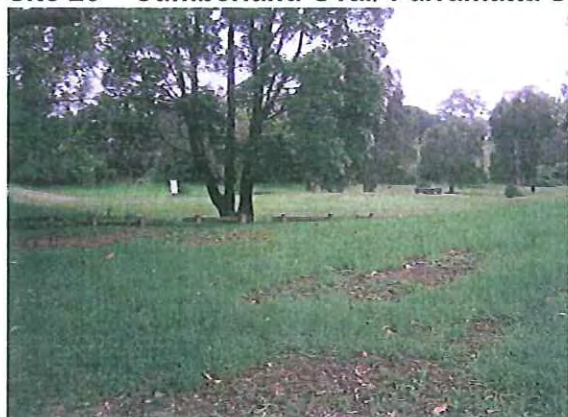
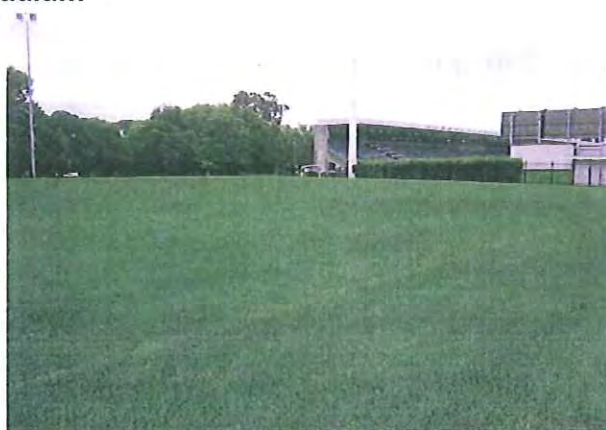
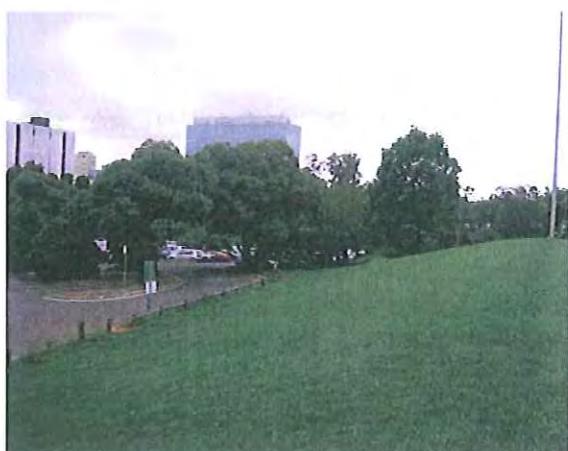
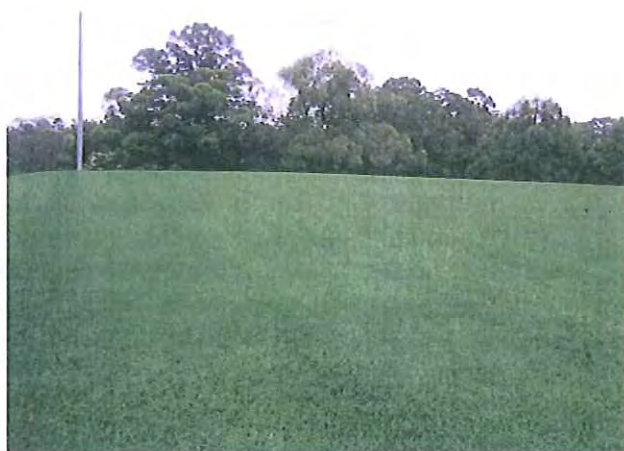
Site 26 – Cumberland Oval/ Parramatta Stadium

An assessment of the site conducted by DECC in December 2007 found that there was no visible evidence or signs of asbestos on the open area of the site. However, the Parramatta pool, which is located on the subject site, is currently being renovated and asbestos has been found in a water storage tank. The site has been assessed by work cover and the correct procedures are in place for the asbestos removal. Hence, with the redevelopment of the site, there is potential exposure of the buried asbestos during the excavation work.

1. Considers noting factual information on the sites' history - i.e. that associated companies of James Hardie has disposed asbestos on the site on the relevant planning certificates (i.e. s.149 certificate)
2. Should the area be disturbed then appropriate asbestos management plans for the site should be developed to ensure that human health is protected.

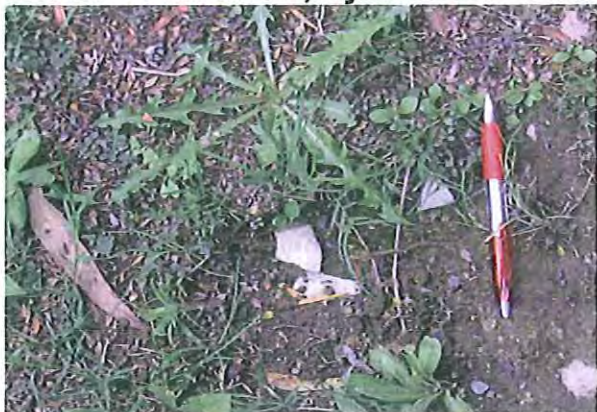
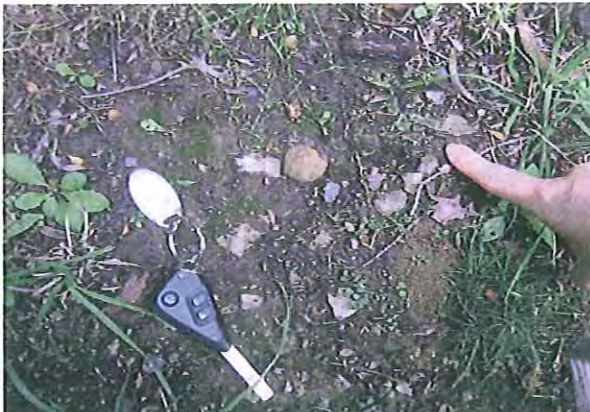
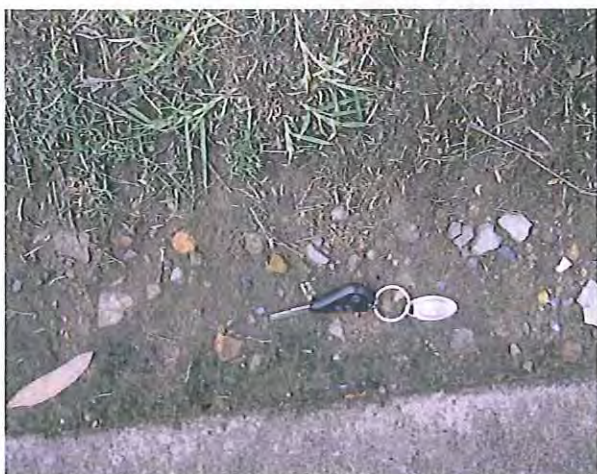
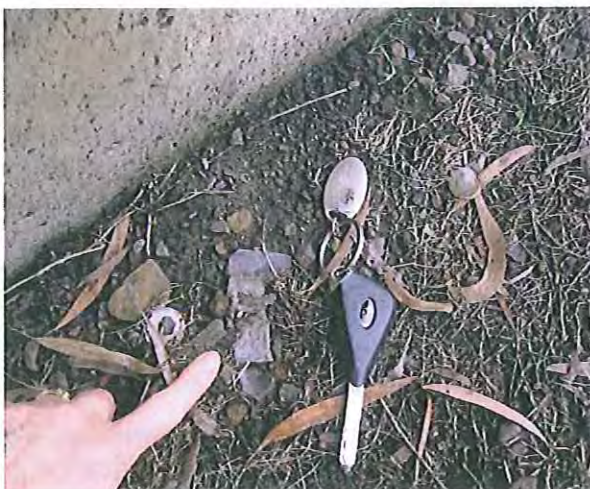
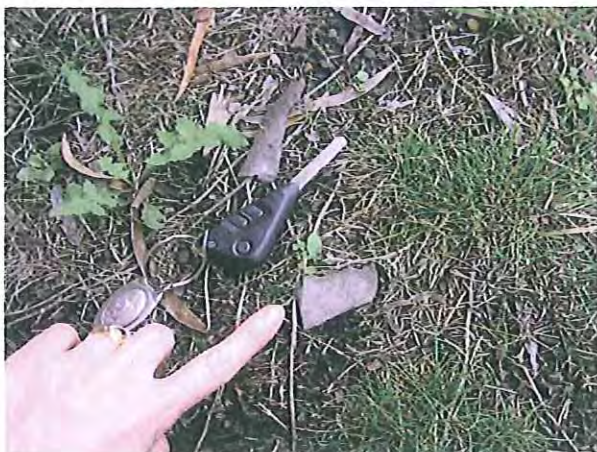
Site 28 – Pike Street, Rydalmere

An assessment of the site conducted by DECC in December 2007 found that the asbestos was present as bonded sheet matrix, but small pieces of asbestos were observed along the length of Pike Street. The mowing of the grass verge, which contains asbestos, has the potential to cause the asbestos to become airborne.

1. The visible asbestos is removed following recognized Occupational Health and Safety practises;
2. A management plan is developed by an occupational hygienist with recognized experience in asbestos identification and management to ensure that the asbestos is not disturbed unless appropriate plans for investigation/ remediation are developed and assessed as suitable for implementation by a site auditor accredited under the CLM Act (this may include clean fill to be placed across affected areas and re-grassing of the site); and
3. Considers making appropriate notation on the relevant planning certificates (i.e. s.149 certificate).

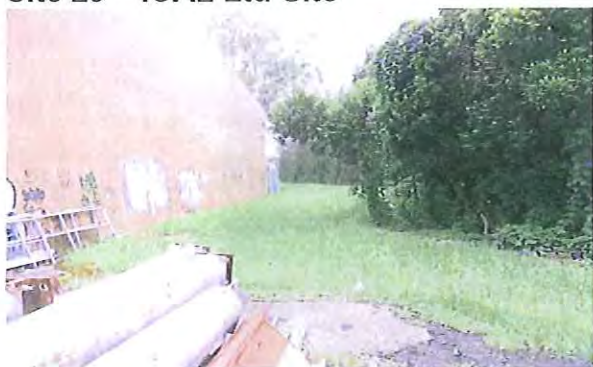
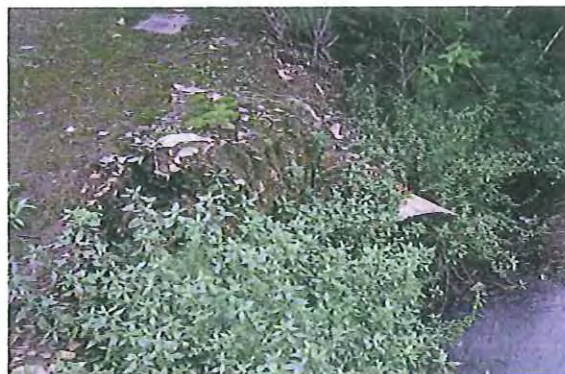
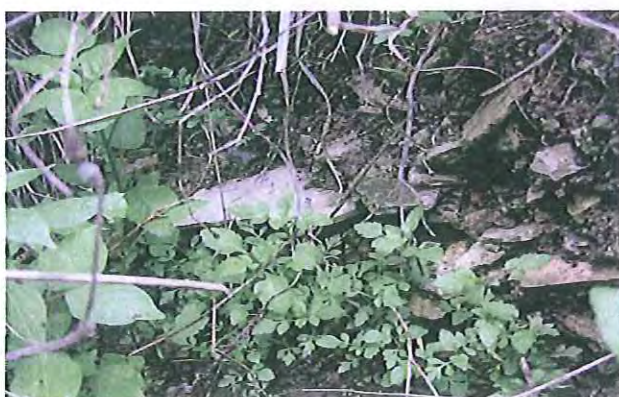
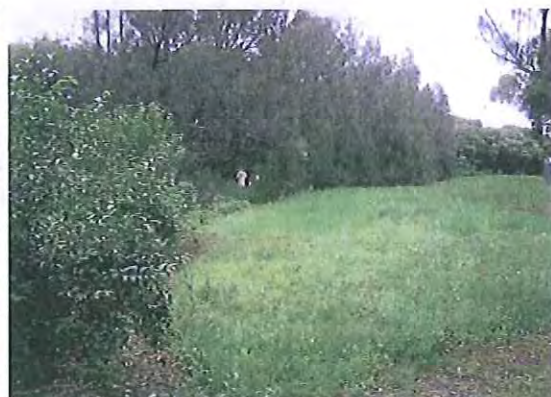
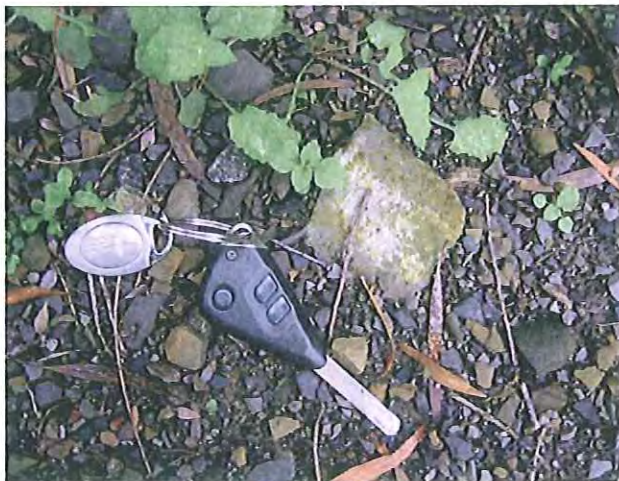
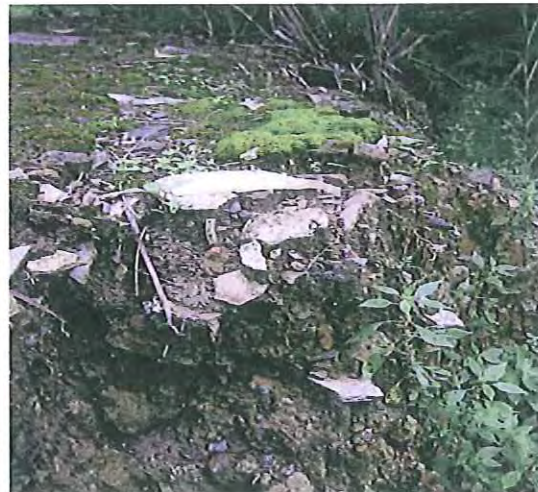
Site 29 – ICAL Ltd Site

An assessment of the site conducted by DECC in December 2007 found that asbestos was present as bonded sheet matrix and broken cement pipe along the river bank. Erosion may further expose asbestos waste, particularly on the river bank adjacent to an outflow pipe.

1. The visible asbestos is removed following recognised Occupational Health and Safety practises;
2. A management plan is developed by an occupational hygienist with recognized experience in asbestos identification and management to ensure that the asbestos is not disturbed unless appropriate plans for investigation/ remediation are developed and assessed as suitable for implementation by a site auditor accredited under the CLM Act (this may include clean fill to be placed across affected areas and re-grassing of the site); and
3. Council considers making appropriate notation on the relevant planning certificates (i.e. s.149 certificate).
