# **Macquarie River debris rafts**

## **Expert opinion: hydro-geomorphology**

Prepared for NSW Environment Protection Authority

E221304 RP#1

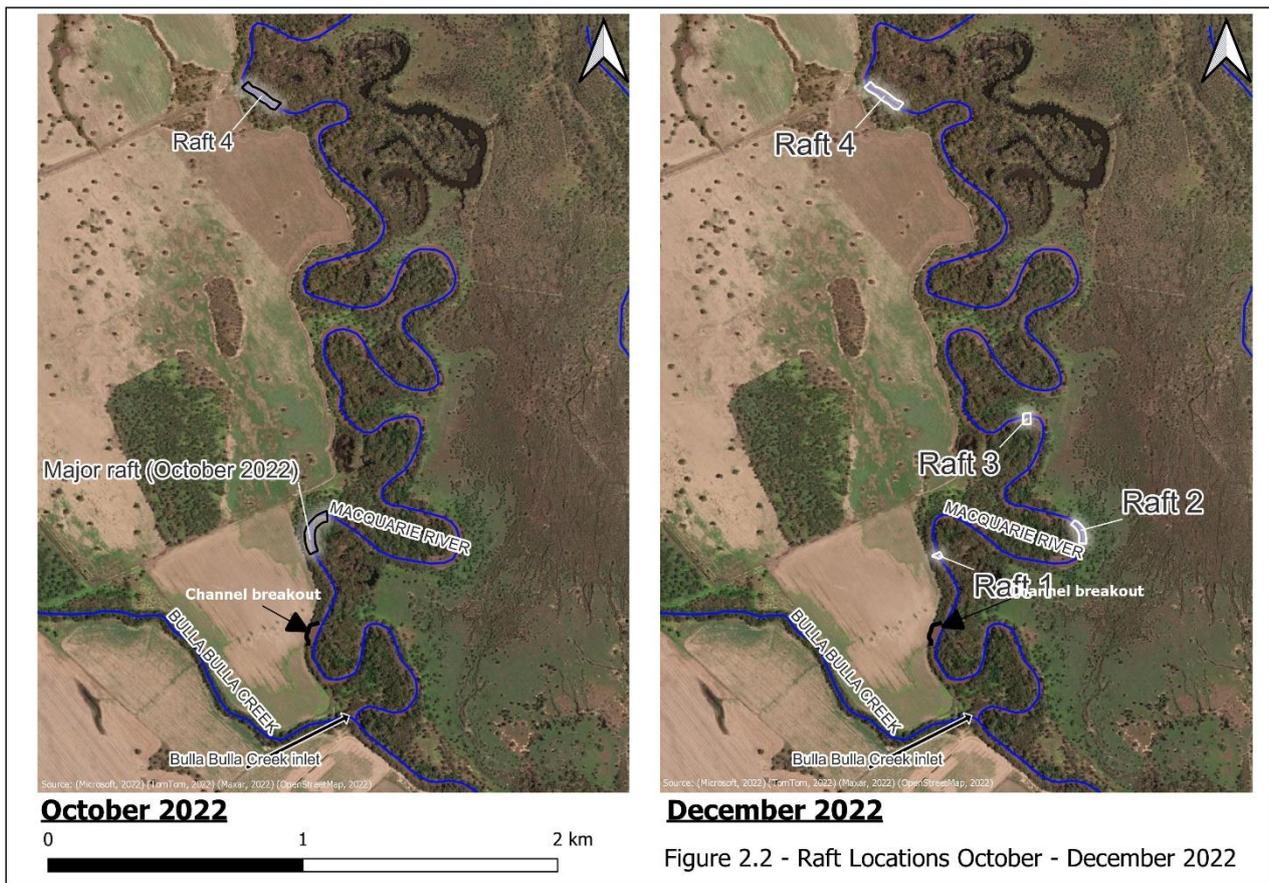
**Figure 2.2 Raft locations October to December 2022**

6. On 4 December 2022 (after peak flooding had subsided), the SES undertook another aerial survey. This survey confirmed that the upstream raft from the 15 October survey had broken up into three smaller rafts (referred to as Rafts 1, 2 and 3 in this report). The Raft 4 location was unchanged.

Figure 2.2 shows the locations of Rafts 1 to 4 from the October 15 and December 4 surveys. Section 2.3 provides further details on Rafts 1 to 7 (based on site observations on 19 December 2022 and 4 January 2023).

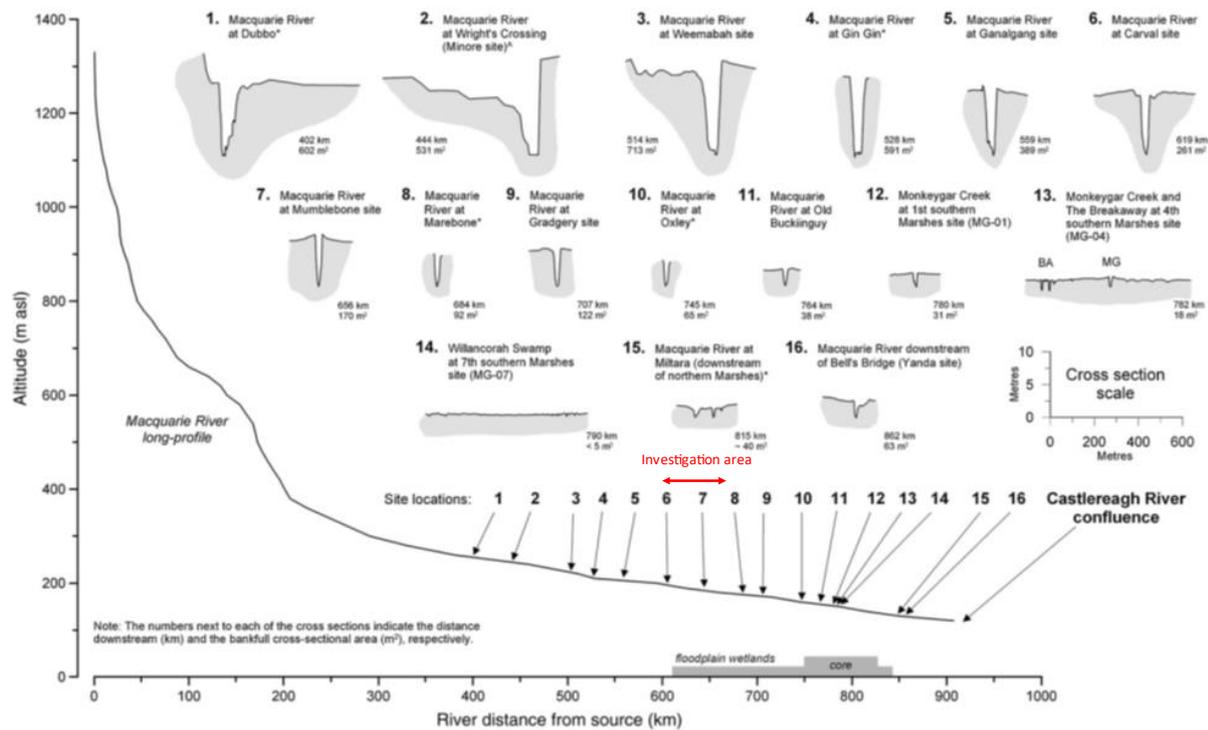
**Figure 3.1** Change to the Macquarie River channel along river reach

Figure 3.1 is reproduced from Ralph 2009 and shows the changes to the Macquarie River channel between Dubbo and the end of the river system. Similar figures that show changes to streamflow, stream power, channel area, floodplain width and sinuosity over the same river reach are provided in Figure A.5 and Figure A.6 (Appendix A). This information shows that between Warren and Marebone the Macquarie River channel progressively becomes smaller, with Ralph 2009 estimating the bank-full channel area to be 261 m<sup>2</sup> at Carvel (just downstream of Warren) and 92 m<sup>2</sup> at Marebone (see Figure 3.1) and that large and small flood discharge rates reduce by a similar amount (see Figure A.5). This diminishing channel trend occurs as the flood discharges conveyed in the channel reduce over the river reach due to losses to floodplain wetlands and anabranches.

The key conclusion relevant to this report scope is that the ability of the river to flush floating debris progressively reduces between Warren and Marebone.

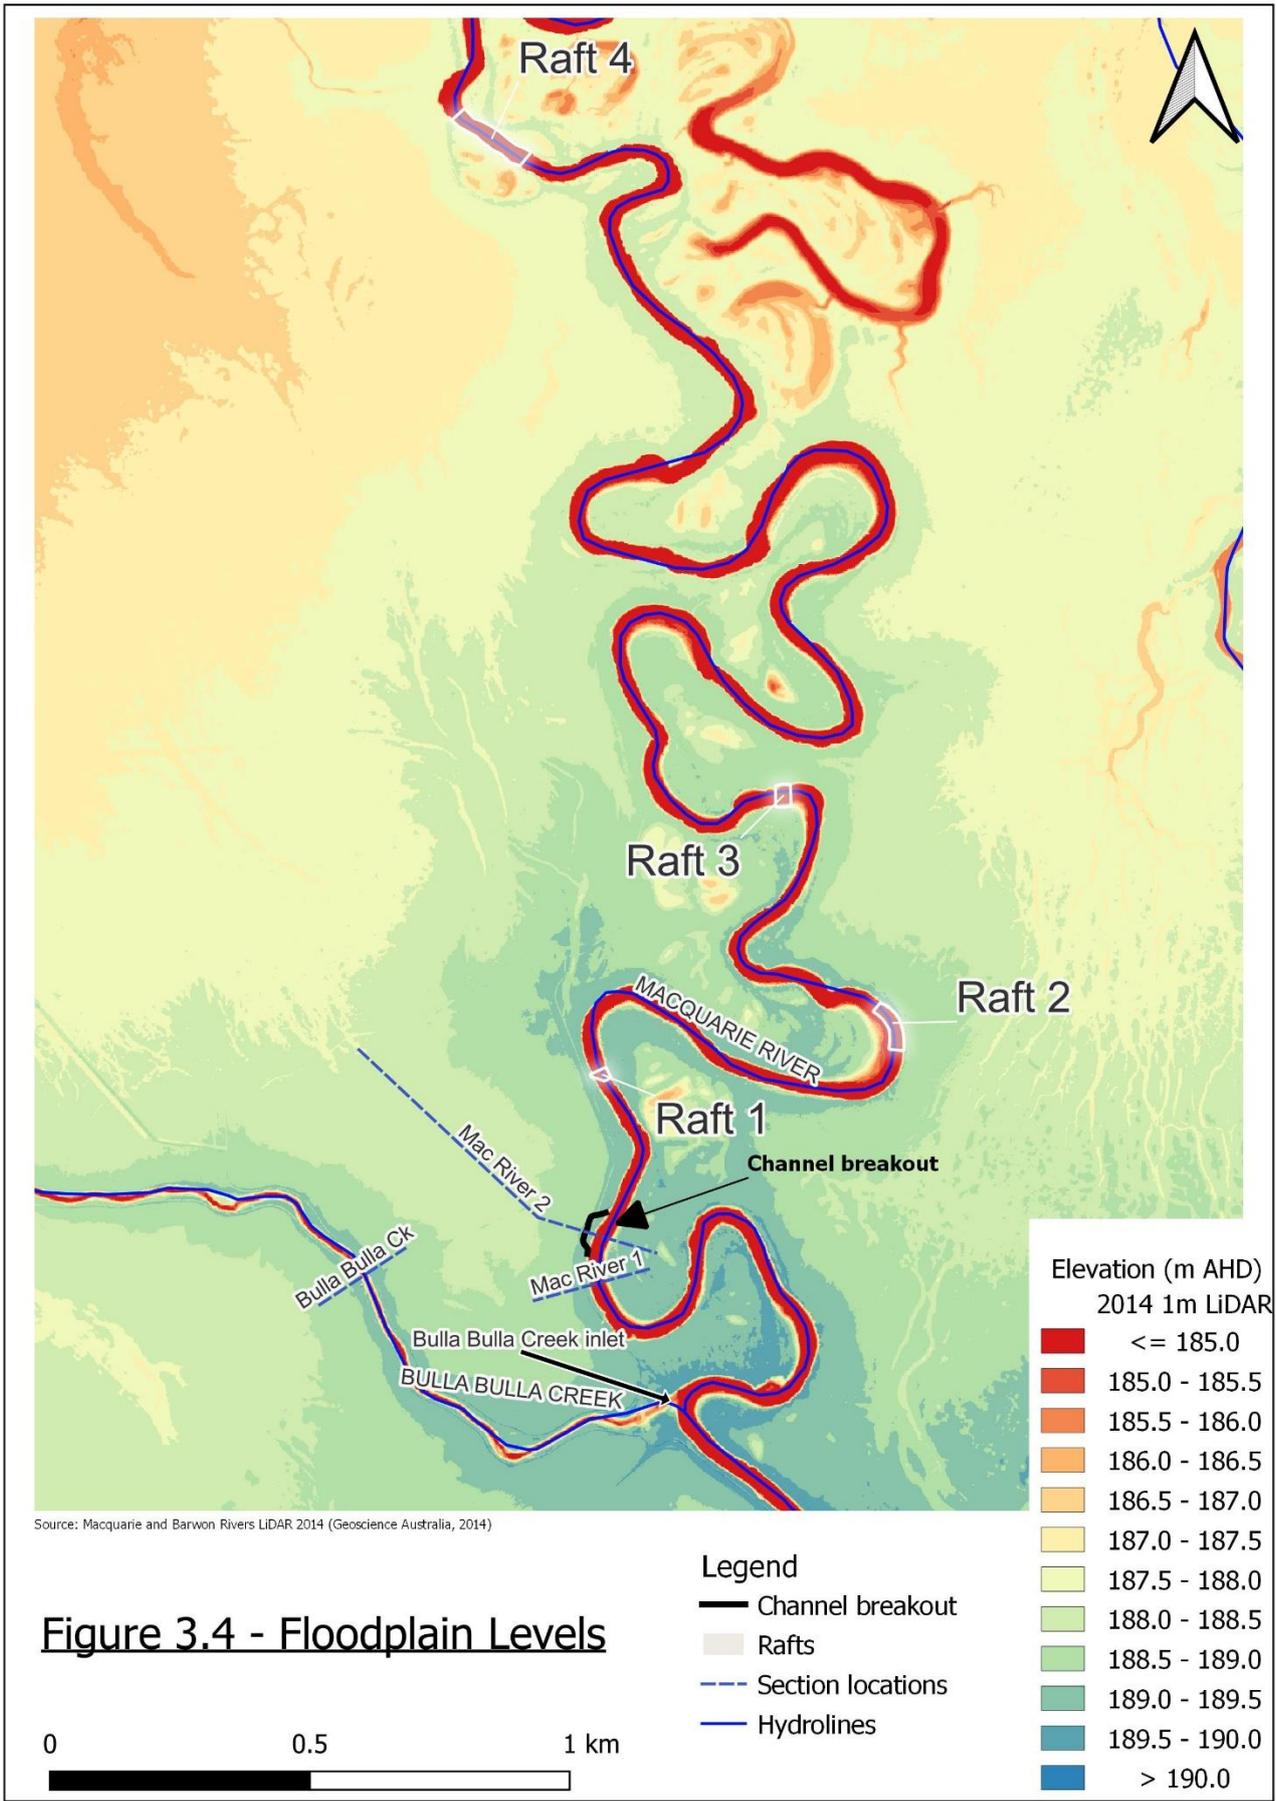
Figure 3.2 Floodplain levels

- Figure 3.2 shows floodplain levels;
- Figure 3.3 compares channel cross-section of the Macquarie River (referred to as Mac River 1) and Bulla Bulla Creek. The cross-section locations are indicated in Figure 3.2; and
- Figure 3.4 is a long-section of the Macquarie River channel, from Raft 4 to the Bulla Bulla Creek inlet.

the river corridor (which refers to the channel and adjoining billabongs) and there is no evidence of overflows to the adjoining floodplain area. The constructed levee (indicated in the photograph) may have contained the out-of-channel flows to the river corridor. The extent of this levee is also evident in Figure 3.2.

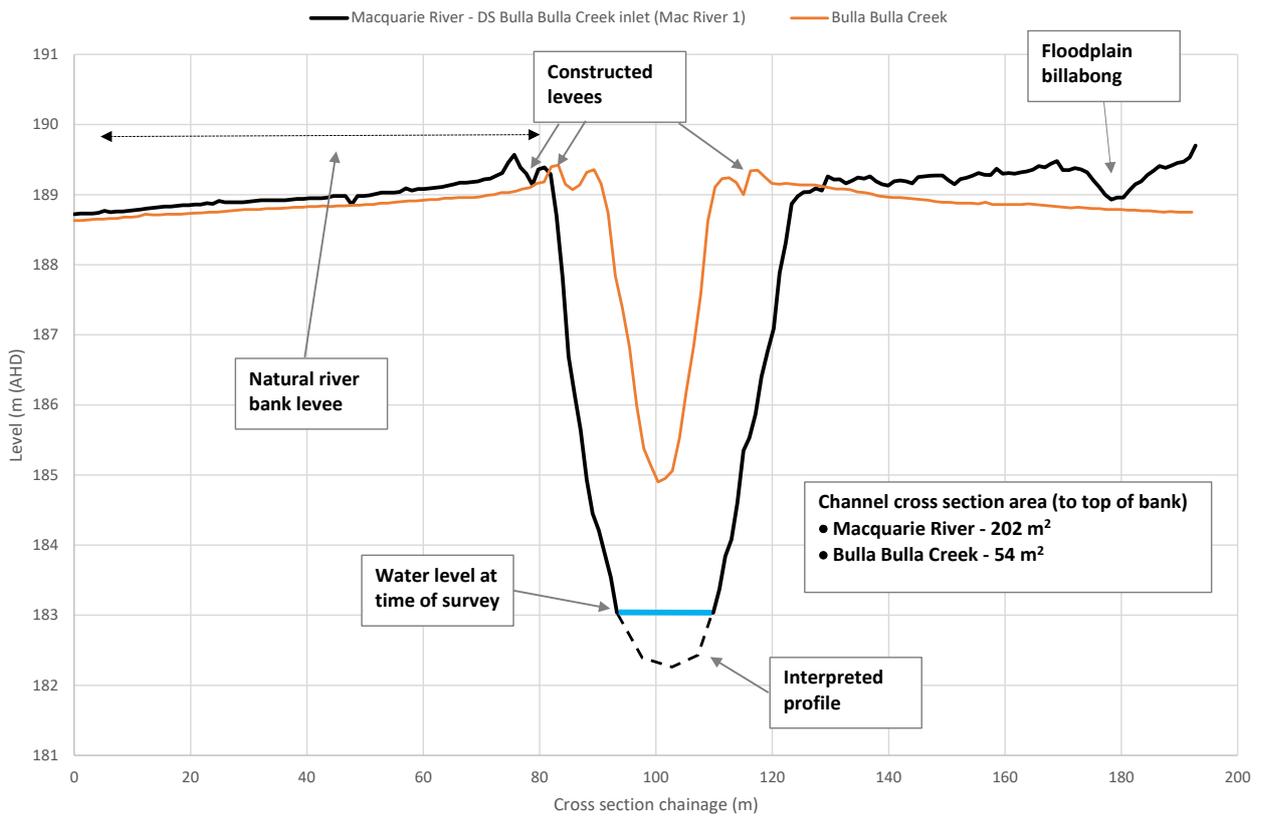
Figure 3.3 Bulla Bulla Creek and Macquarie River channel sections

- The Macquarie River and Bulla Bulla Creek have natural riverbank levees which have formed overtime by sediment accretion processes. These levees typically occur adjacent to the channel and floodplain billabongs (which are collectively referred to as the river corridor in this report). Due to these levees, the river channel top-of-bank is typically around 0.5 to 1.0 m higher than the adjoining floodplain. This means that when the river is flowing at bank full, the water in the channels (and greater river corridor) is perched relative to the floodplain and any overflows from the channel will spill to the floodplain and will generally not re-enter the channel. Examples of natural riverbank levees are noted in Figure 3.3.

- Constructed levees that are approximately 0.3 to 0.5 m higher than the natural riverbank levees have been established along the interface between most paddocks and the river corridor. Constructed levees are evident in the Macquarie River (left bank only) and Bulla Bulla Creek cross-sections in Figure 3.3.

- The Macquarie River channel area (to top-of-bank) is approximately four times larger than the Bulla Bulla Creek channel area (see Figure 3.3). This means that when the river is flowing at bank full, the Macquarie River Channel has approximately four times the capacity of Bulla Bulla Creek. However, this ratio could be impacted by the partial channel blockage caused by the debris rafts.

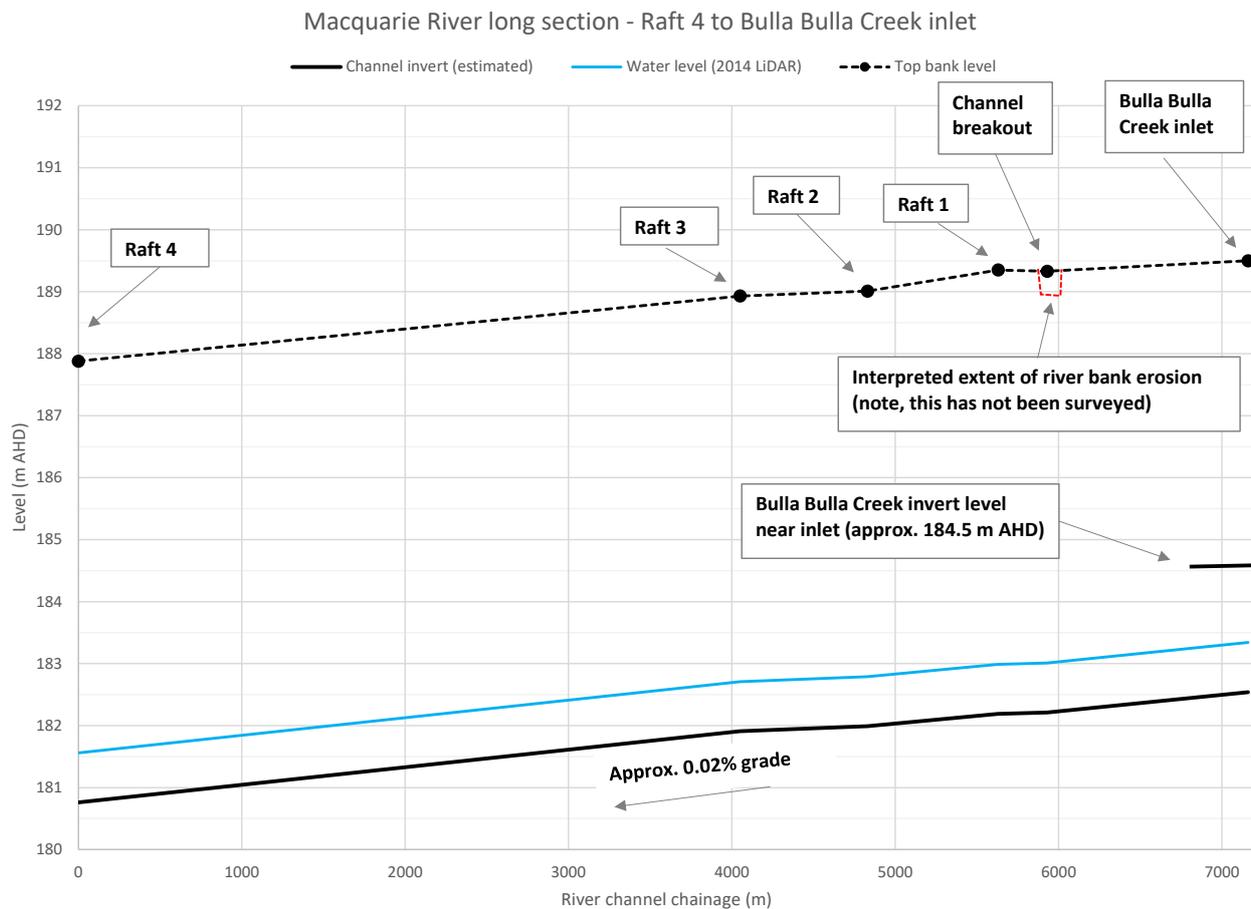
**Figure 3.4 Macquarie River long section – Raft 4 to Bulla Bulla Creek inlet**

- Figure 3.4 shows the longitudinal profile of the Macquarie River between Raft 4 and the Bulla Bulla Creek inlet. The figure includes the interpreted channel invert, river water level (at the time of survey) and top-of-bank all which grade at approximately 0.02% (1 m of fall for every 5 km of river reach). The interpreted extent of riverbank erosion (or scour profile) at the channel breakout location is also shown. The following conclusions can be made from this figure:

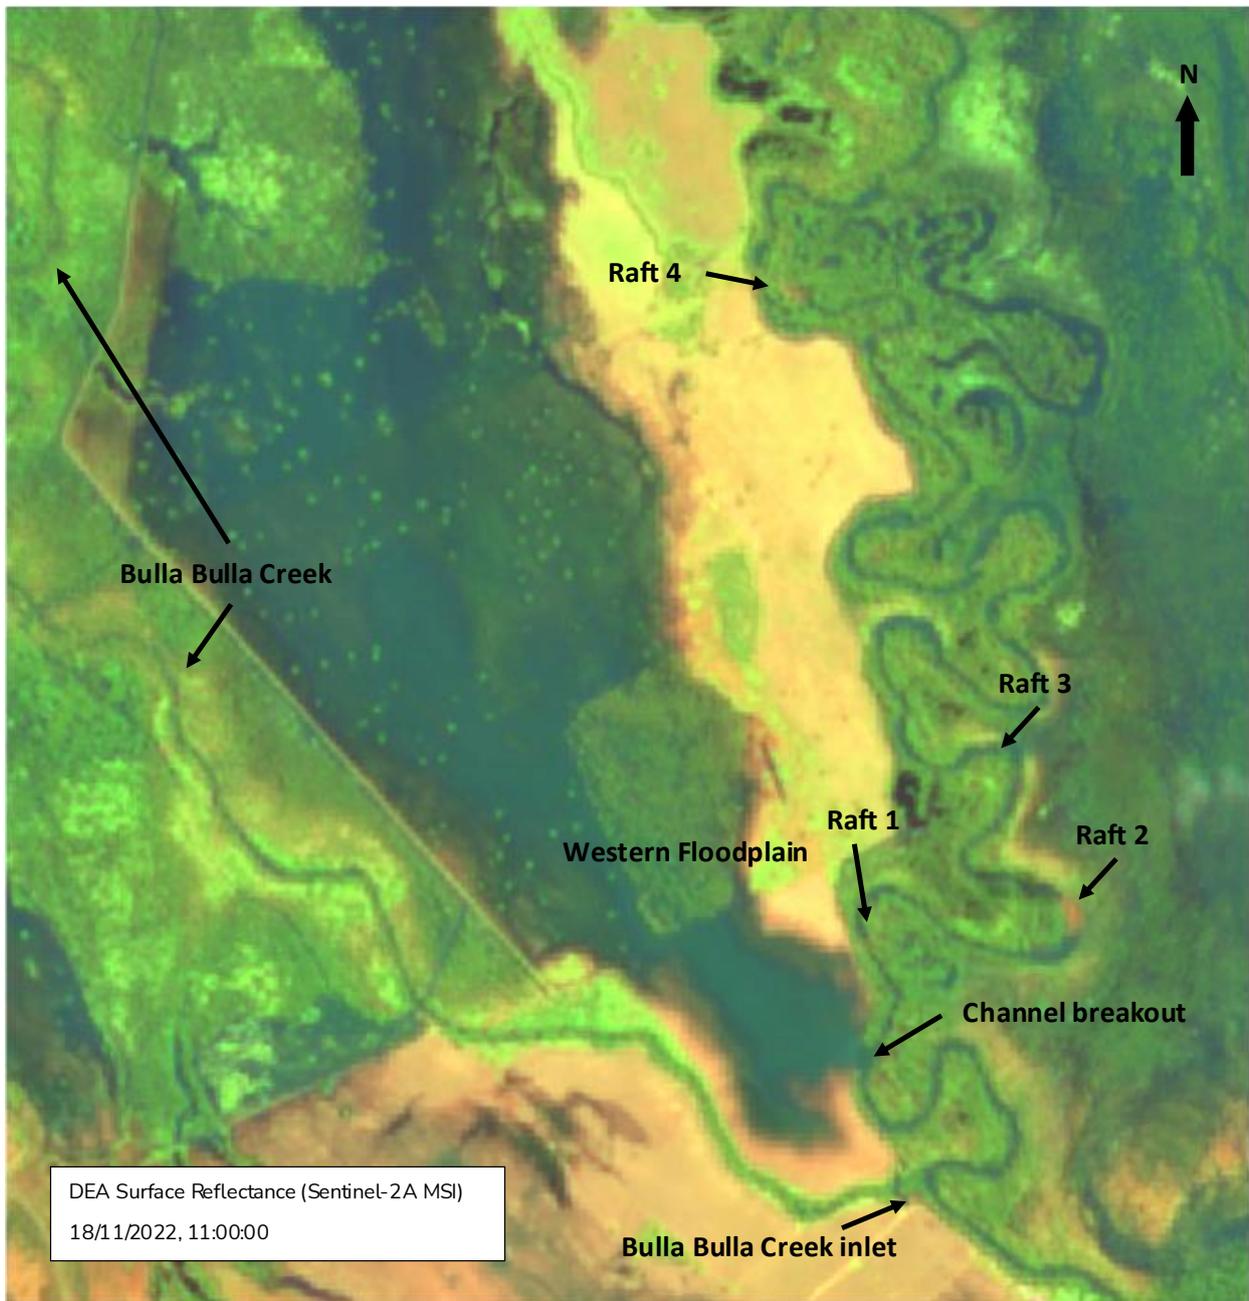
- Floodwaters spilled from the channel onto the adjoining western floodplain at the channel breakout location. Overflows at the channel breakout are also evident in imagery from the December 2021 and August and September 2022 floods and appear to occur when the streamflow at the Warren Weir gauge (421004) exceeds 12,000 ML/day.

- There is no evidence of channel overflows to the floodplain occurring at any of the raft locations.
- Floodwaters that spill from the channel breakout accumulate on the western floodplain which overflows to Bulla Bulla Creek. Bulla Bulla Creek re-joins the Macquarie River Channel downstream of Raft 6 (indicated in Figure 3.6) and would return some water to the Macquarie River Channel. However, Bulla Bulla Creek appears to overflow to floodplain areas to the north-west (evident in Figure 3.6 only). This water does not appear to re-enter the Macquarie River Channel. It is noted that this flooding regime is consistent with descriptions provided by local community members during the site visit.

**Figure 3.5** Satellite imagery – Rafts 1 to 4 (18 November 2022)

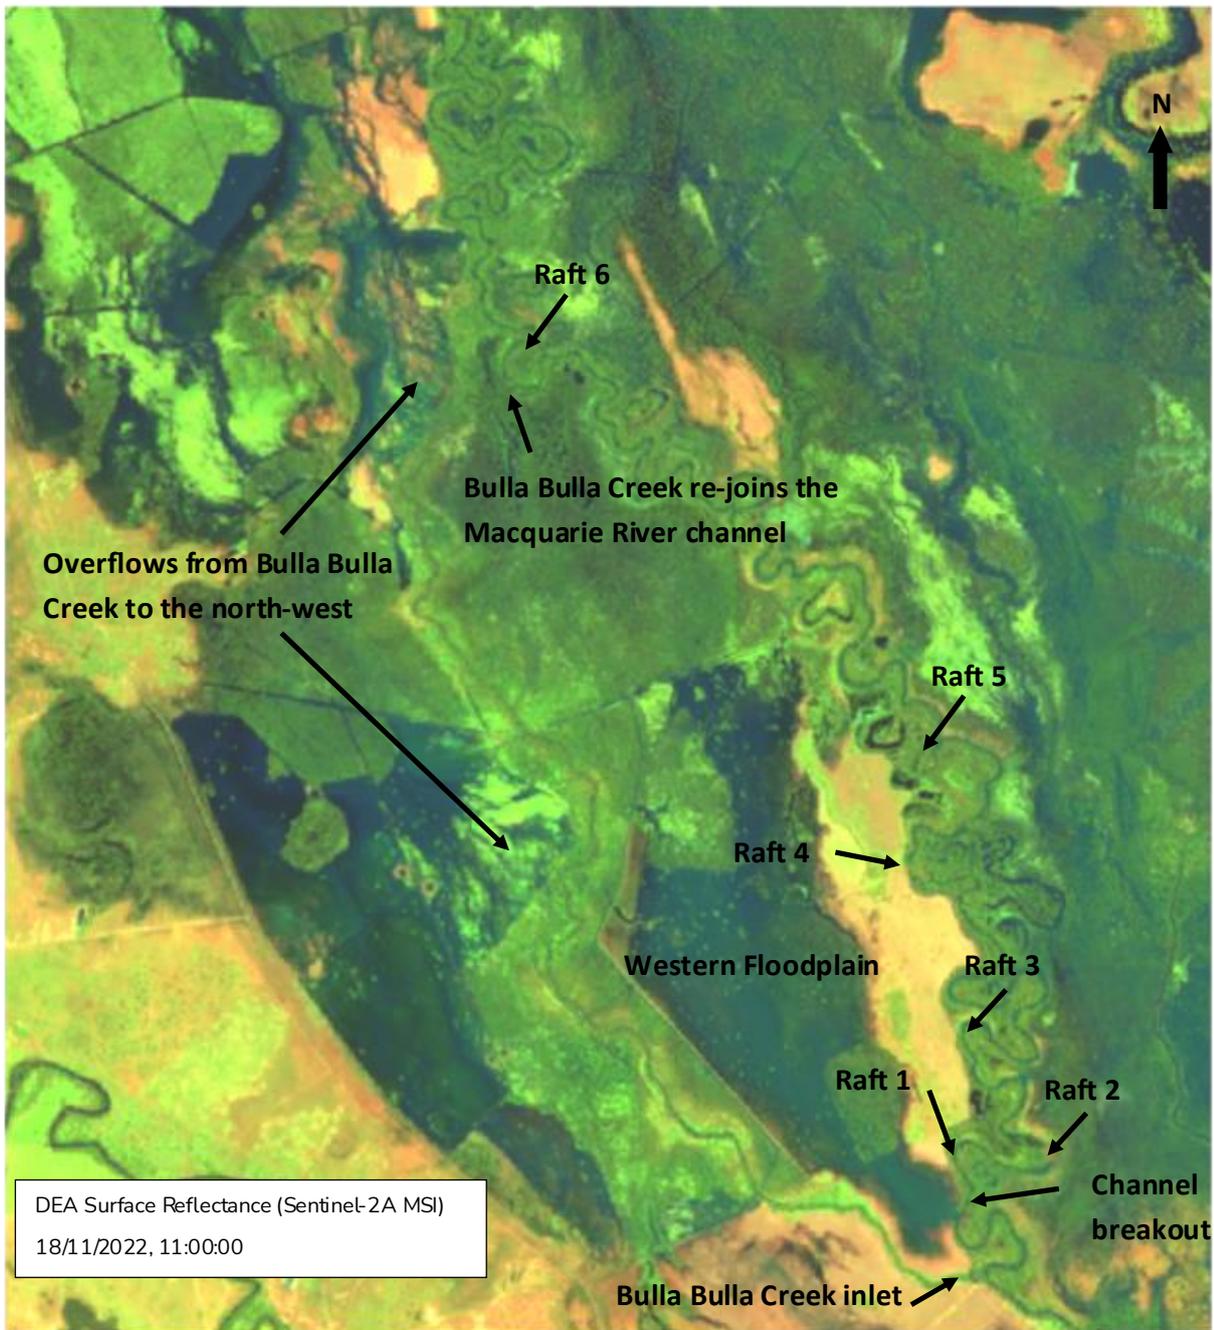
**Figure 3.6** Satellite imagery – Rafts 1 to 6 (18 November 2022)

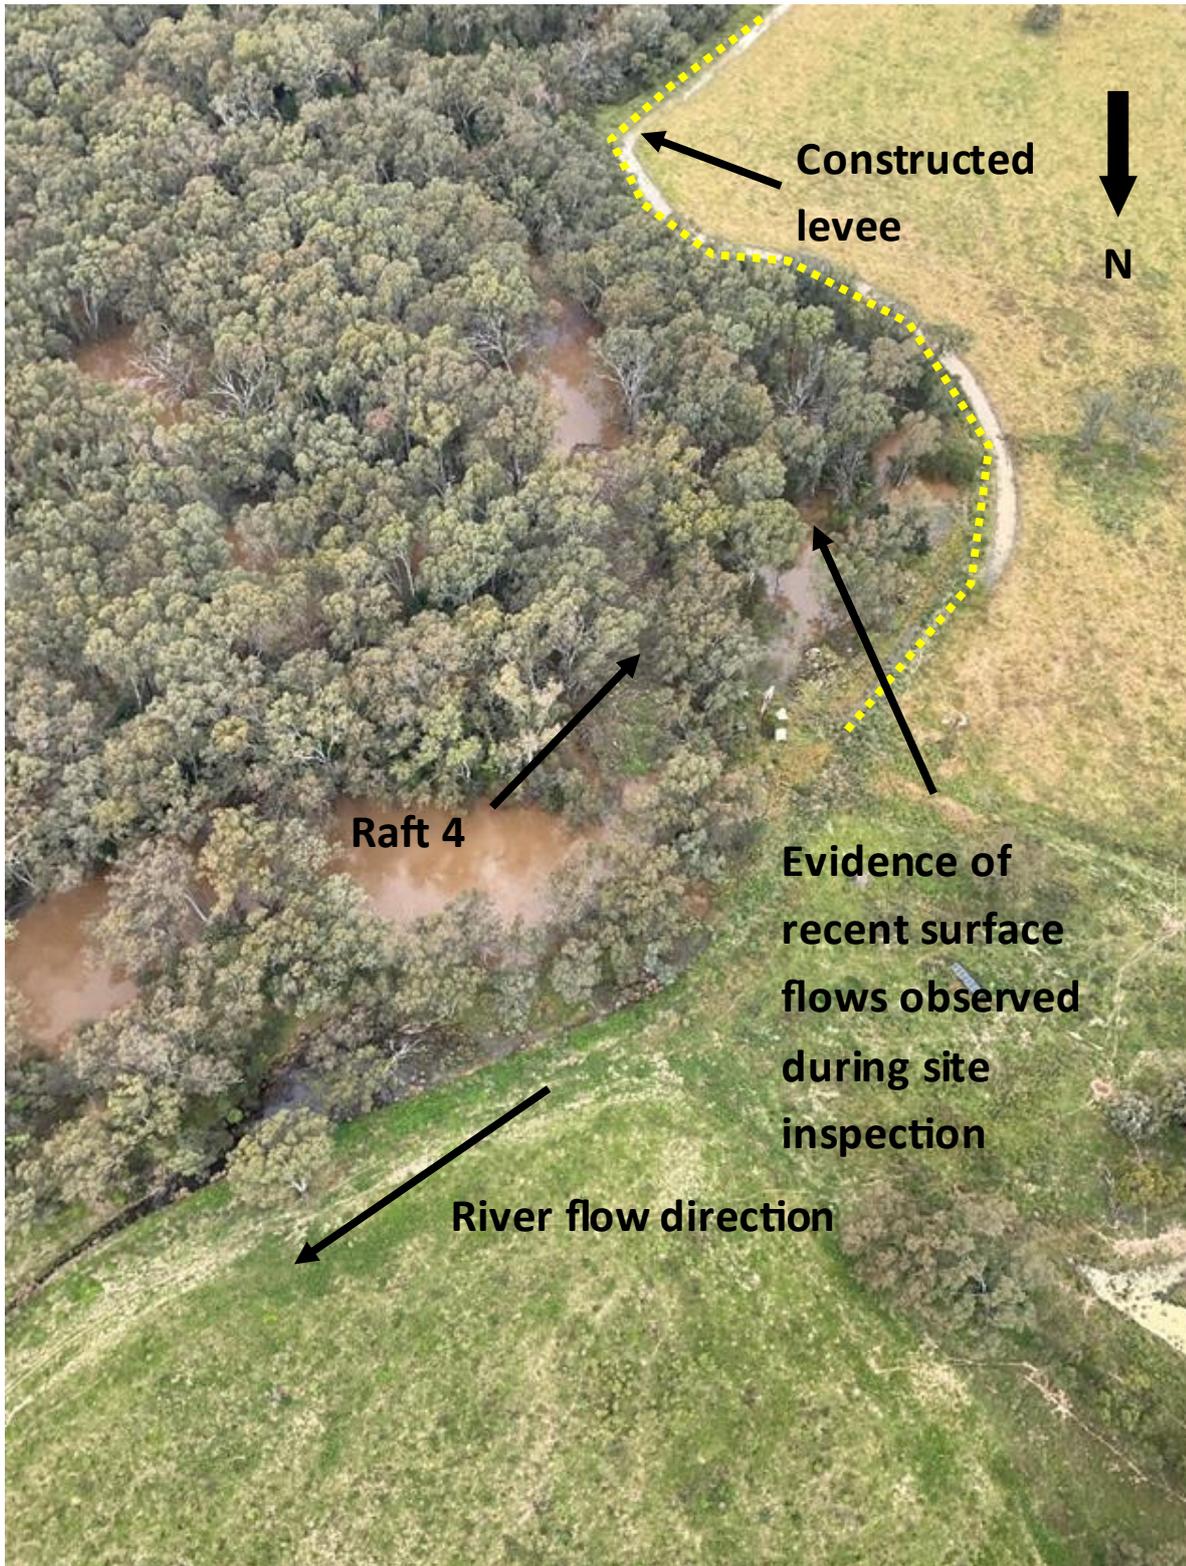
Photograph 3.1 is of the Raft 4 location, looking upstream. This image shows that out-of-channel flows occurred around Raft 4 on both sides the channel (but within the river corridor), which aligns with site observations that recent out-of-channel flows occurred around the western flank of the raft through an area that comprises a shallow billabong (see Section 2.3.4). The photograph shows that out-of-channel flows were maintained within

**Photograph 3.1** Aerial image of Raft 4 – 27 October 2022

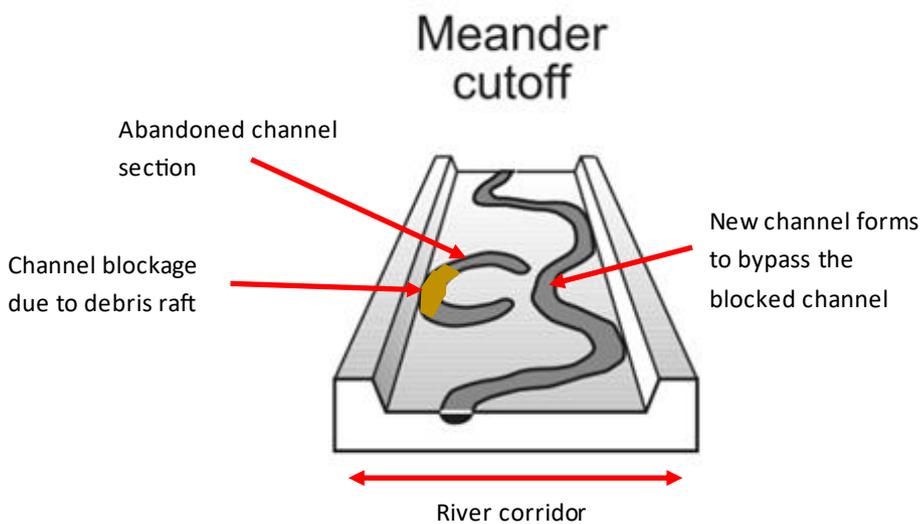
**Figure 4.1** Meander cutoff process

If out-of-channel flows occur within the river corridor it is possible that a new channel could develop within the corridor that bypasses the blocked portion of the existing channel. This would be similar to a meander cutoff process that occurs naturally within the Macquarie River corridor due to the lateral migration of the channel. If this were to occur, it would be of little consequence as the Macquarie River would still flow through the river corridor and the abandoned channel would become a billabong overtime. Figure 4.1 shows the meander cutoff process.

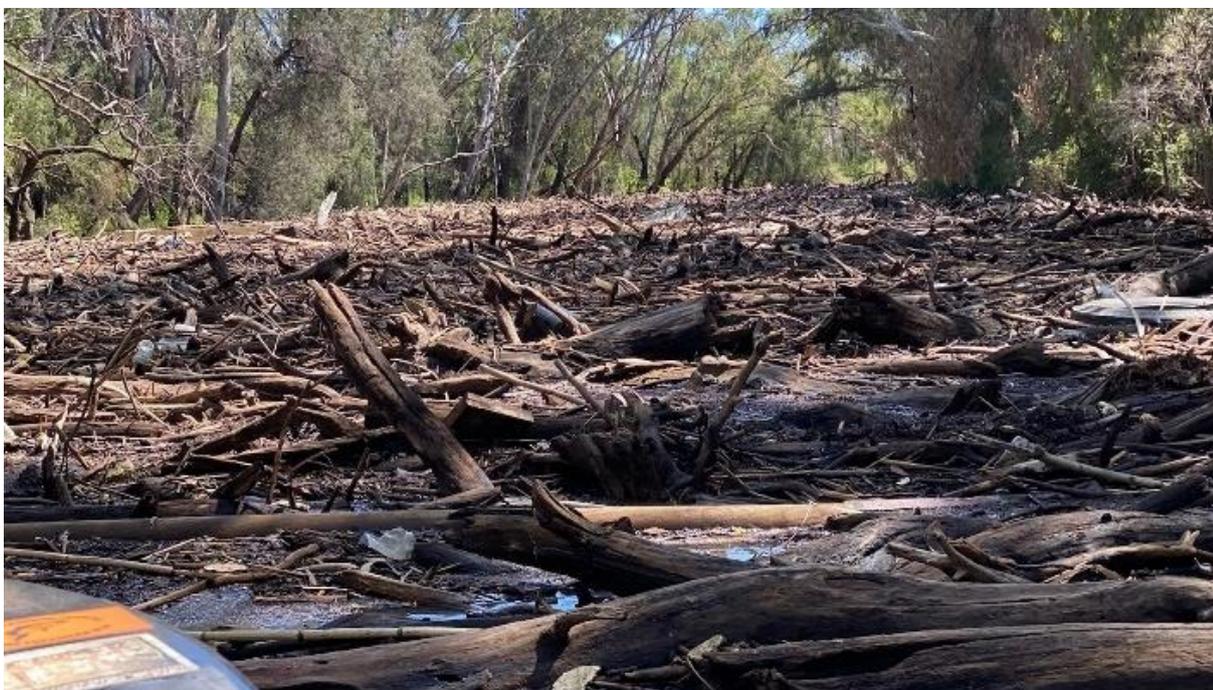
**Figure B.9** large raft downstream of channel breakout – around 15 October 2022

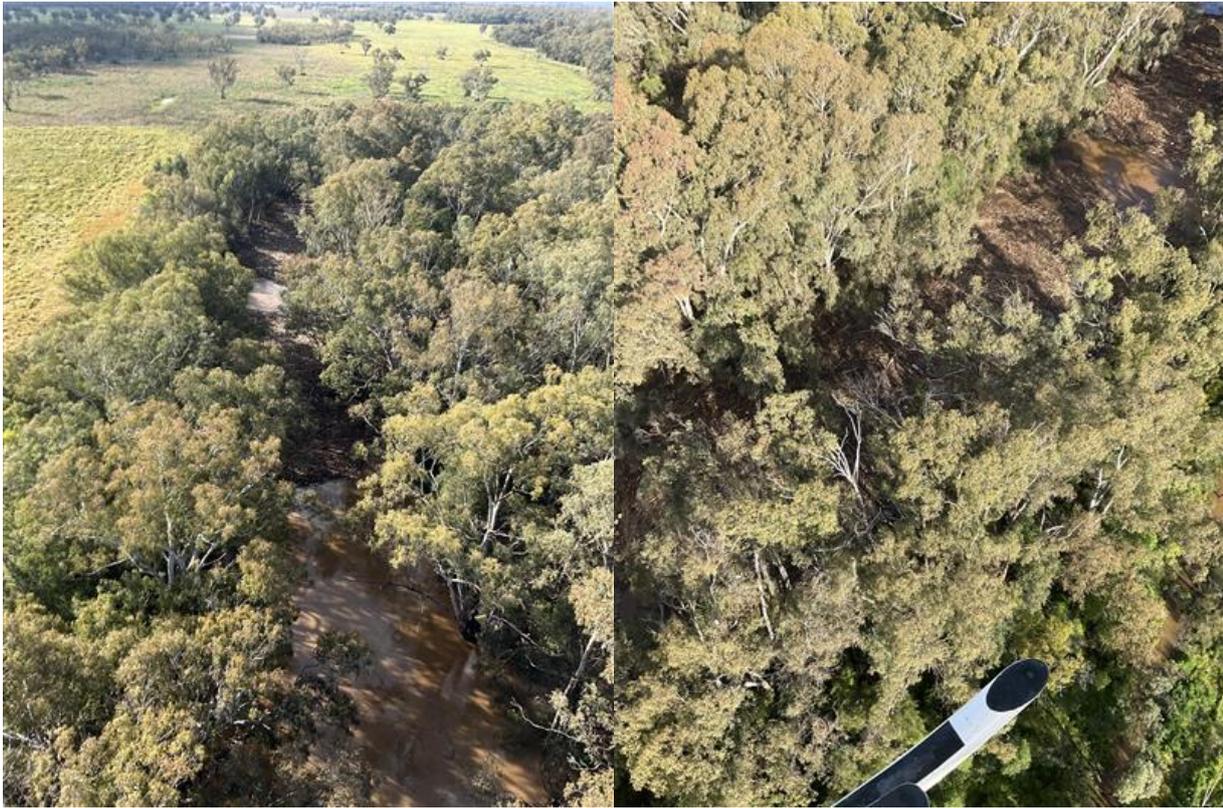
**Figure B.10** Aerial images of the large raft downstream of channel breakout – 15 October 2022
